RE: Massey South Lake Dam
MS00071
Panola County, MS

FORMAL INSPECTION CHECKLIST

MASSEY SOUTH LAKE DAM

Panola County, MS
Dam Inventory MS00071

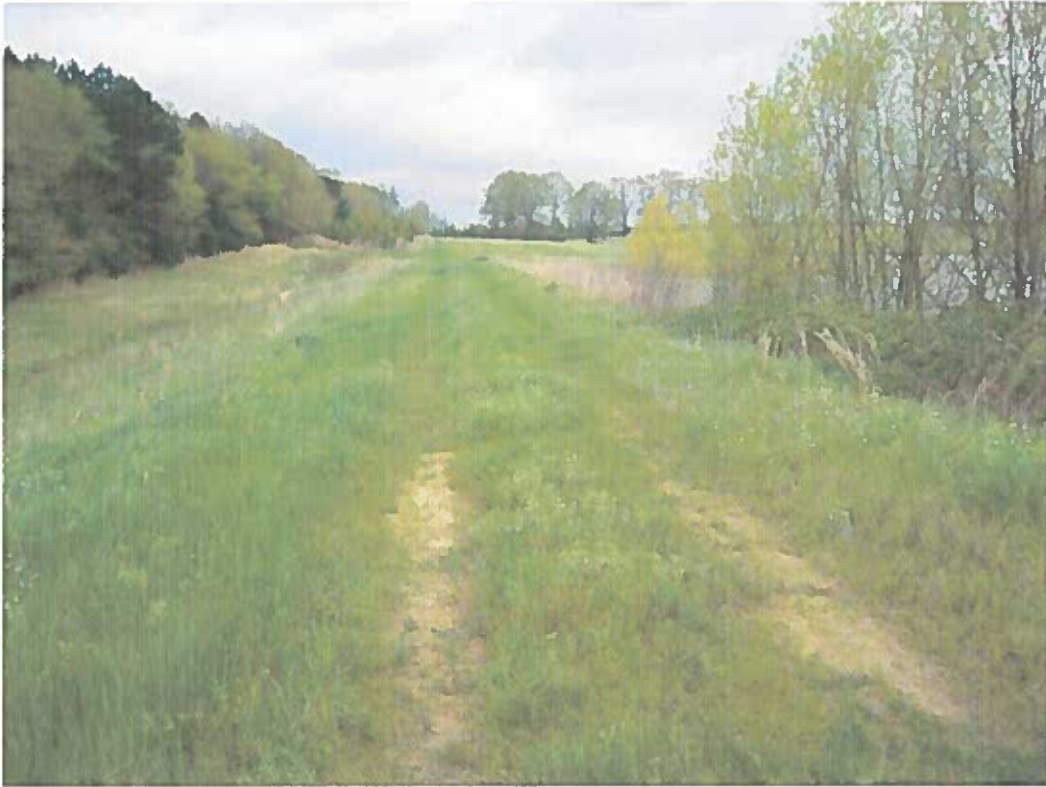
Small trees and brush present on upstream crown of levee

Top of dam

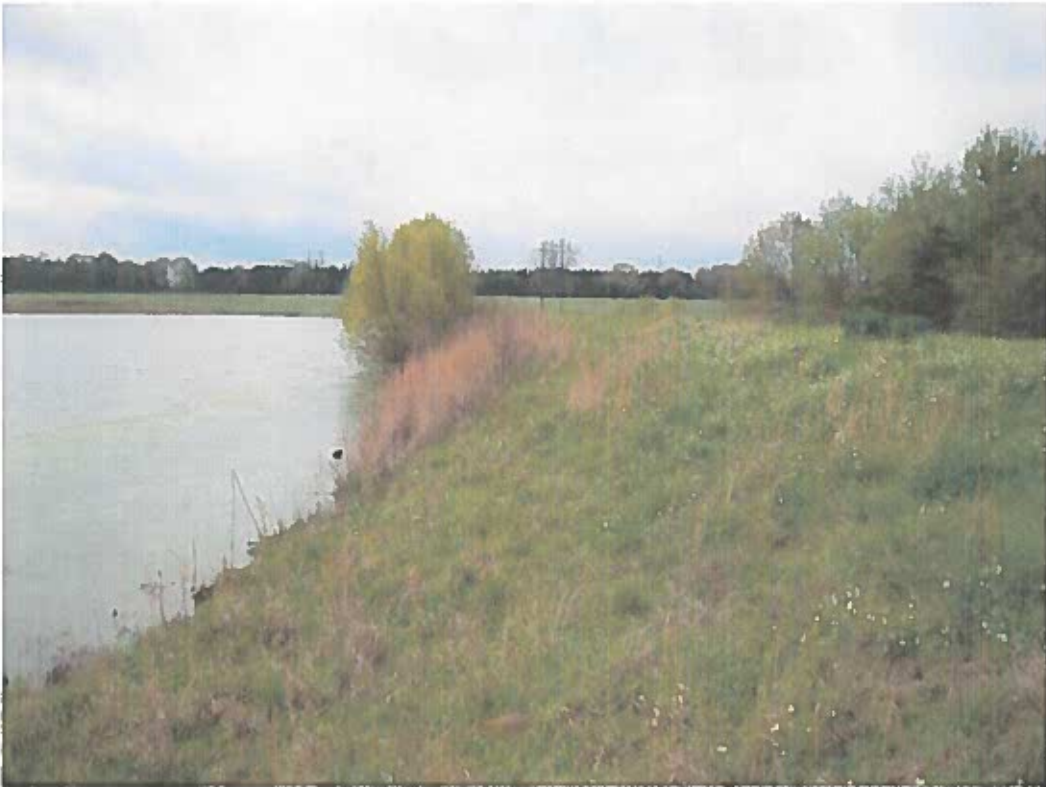
Small trees and brush present on slope

Comments: Old beaver activity present in a few locations; no recent activity observed

Upstream slope

Remove trees and brush from upstream slope
Repair old beaver damage to upstream slope
Repair one sinkhole/beaver damage on downstream slope

Increase frequency of maintenance (mowing, tree removal, etc.) on upstream slope

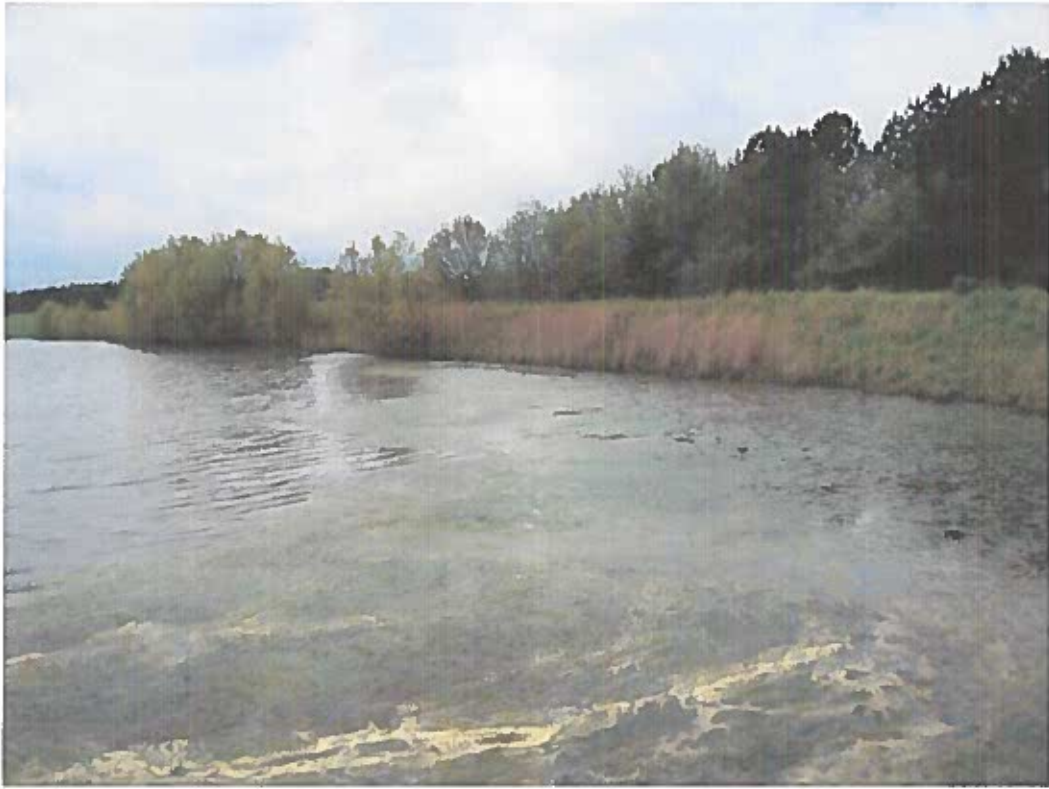
Upstream slope

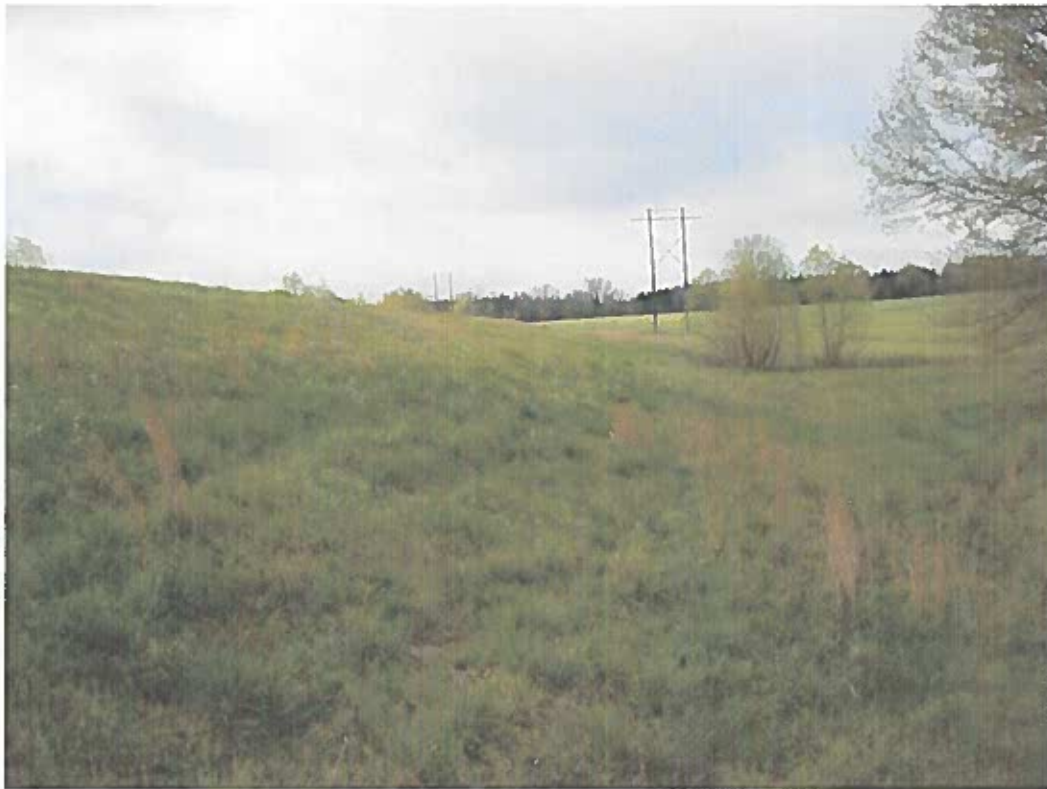
Comments: One isolated sinkhole or old beaver activity noted about 200 feet from north end of dam

Downstream slope

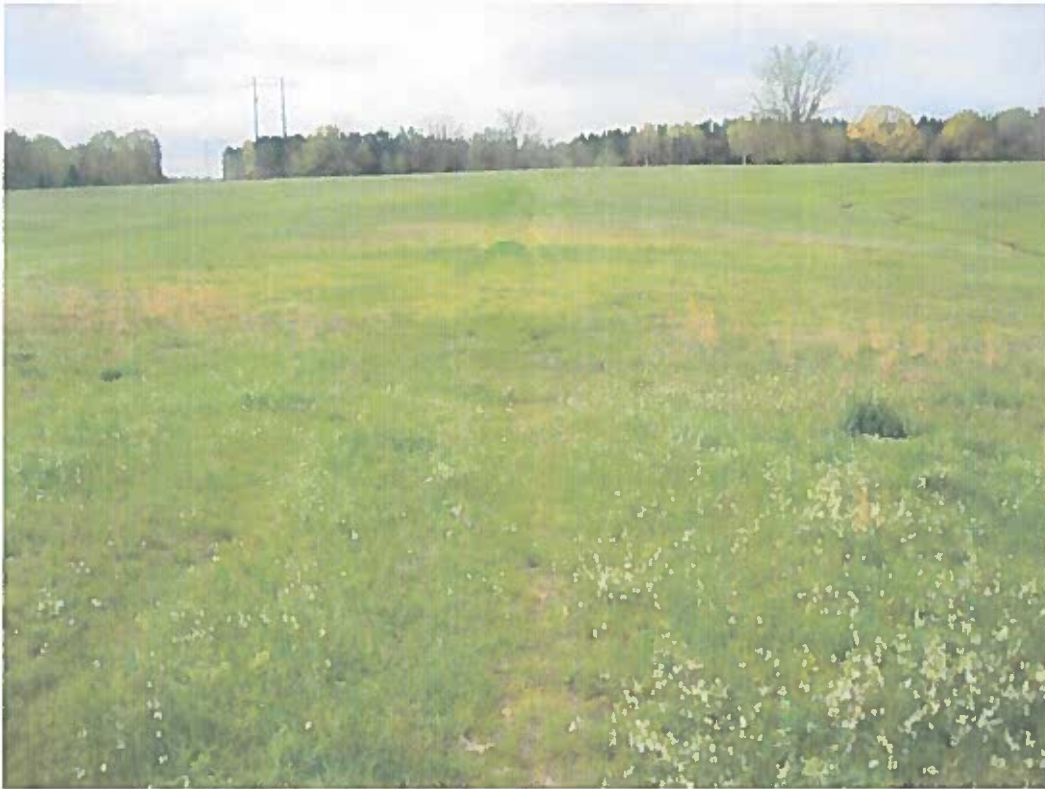
Emergency spillway control section

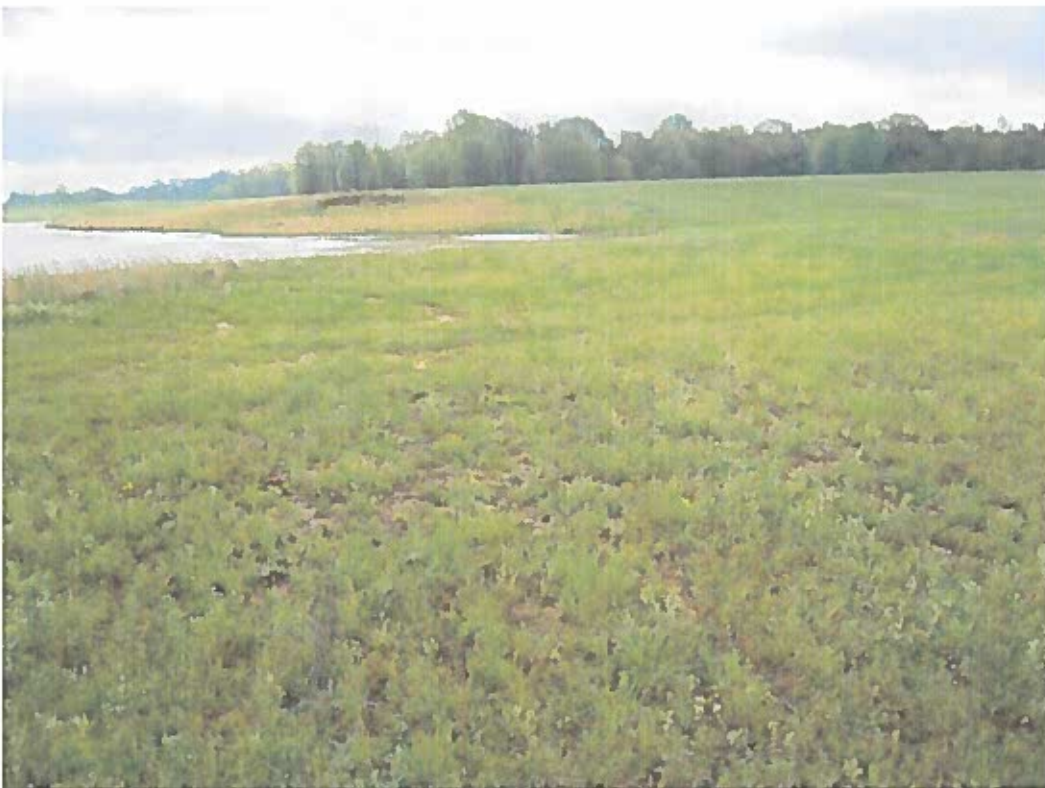
Emergency spillway inlet section

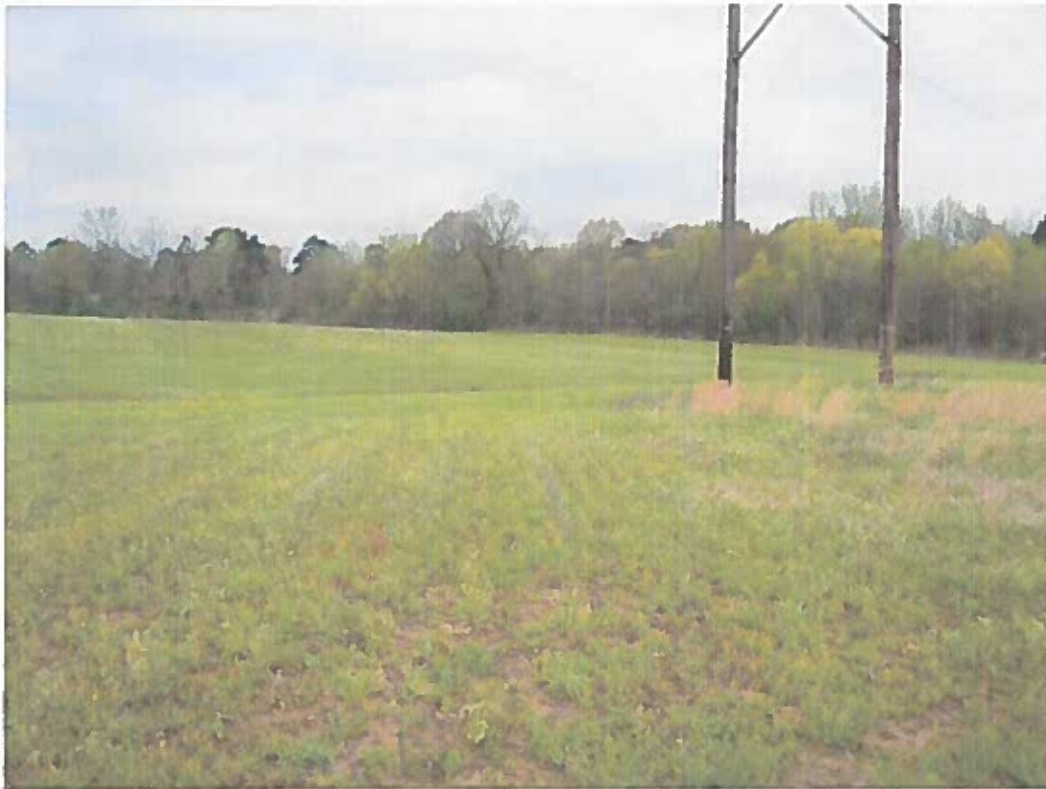
Emergency spillway outlet

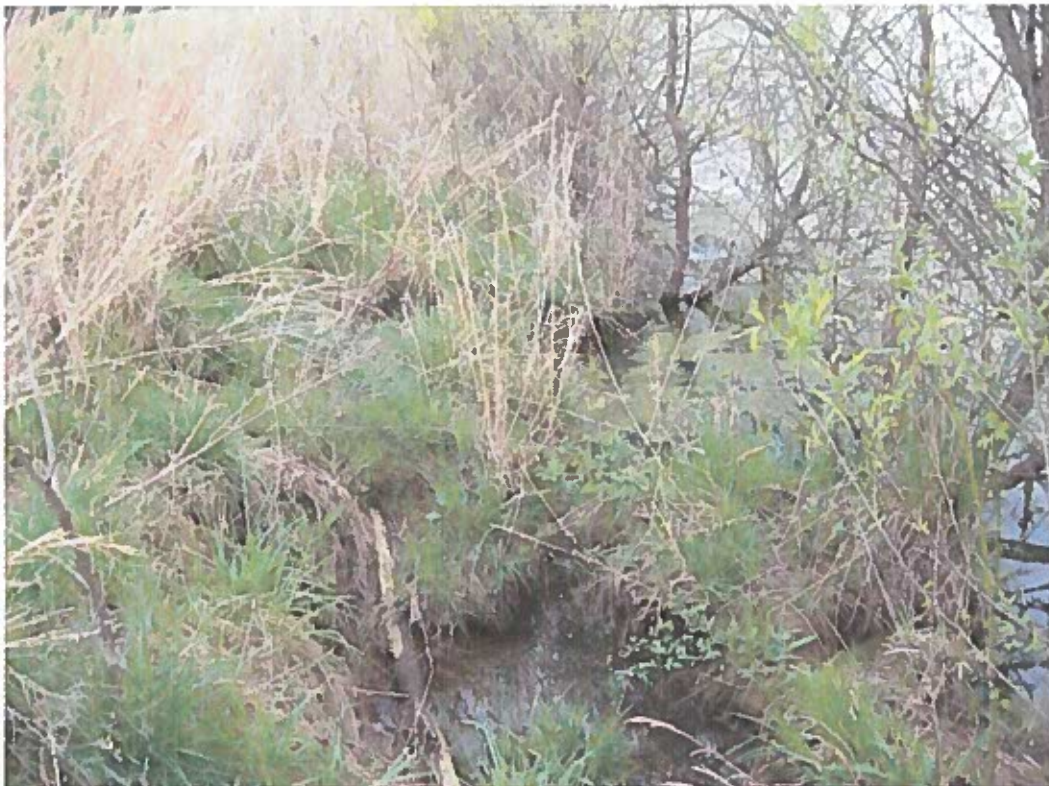
Old beaver activity

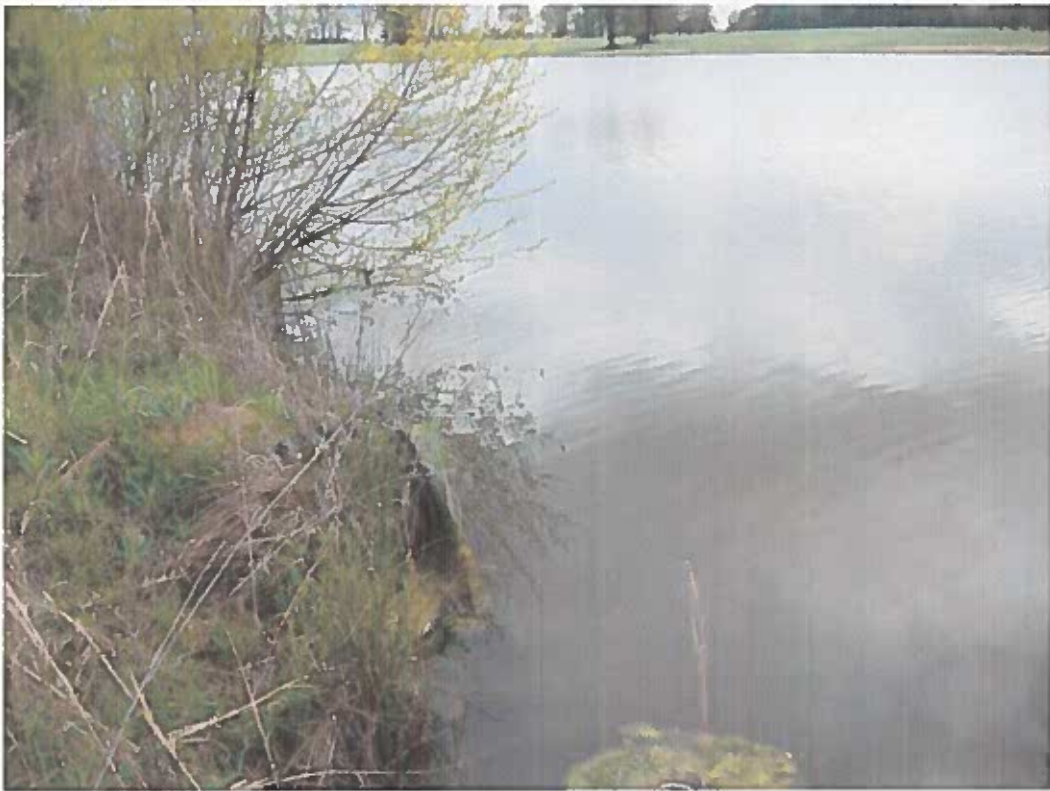
Principle spillway inlet
