Formal Inspection Checklist

DAM NAME: *Lake Tiak-O'Khata Dam*

DAM INVENTORY NO: *MS00189*

Field Inspection Photos – Lake Tiak-O'Khata Dam
January 11th & 20th, 2018

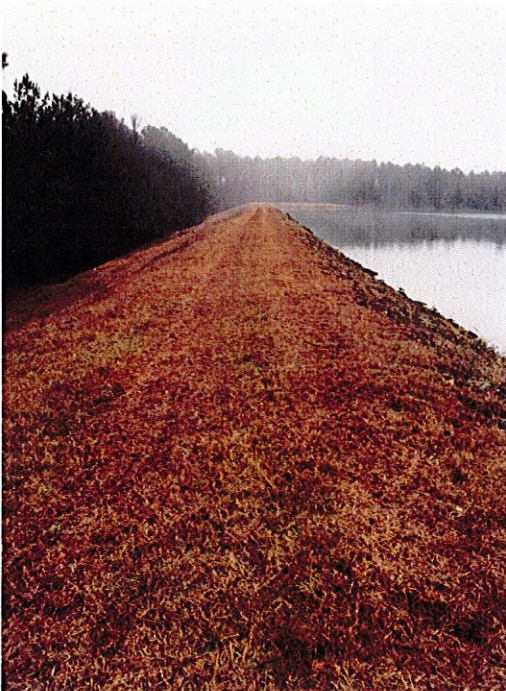
Dam Crest looking south from Station 12+00

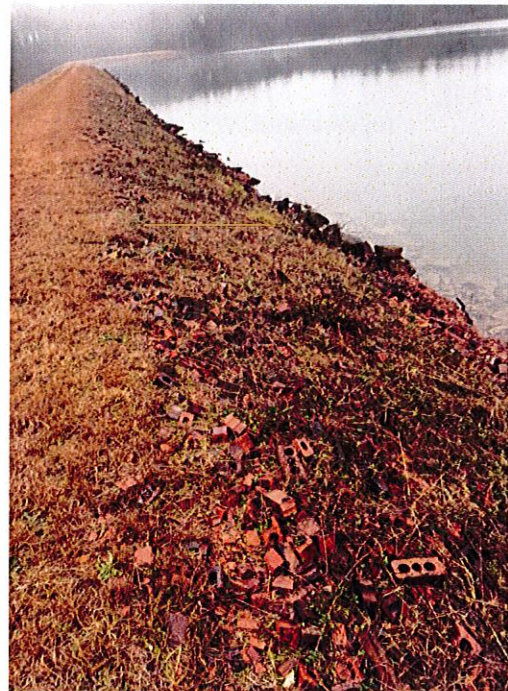
Upstream slope looking south from Station 12+00

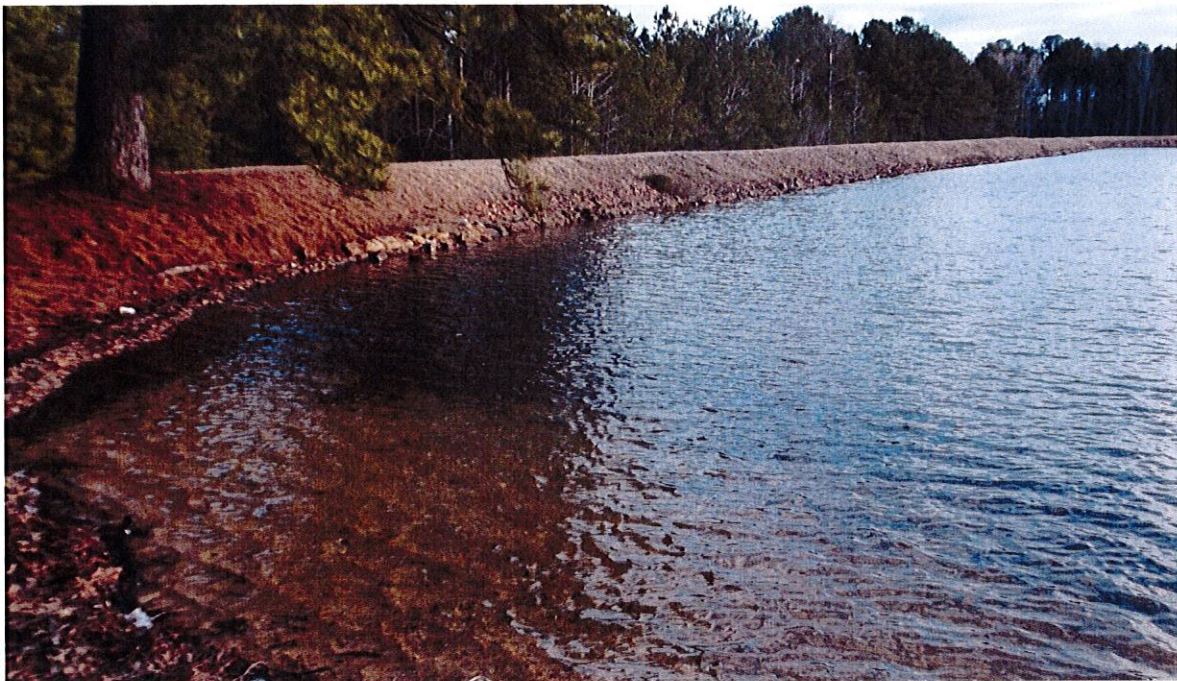
Upstream slope looking south from the Primary Spillway

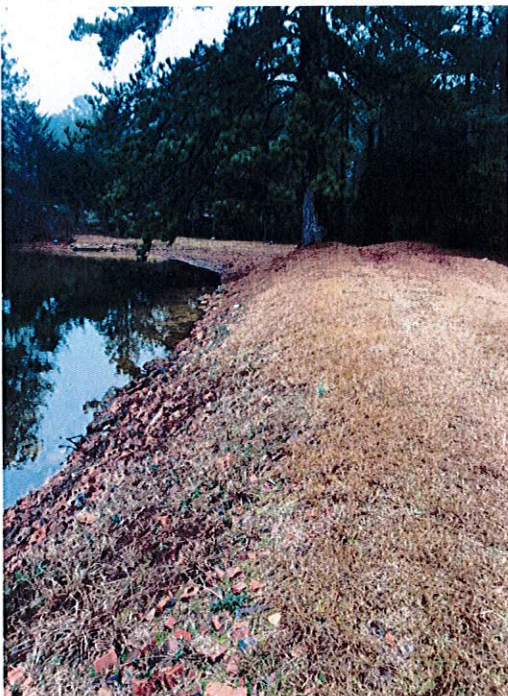
Looking North toward Primary Spillway
From Station 11+00

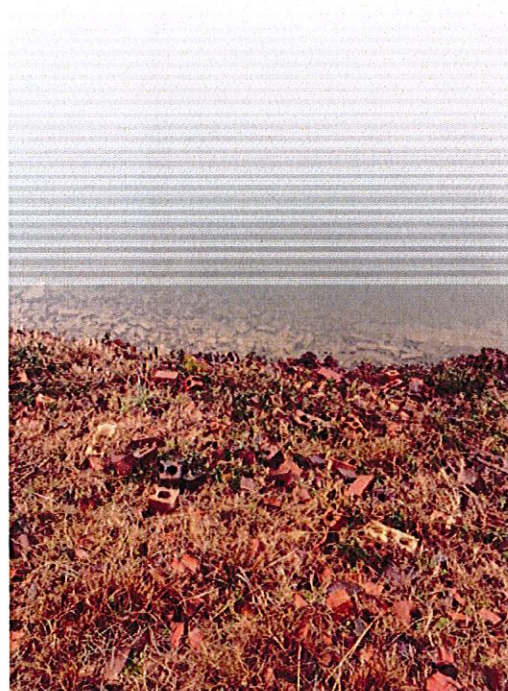
Rip-rap (mostly comprised of old brick) sparse on southern end. Minor wave erosion and scarps. Holes along top of banks indicate rodent activity.

Brick erosion/wave protection

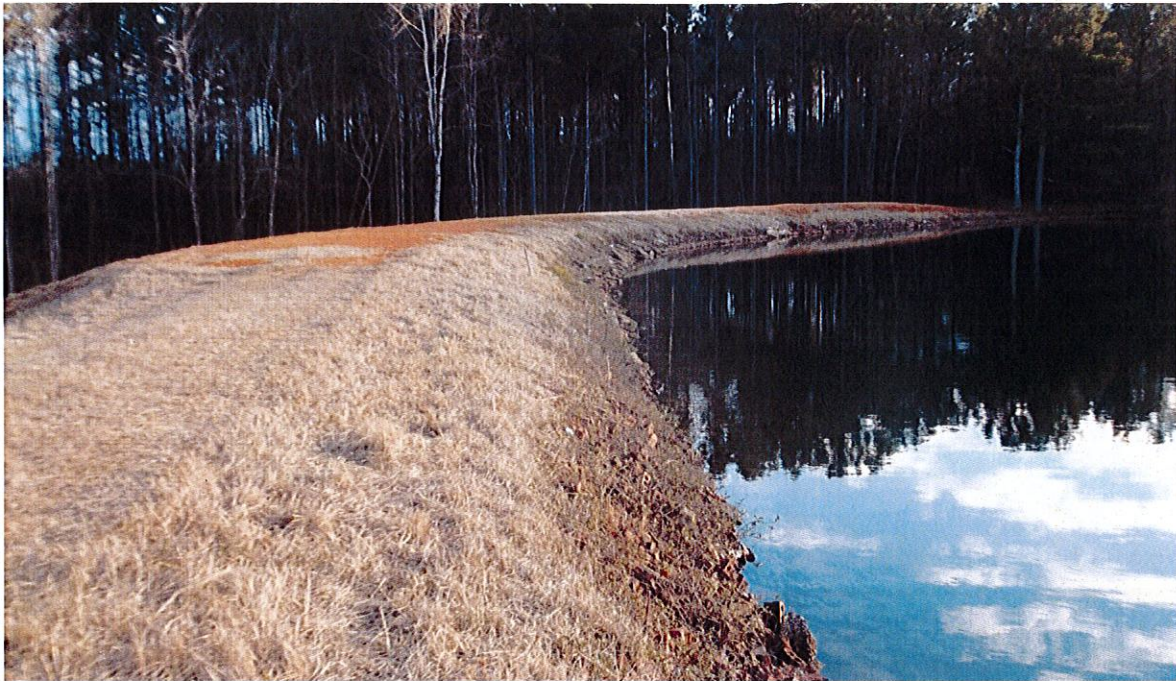
Looking South from Station 5+00 - South end of levee and Emergency Spillway beyond

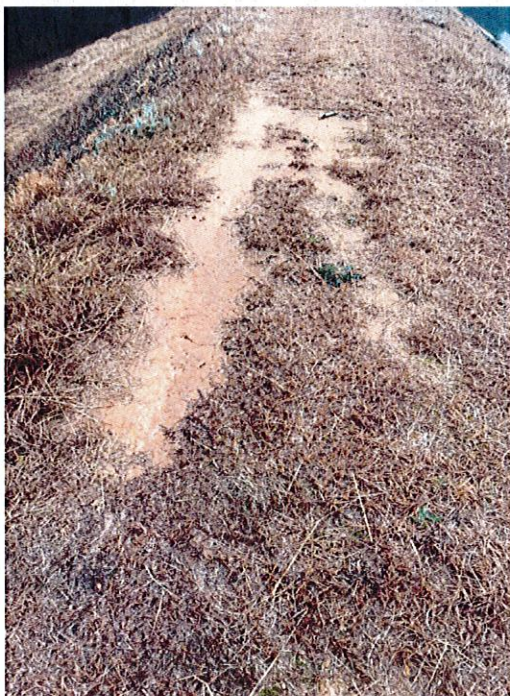
Vegetation wearing on dam crest; Station 6+50

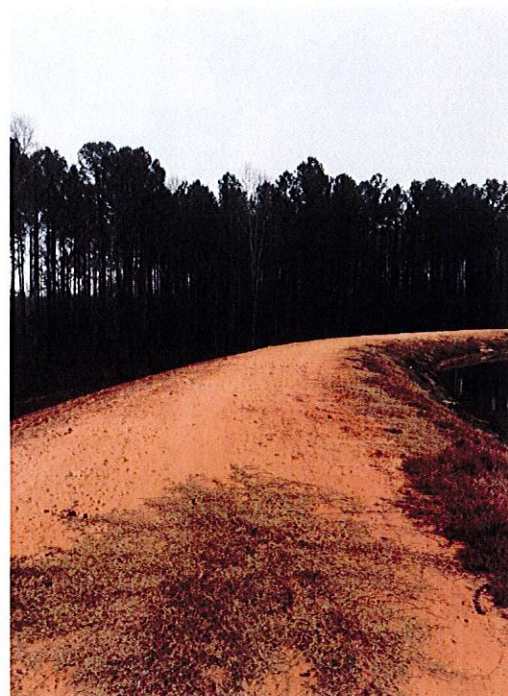
- *No established vegetation on south end at rehabilitated embankment*
- *Small Rills beginning to form*
- *Current design criteria requires crest to be constructed a minimum of 14' wide.*

Looking South from Station 4+00; Dam Crest on south end; recently rehabilitated; Vegetation Required

- *Revegetate failed grass vegetation on crest of dam on southern end (approximately 400 linear feet of crest). Includes re-grading rills where required.*
- *Improve Grass vegetation stand on downstream slope of rehabilitated section on southern end of levee.*
- *Fill and repair rodent holes on upstream slope of dam, as well as downstream slope.*
- *Continue to monitor seepage during owner's inspections*
- *Plug 6" black steel pipe located near crest of dam at station 9+00 with concrete grout. The original purpose of this pipe is unknown.*
- *Continue to monitor primary spillway and exit chute for undermining or loss of armor protection.*

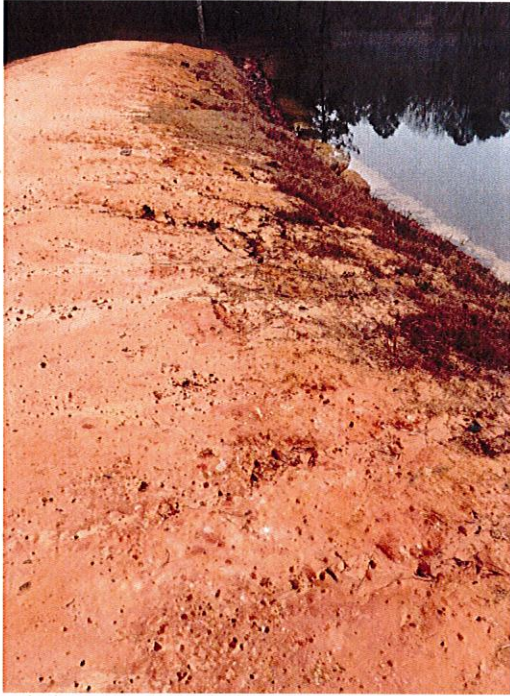
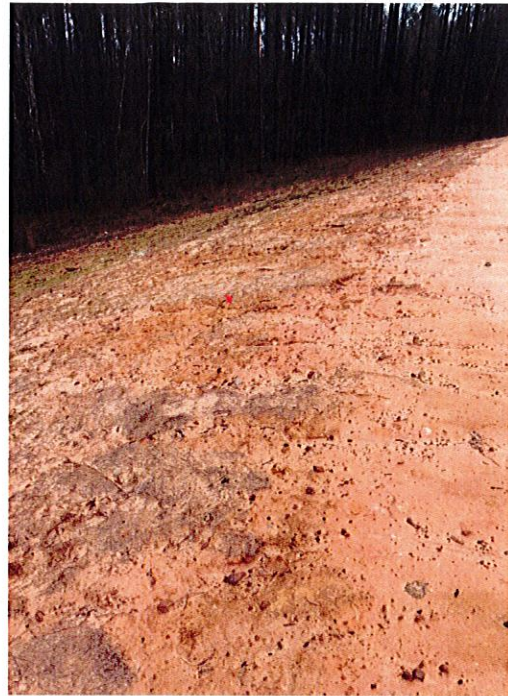
Rehabilitation of the downstream slope of the dam between levee stations 1+00 and 4+00 was completed in 2016. Vegetation is light on the slope of the rehabilitated area resulting in rill and minor gully erosion.

Rill and gully erosion forming on crest and upstream/downstream slopes at south end of levee

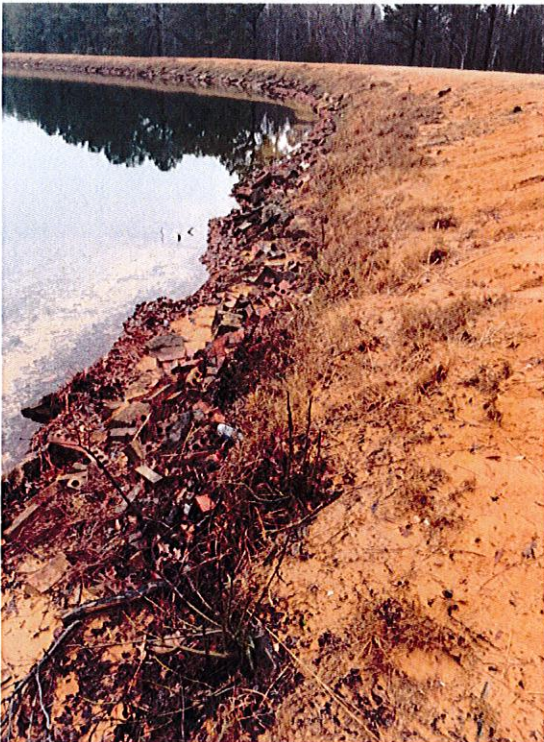
Looking North - Station 1+50

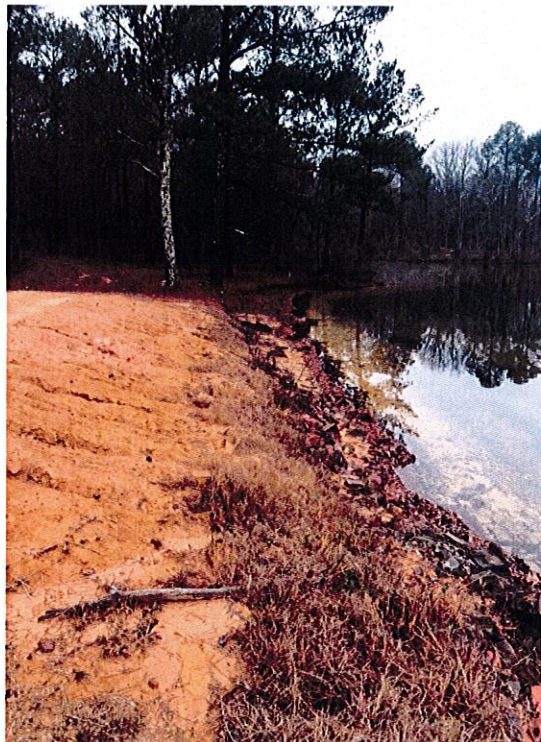
Looking South – Station 1+50 South end of Levee. Emergency Spillway beyond.

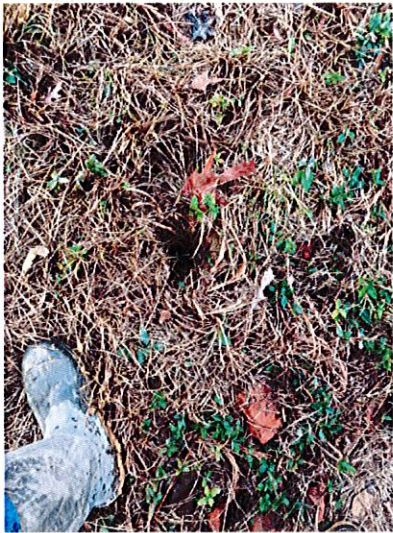
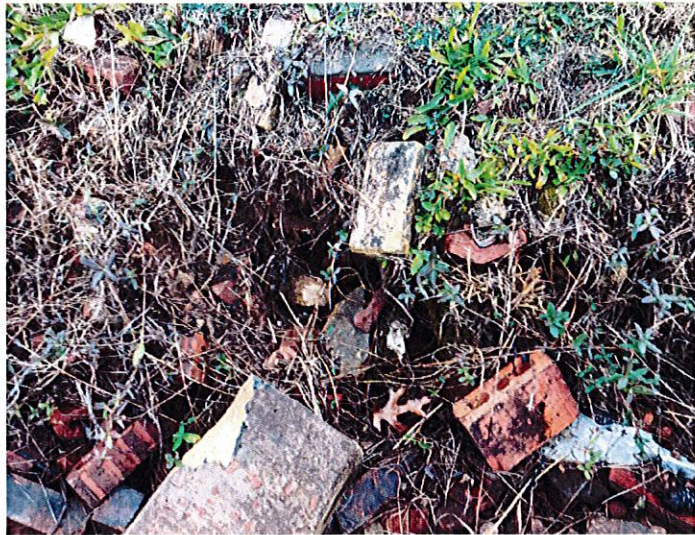
Multiple rodent burrows/holes on upstream slope all along the levee

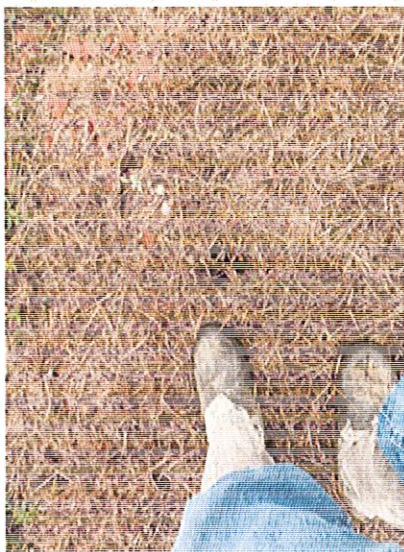
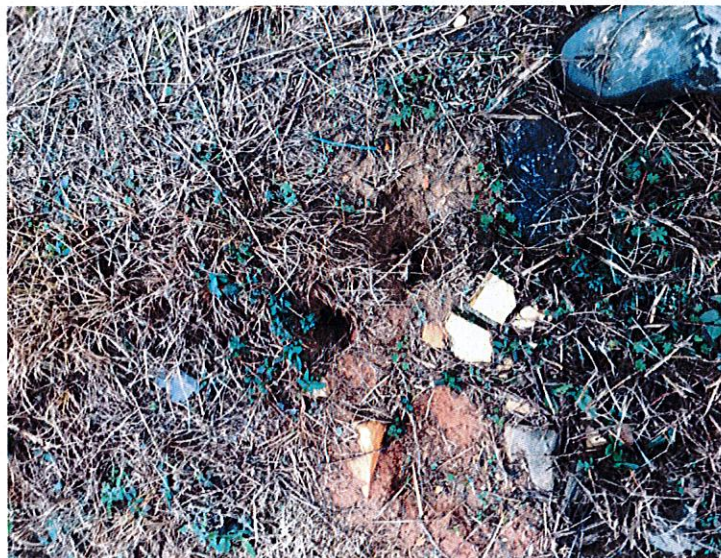
Multiple rodent burrows/holes on upstream slope all along the levee

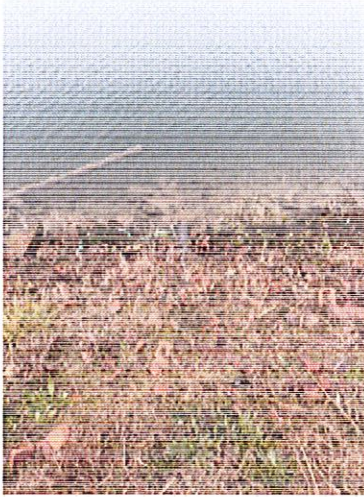
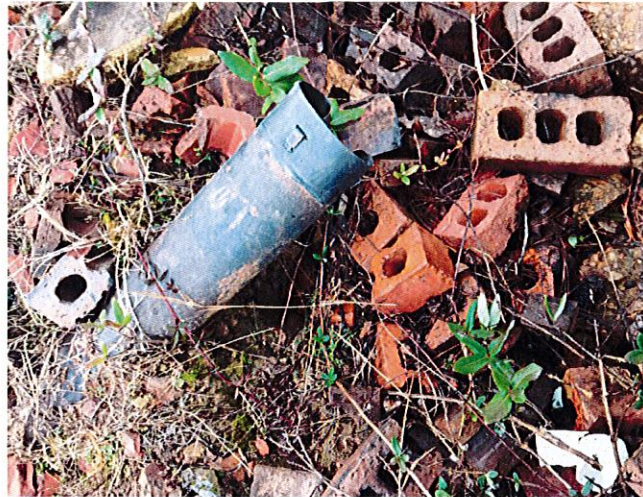
Black steel pipe protruding out of upstream slope – Station 9+00; unknown purpose

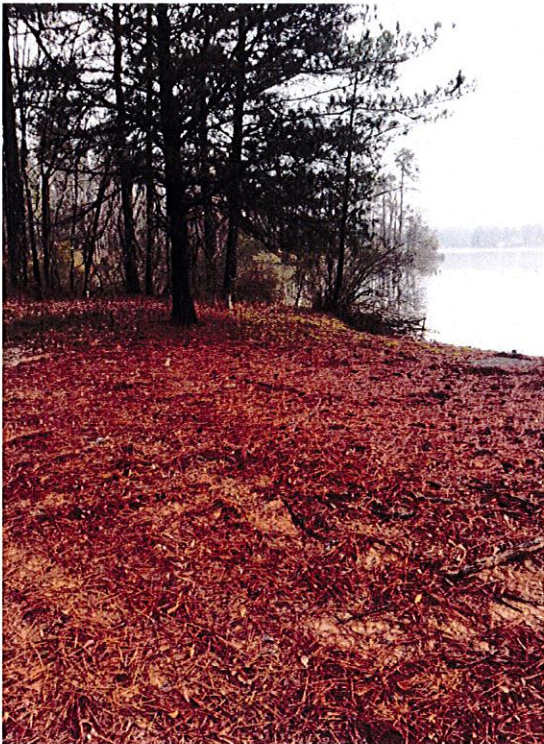
Emergency Spillway, south end of levee

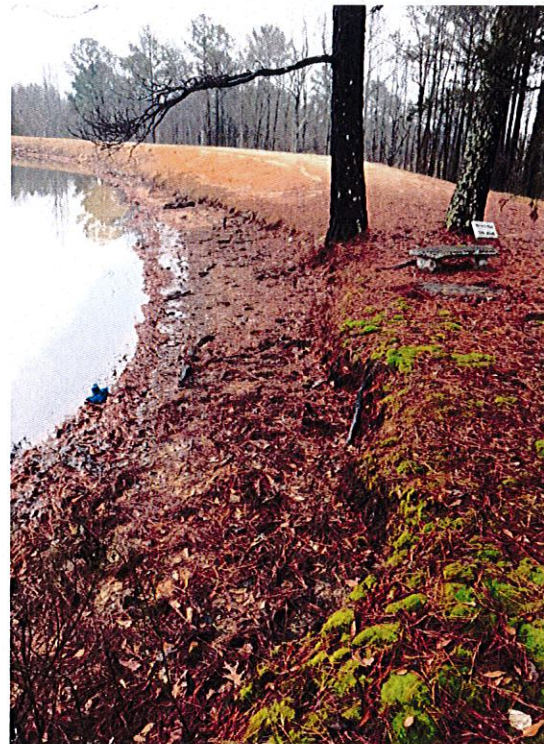
Scarp - wave action eroding bank at Emergency Spillway

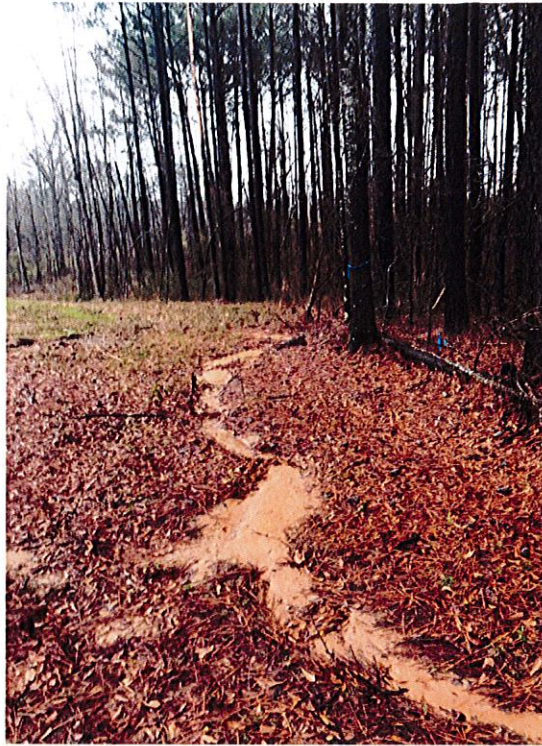
Emergency Spillway - downstream exit channel

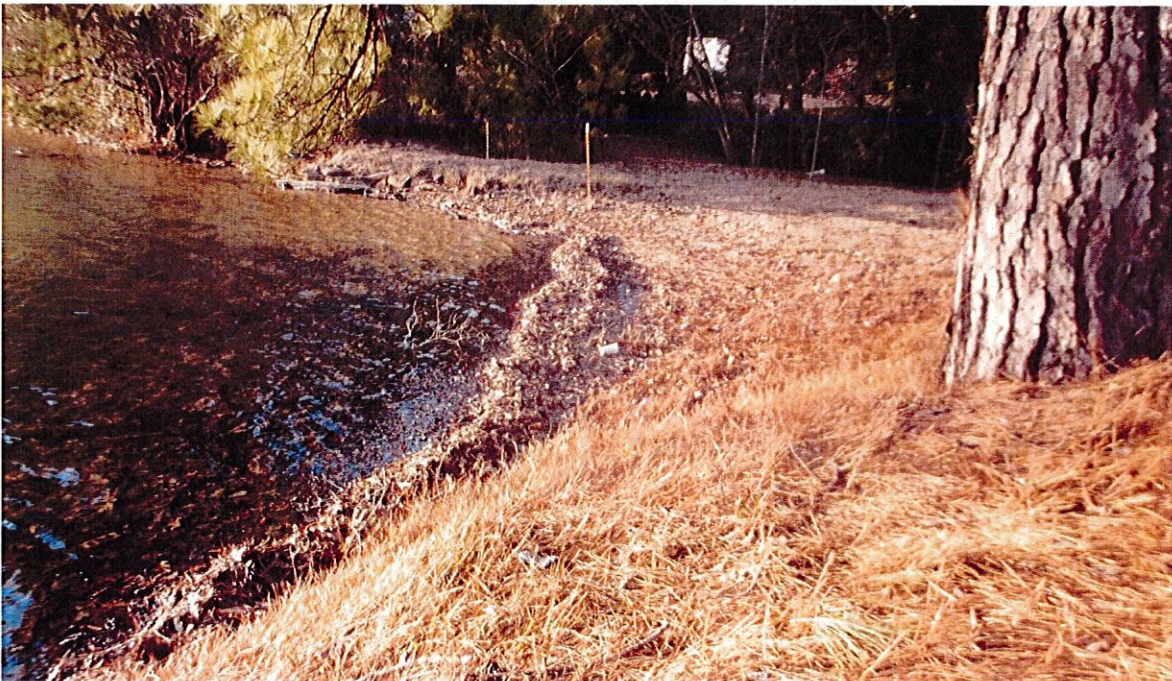
Primary Spillway – Looking north from Station 12+00

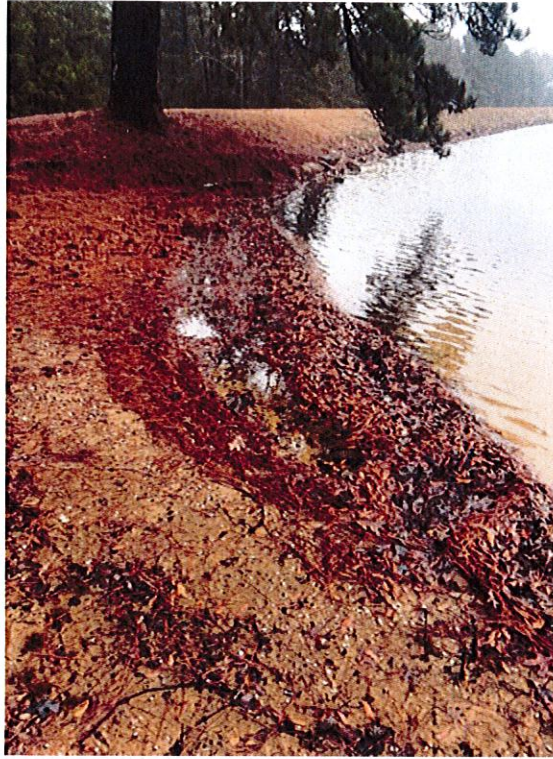
Primary Spillway – Looking south from Station 3+00

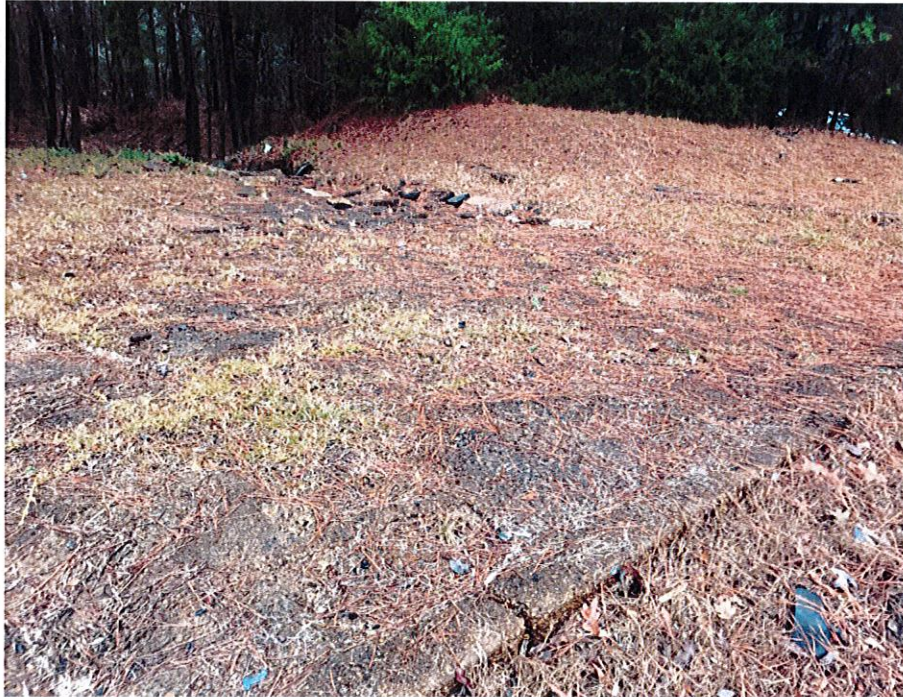
Primary Spillway - weir and concrete control section

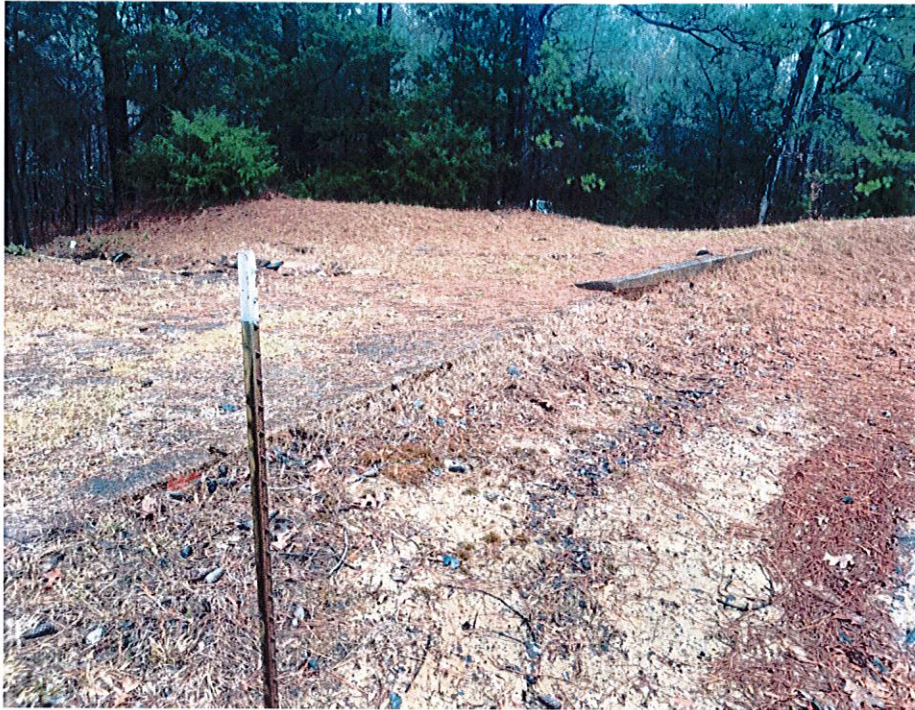
Primary Spillway - weir and concrete control section

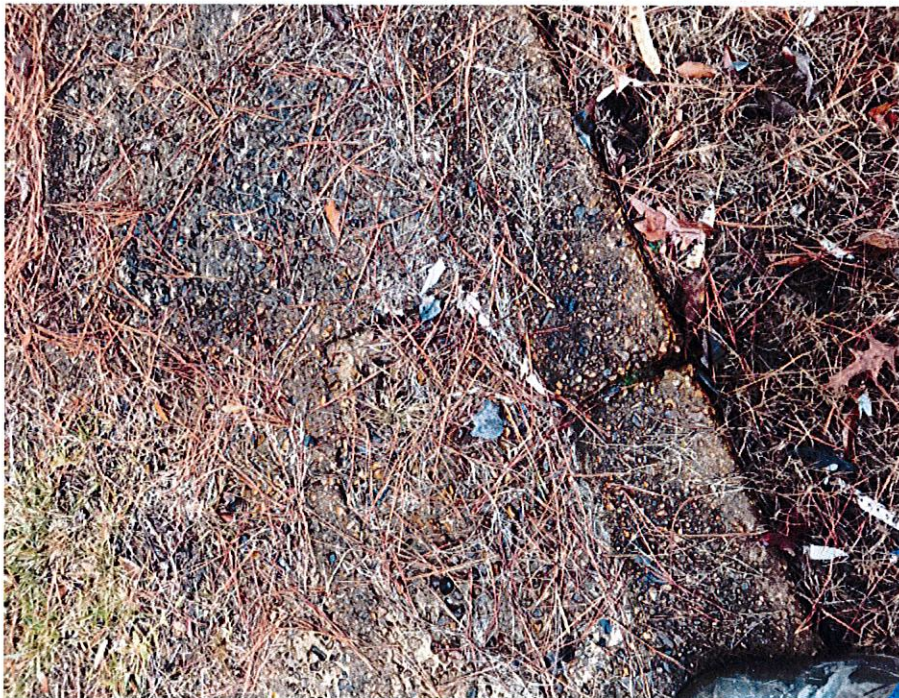
Signs of Movement: *None observed, cracking observed from aged concrete*

Primary Spillway – joint in weir

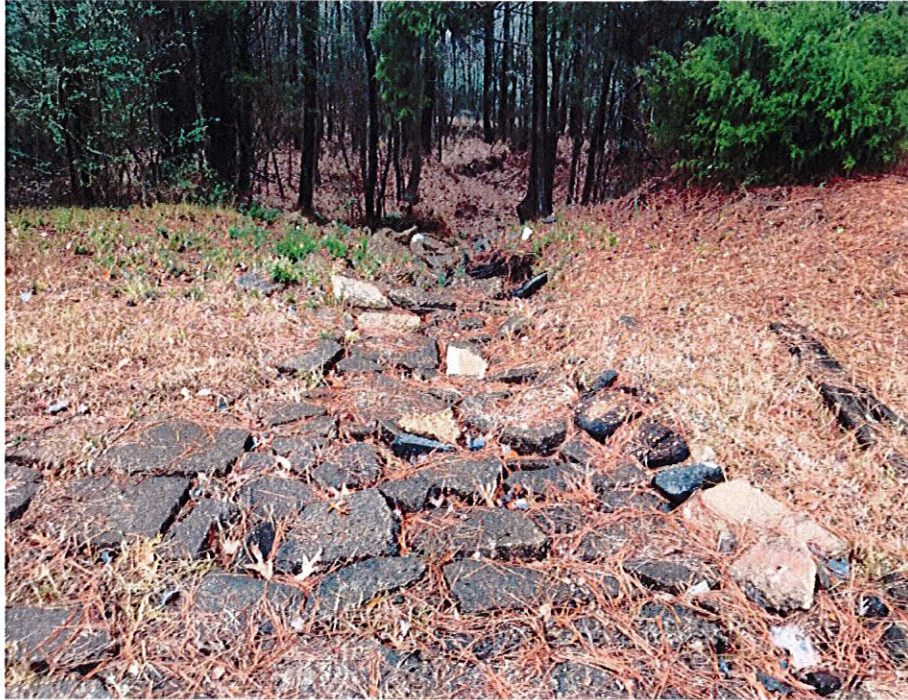
Primary Spillway - concrete rubble exit chute

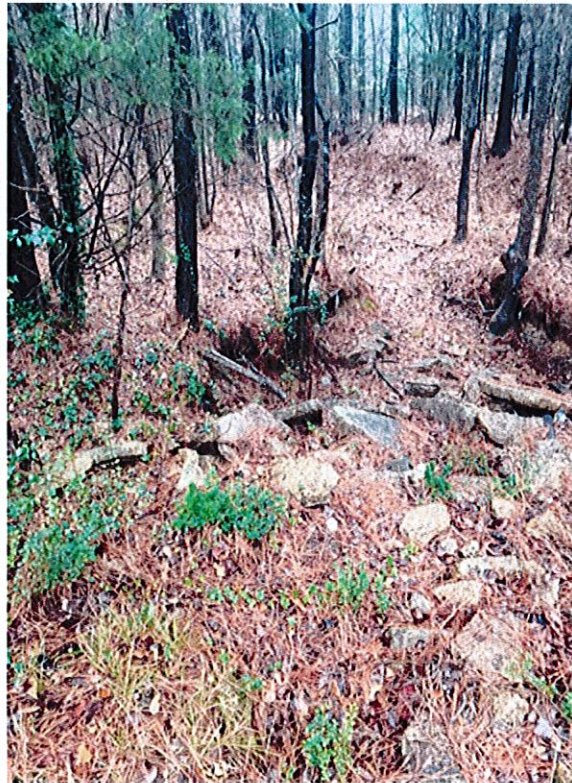
Primary Spillway -Chute at exit channel outfall

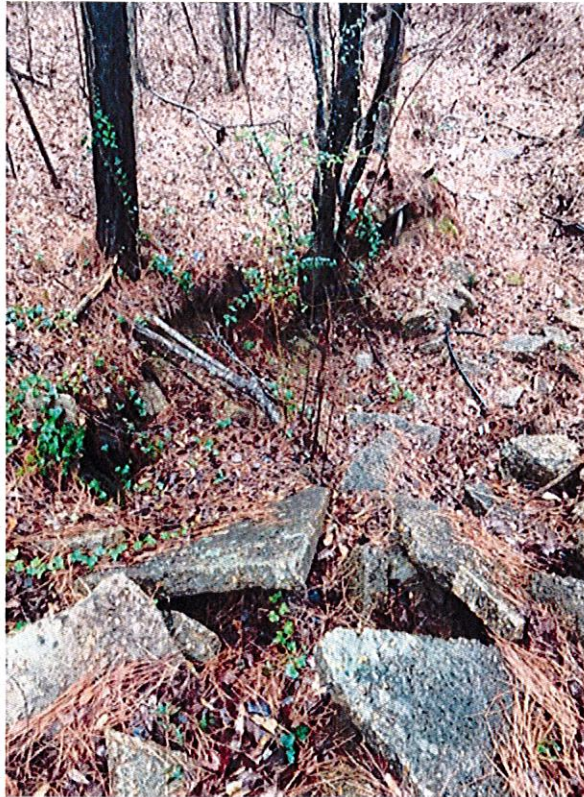
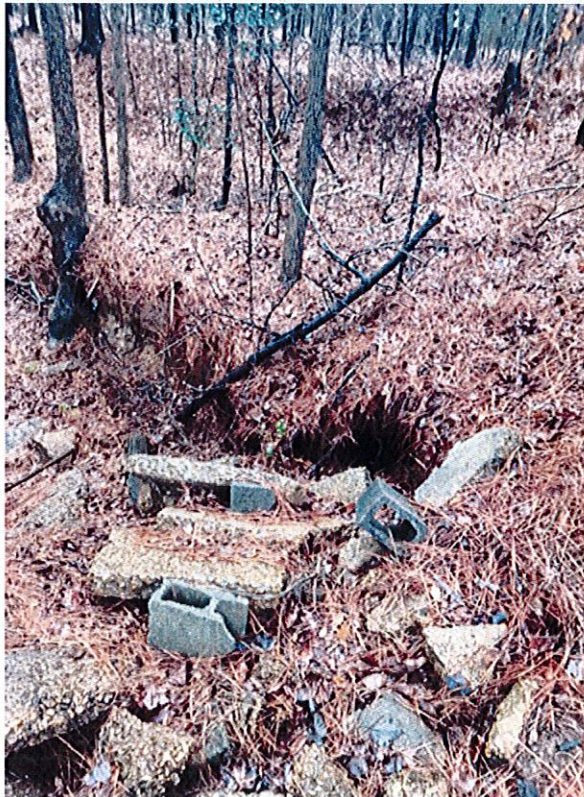
Primary Spillway Exit Channel

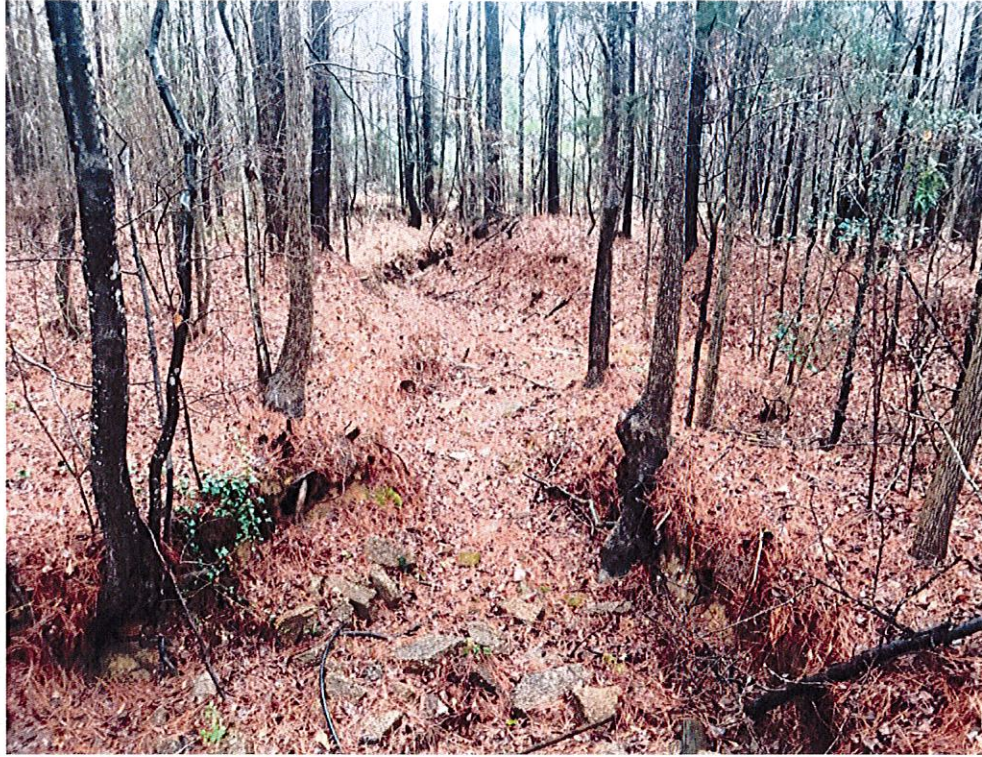
Primary spillway exit channel

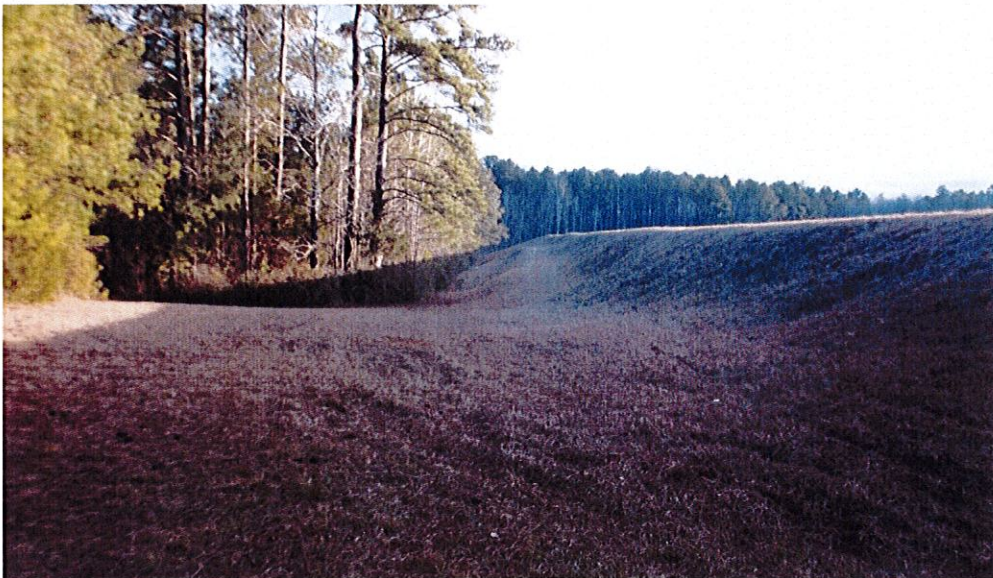
Station 12+00 – Looking South along ownstream slope

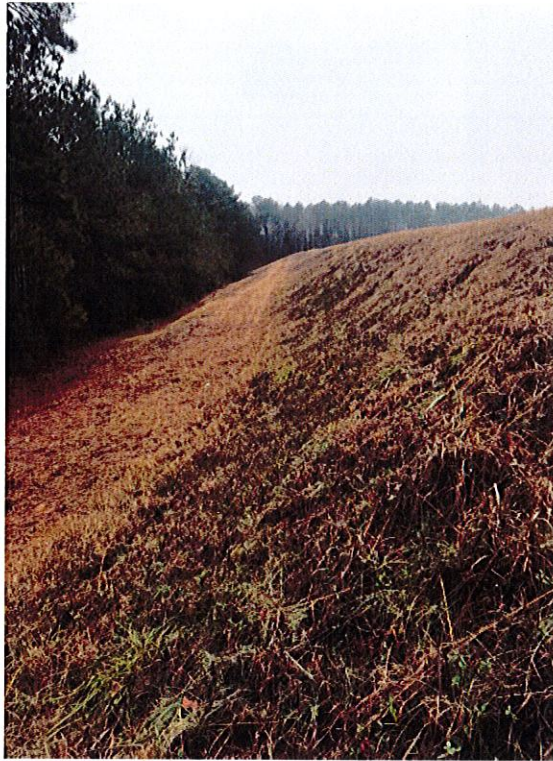
Station 10+00 – Looking South along downstream slope

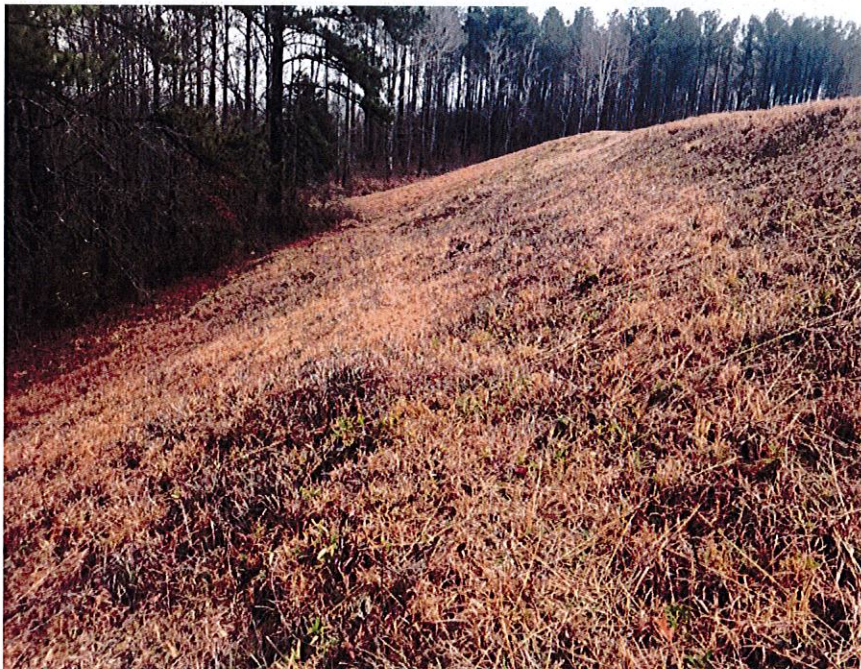
Station 5+00 – Looking south along downstream slope

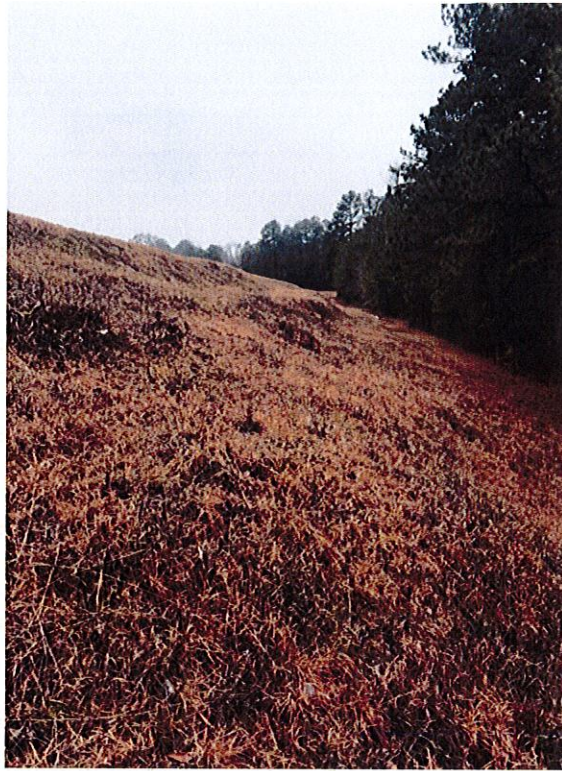
The downstream slope of the dam between stations 4+00 and 12+50 has benched slopes that range in slope from 2:1 to 3:1 (H:V).

Station 4+50 – Looking north along downstream slope - uneven slopes

Yes. The November 2011 inspection recommended that levee back slope be flattened to facilitate maintenance. This has only been partially completed. All other previous recommendations have been addressed adequately.

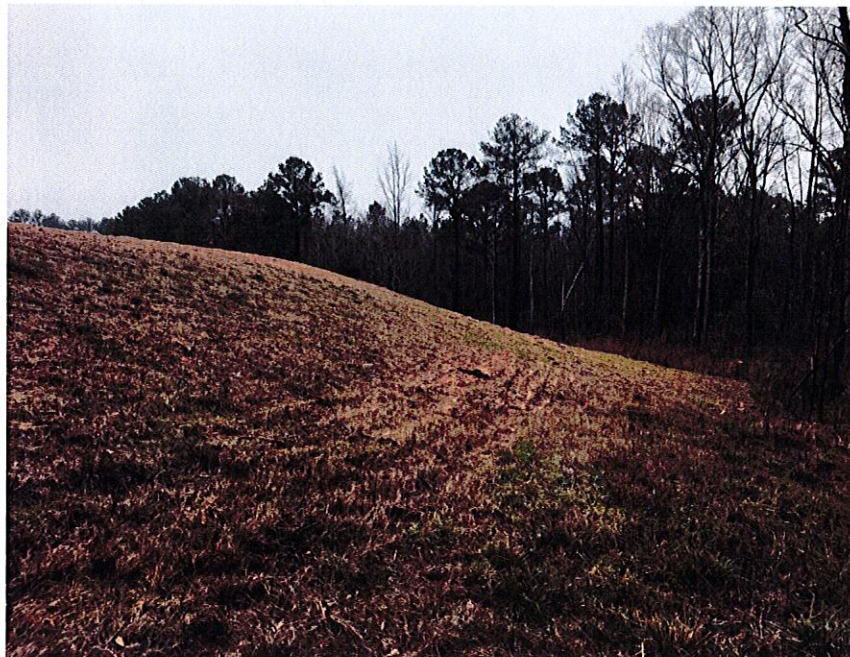
Station 2+00 – Looking northeasterly along rehabilitated (2016) downstream slope

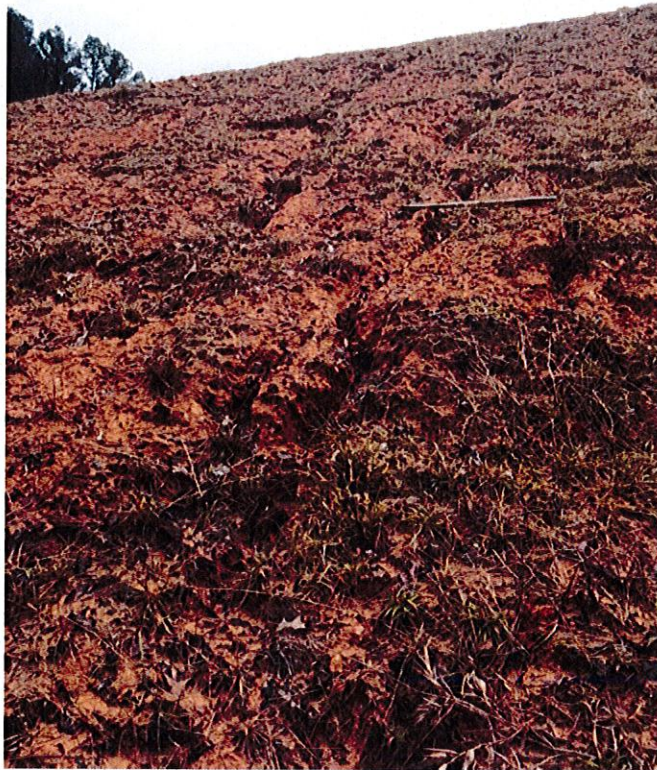
Station 3+00 - Erosion including rills and on rehabilitated downstream slope

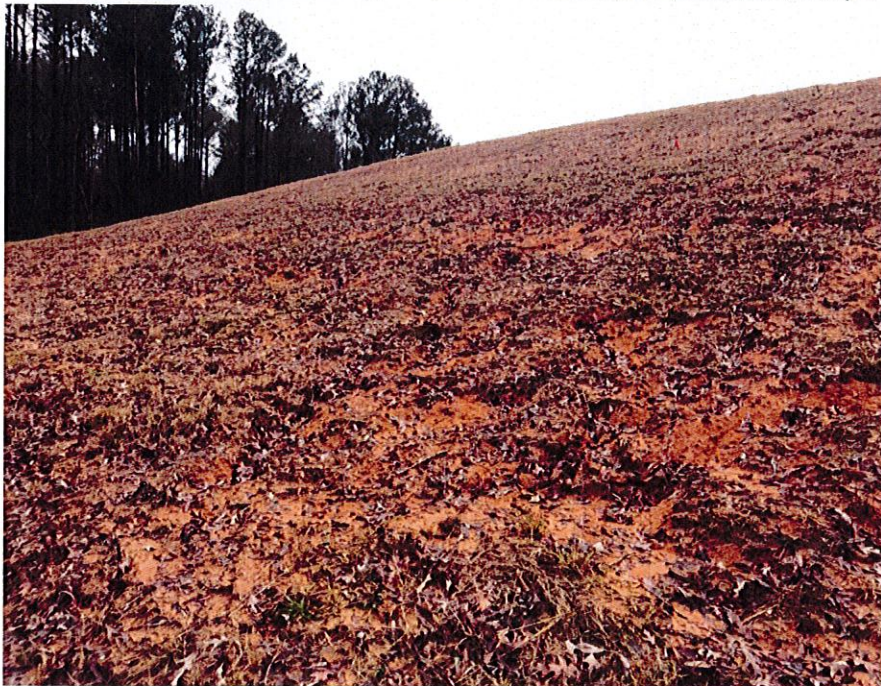
Station 3+00 – Looking southwest along rehabilitated (2016) downstream slope

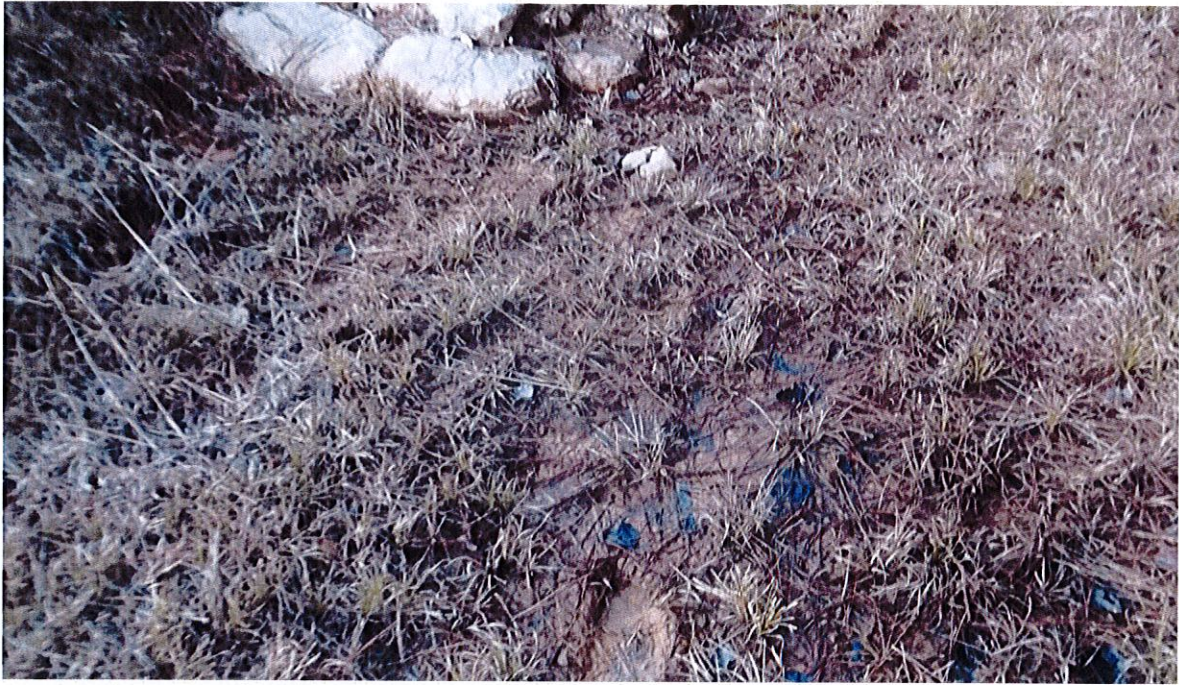
Some seepage exists at points along the toe of slope between levee station 5+00 to 6+00 and between levee station 7+75 to 9+50. Seepage was also observed on the lower bench of the downstream slope in the vicinity of station 7+75, 8+40, 8+95 and 9+15. Seepage velocity observed was very low at all locations. No sediment deposits were observed in the seep locations and all water was clear. The seep at station 7+75 is adjacent to a sandbagged area that had moderate flows during a storm event.

Downstream Slope Right of Station 9+00 - Seepage on the lower bench next to sandbagged area

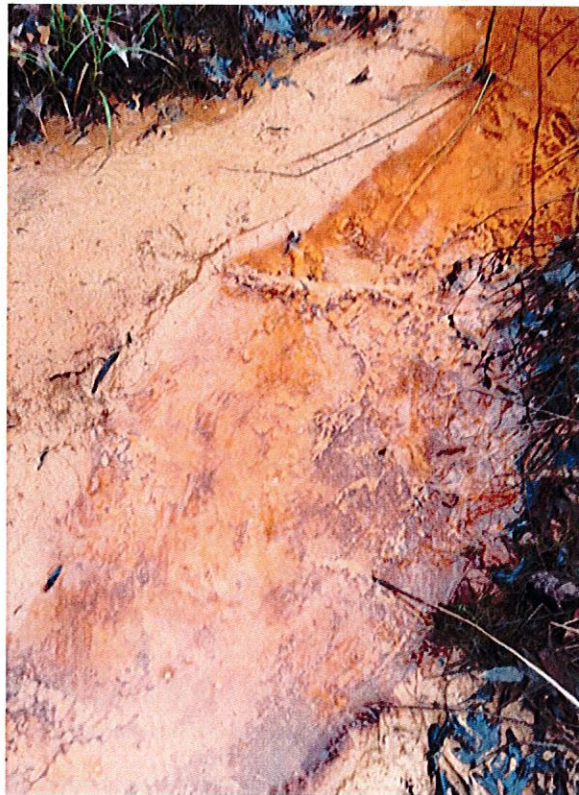
Seepage / flow in stream beyond downstream slope right of Station 2+00

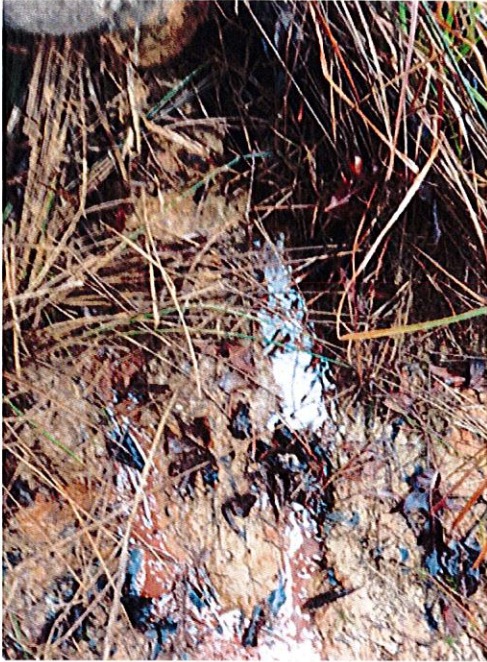
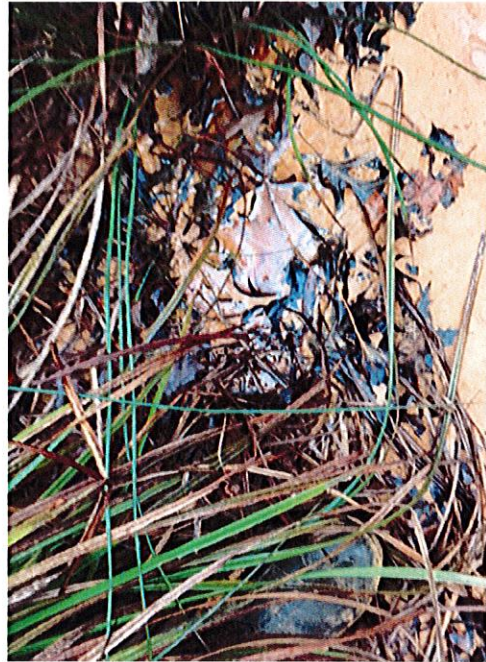
Seepage is entering ditch downstream of the embankment toe approximately due east of levee station 1+00. Seepage in ditch has an orange color with an oily sheen; it may be elevated levels of iron in the groundwater and from iron feeding bacteria that produces the oily sheen.

Seepage in stream beyond downstream slope – Right of Station 3+00. Iron bacteria results in orange water and oily sheen.

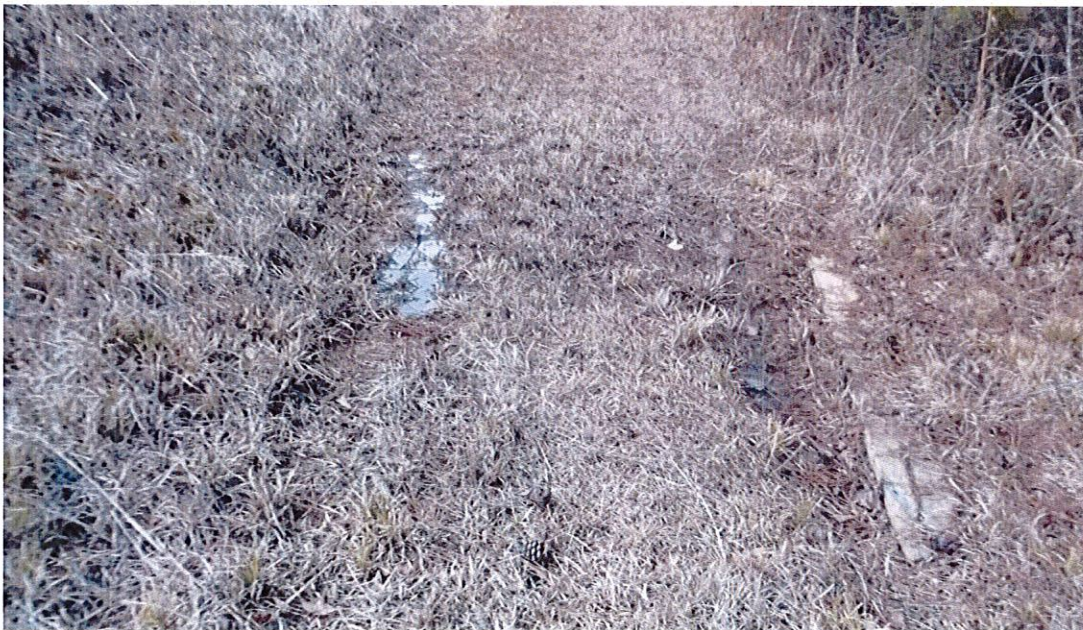
Downstream Slope Right of Station 8+50 - Seepage on the lower bench

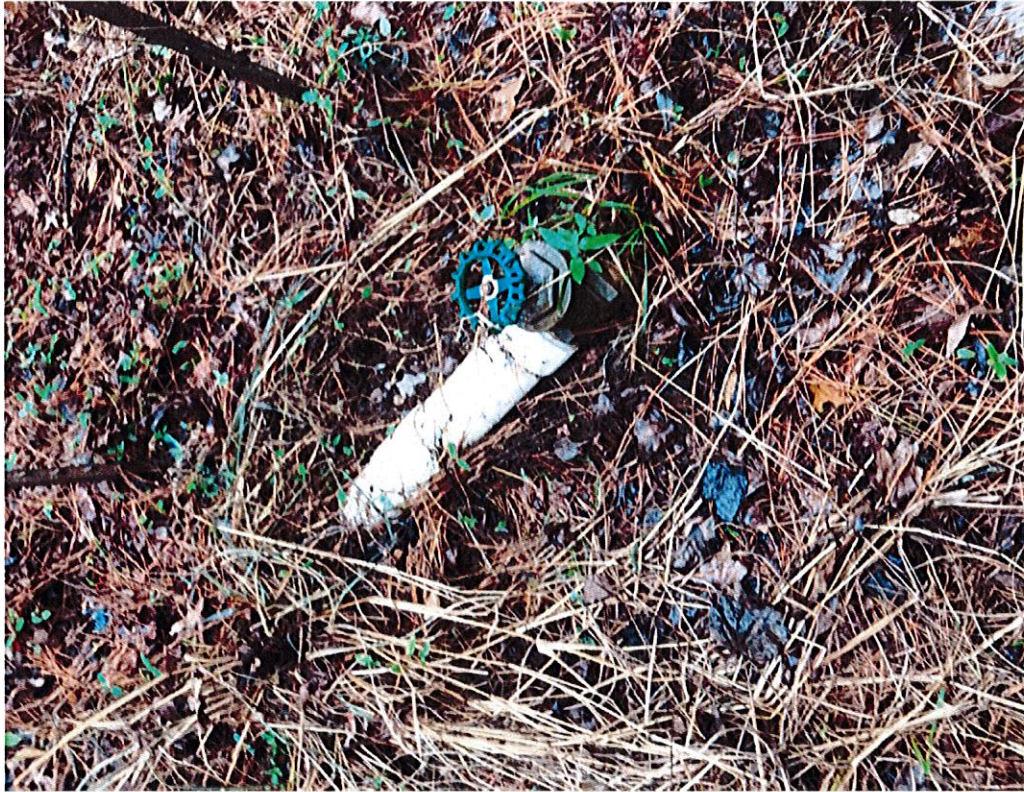
Level Control Piping Valve - 4" PVC pipe with brass valve – At downstream slope toe right of Station 6+15.
