Formal Inspection Checklist

DAM NAME: Second Creek 6B

DAM INVENTORY NO: MS00427

DATE(S) OF INSPECTION: 2/4/16

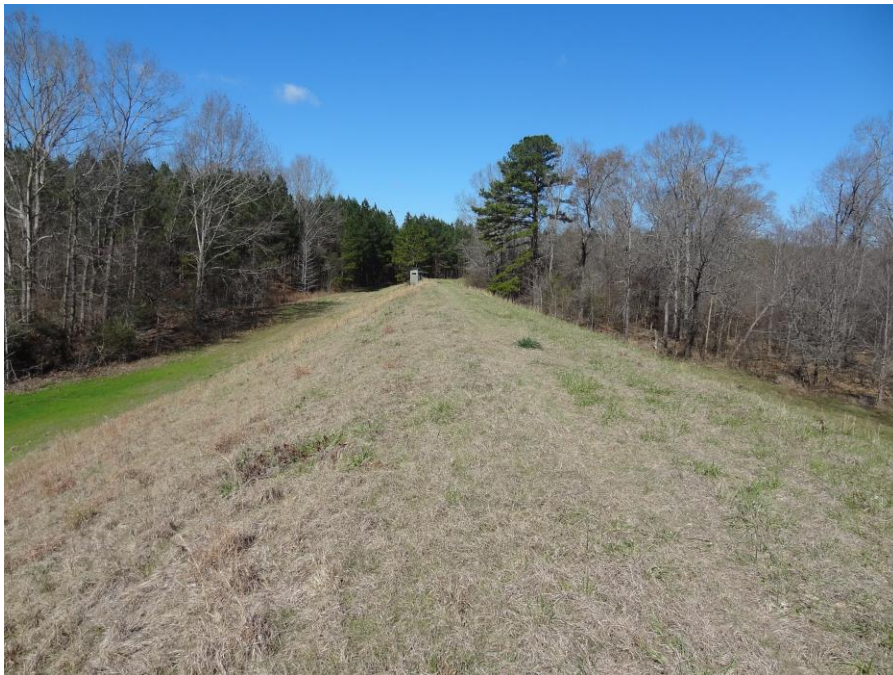
Dam Crest

☐ None ☐ Ruts or Puddles ☐ Erosion ☐ Cracks with Displacement ☐ Sinkholes ☐ Not Wide Enough ☐ Low Area ☐ Misalignment ☐ Inadequate Surface Drainage ☒ Trees, Brush, Briars
☒ Other: small deer stand on 4" legs.

If Trees, Brush, Briars is checked above please describe the nature and extent of vegetation on the dam?
One pine sapling by the deer stand.

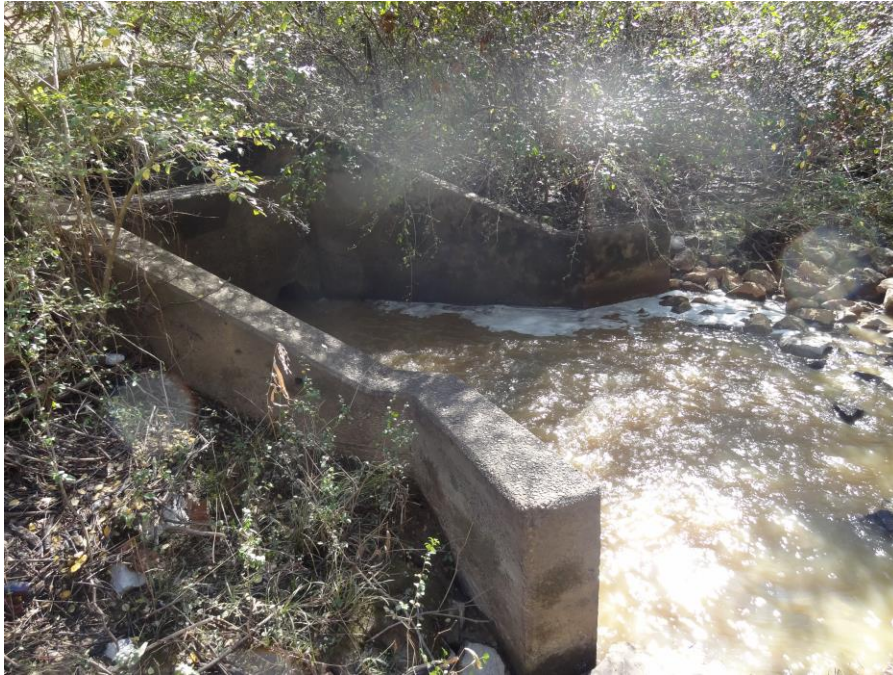
Dam Outlet

Vegetation (Trees, Bushes): Small amount on banks.

Debris: Small amount, all sizes.

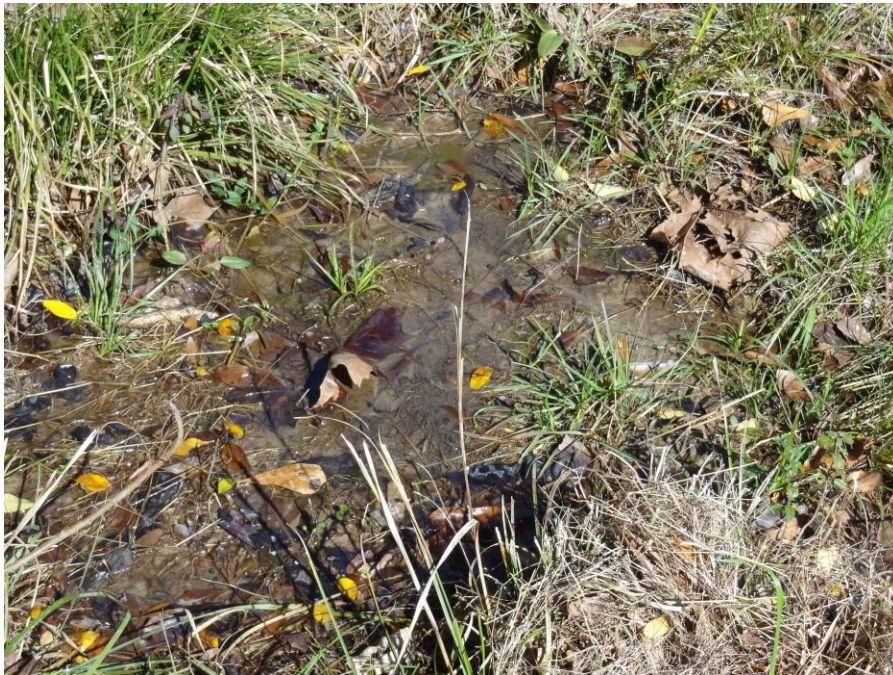
Seep

- ☐ None ☒ Saturated Embankment Area ☐ Seepage Exits on Embankment ☐ Seepage Exits at Point
Source ☒ Seepage Area at Toe ☐ Flow Adjacent to Outlet
☐ Other:

Comments: Saturated above terrace from rain, minimal flow at toe.

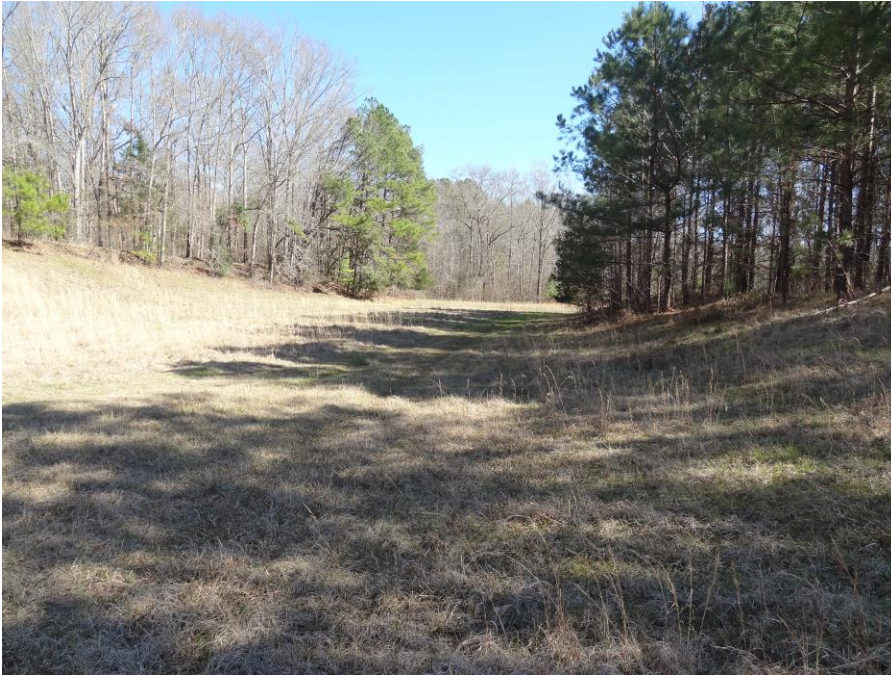
ESW

Channel Side-Slope Stability: Stable; one ATV trail up slope.

Slope Protection/Erosion: Protected. Minimal on ATV trail.

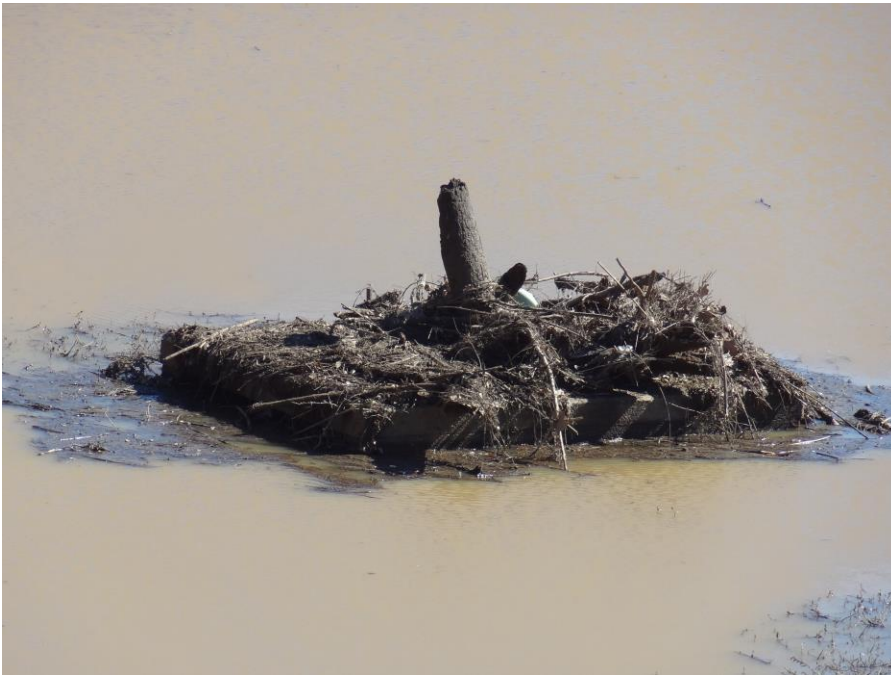
Riser

Unusual Conditions: Crest is covered with mud and debris
