Formal Inspection Checklist

DAM NAME: LAKE FOREST

DAM INVENTORY NO: MS 02788

DATE(S) OF INSPECTION: 15 Mar 2020
19 Mar 2020
26 Mar 2020

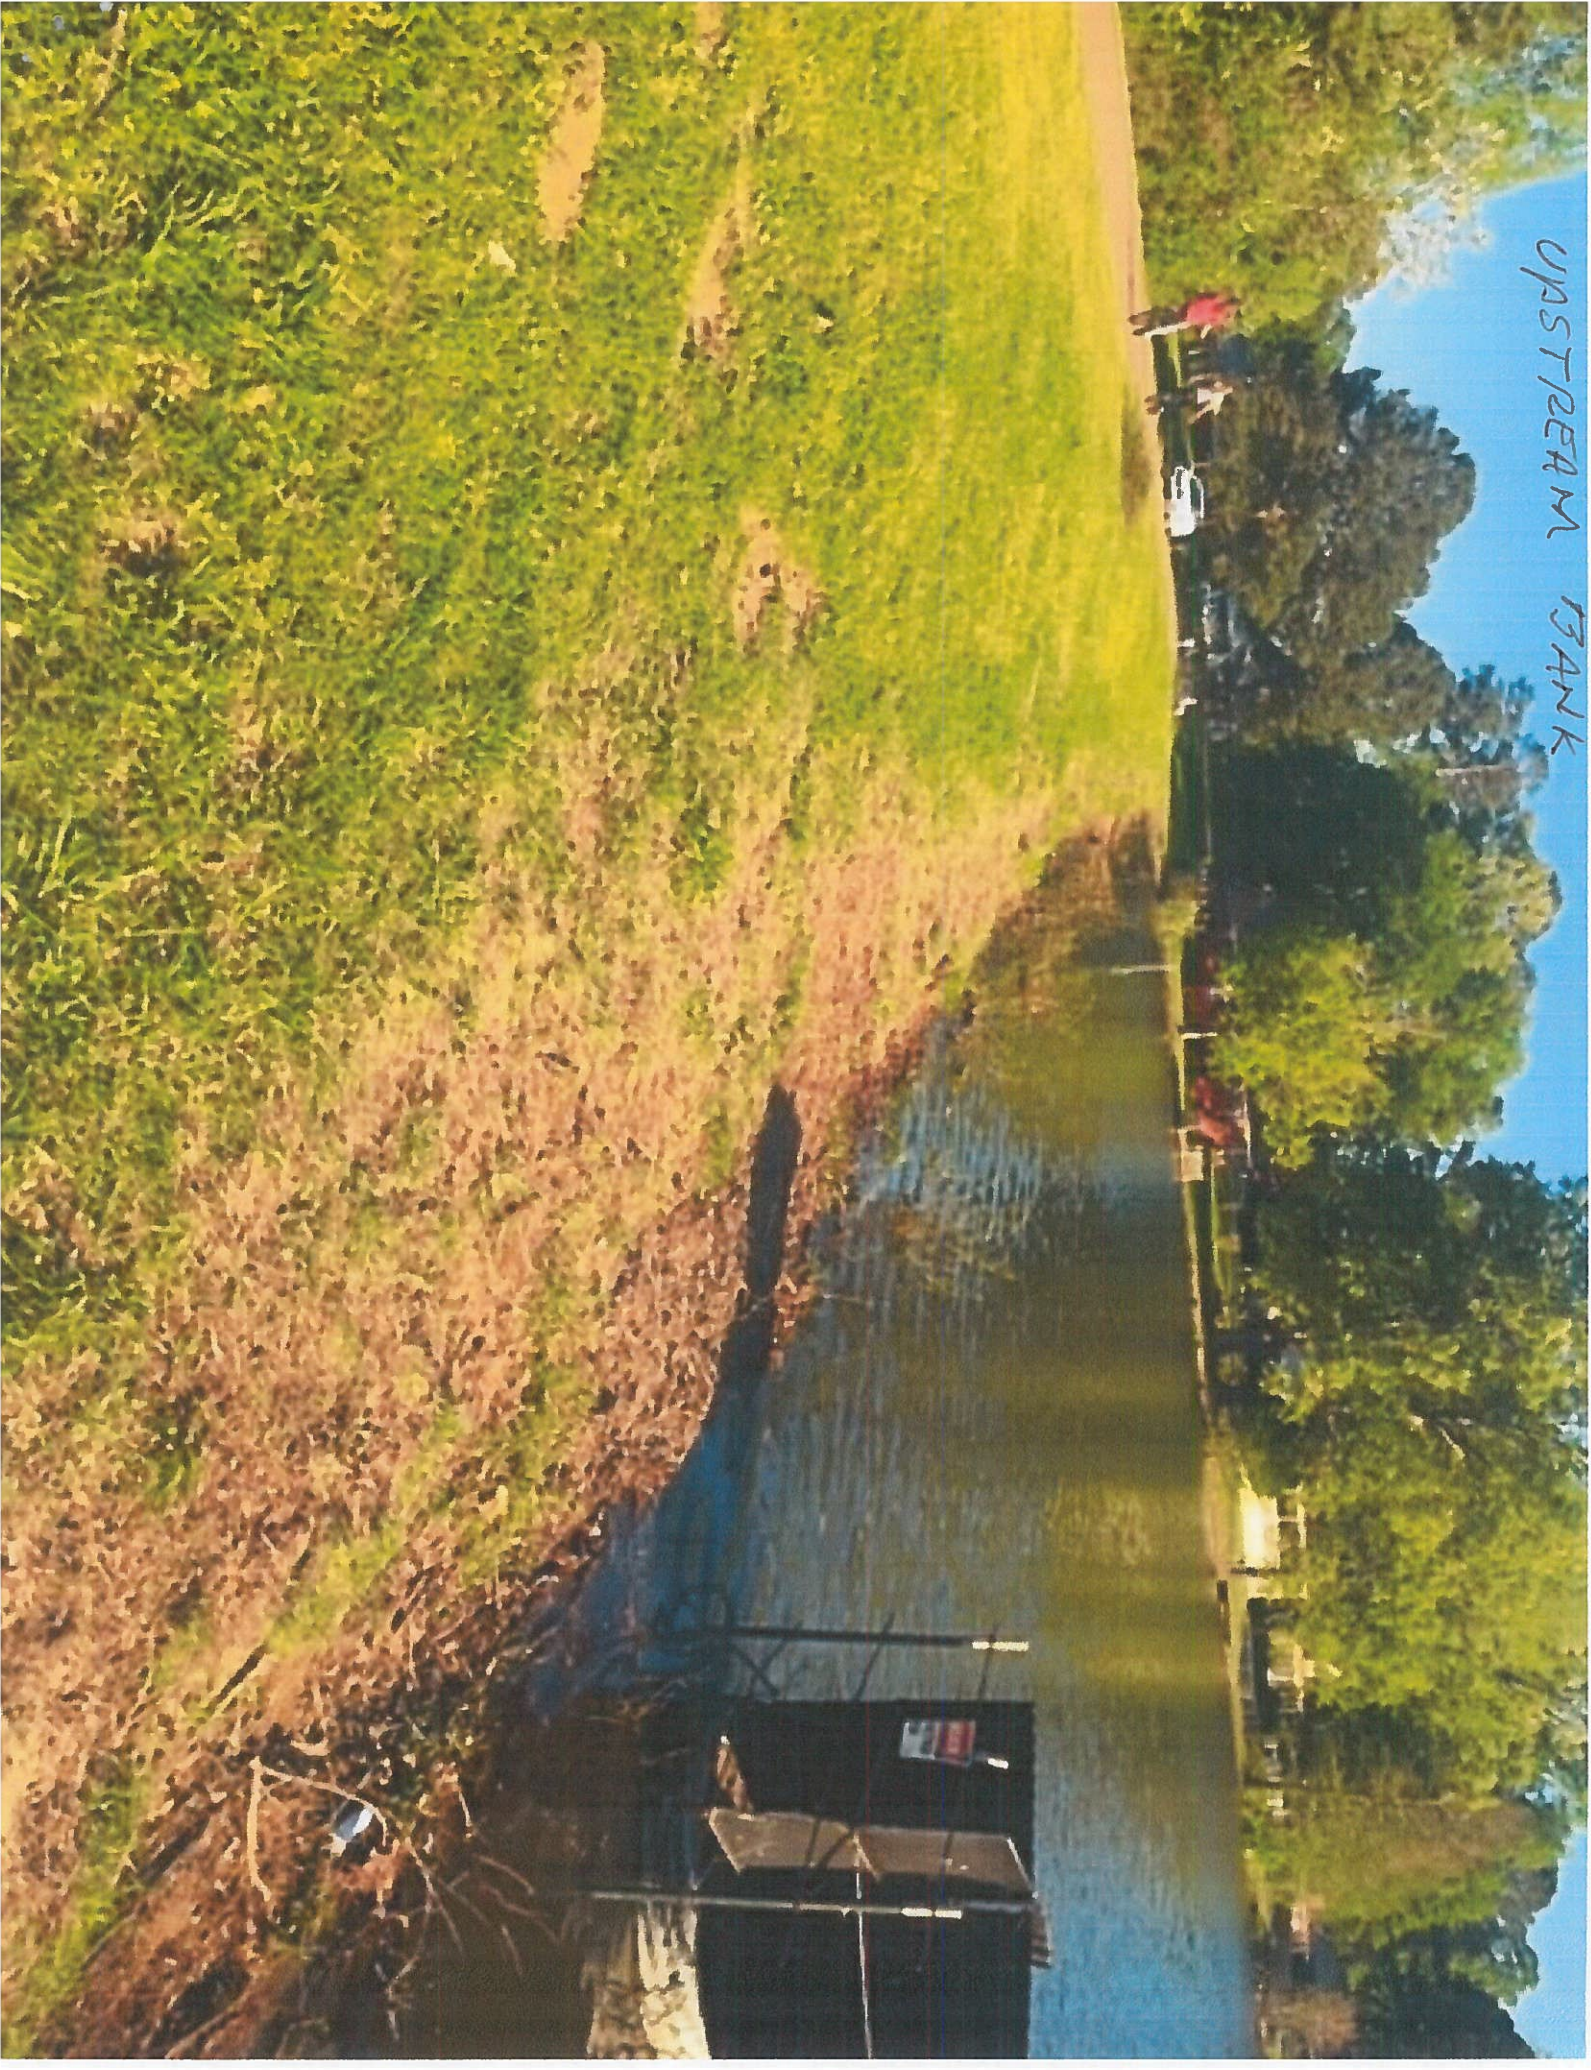
UPSTREAM BANK

Some small willow growth at water's edge removed on 19 Mar 2020.

Small willow growth removed. See photo upstream Bank

Description: *Emergency Spillway 150' wide by 2.0' deep.
Three feet above top of 48" CMP drain pipe
SEE photo Upstream Bank.*

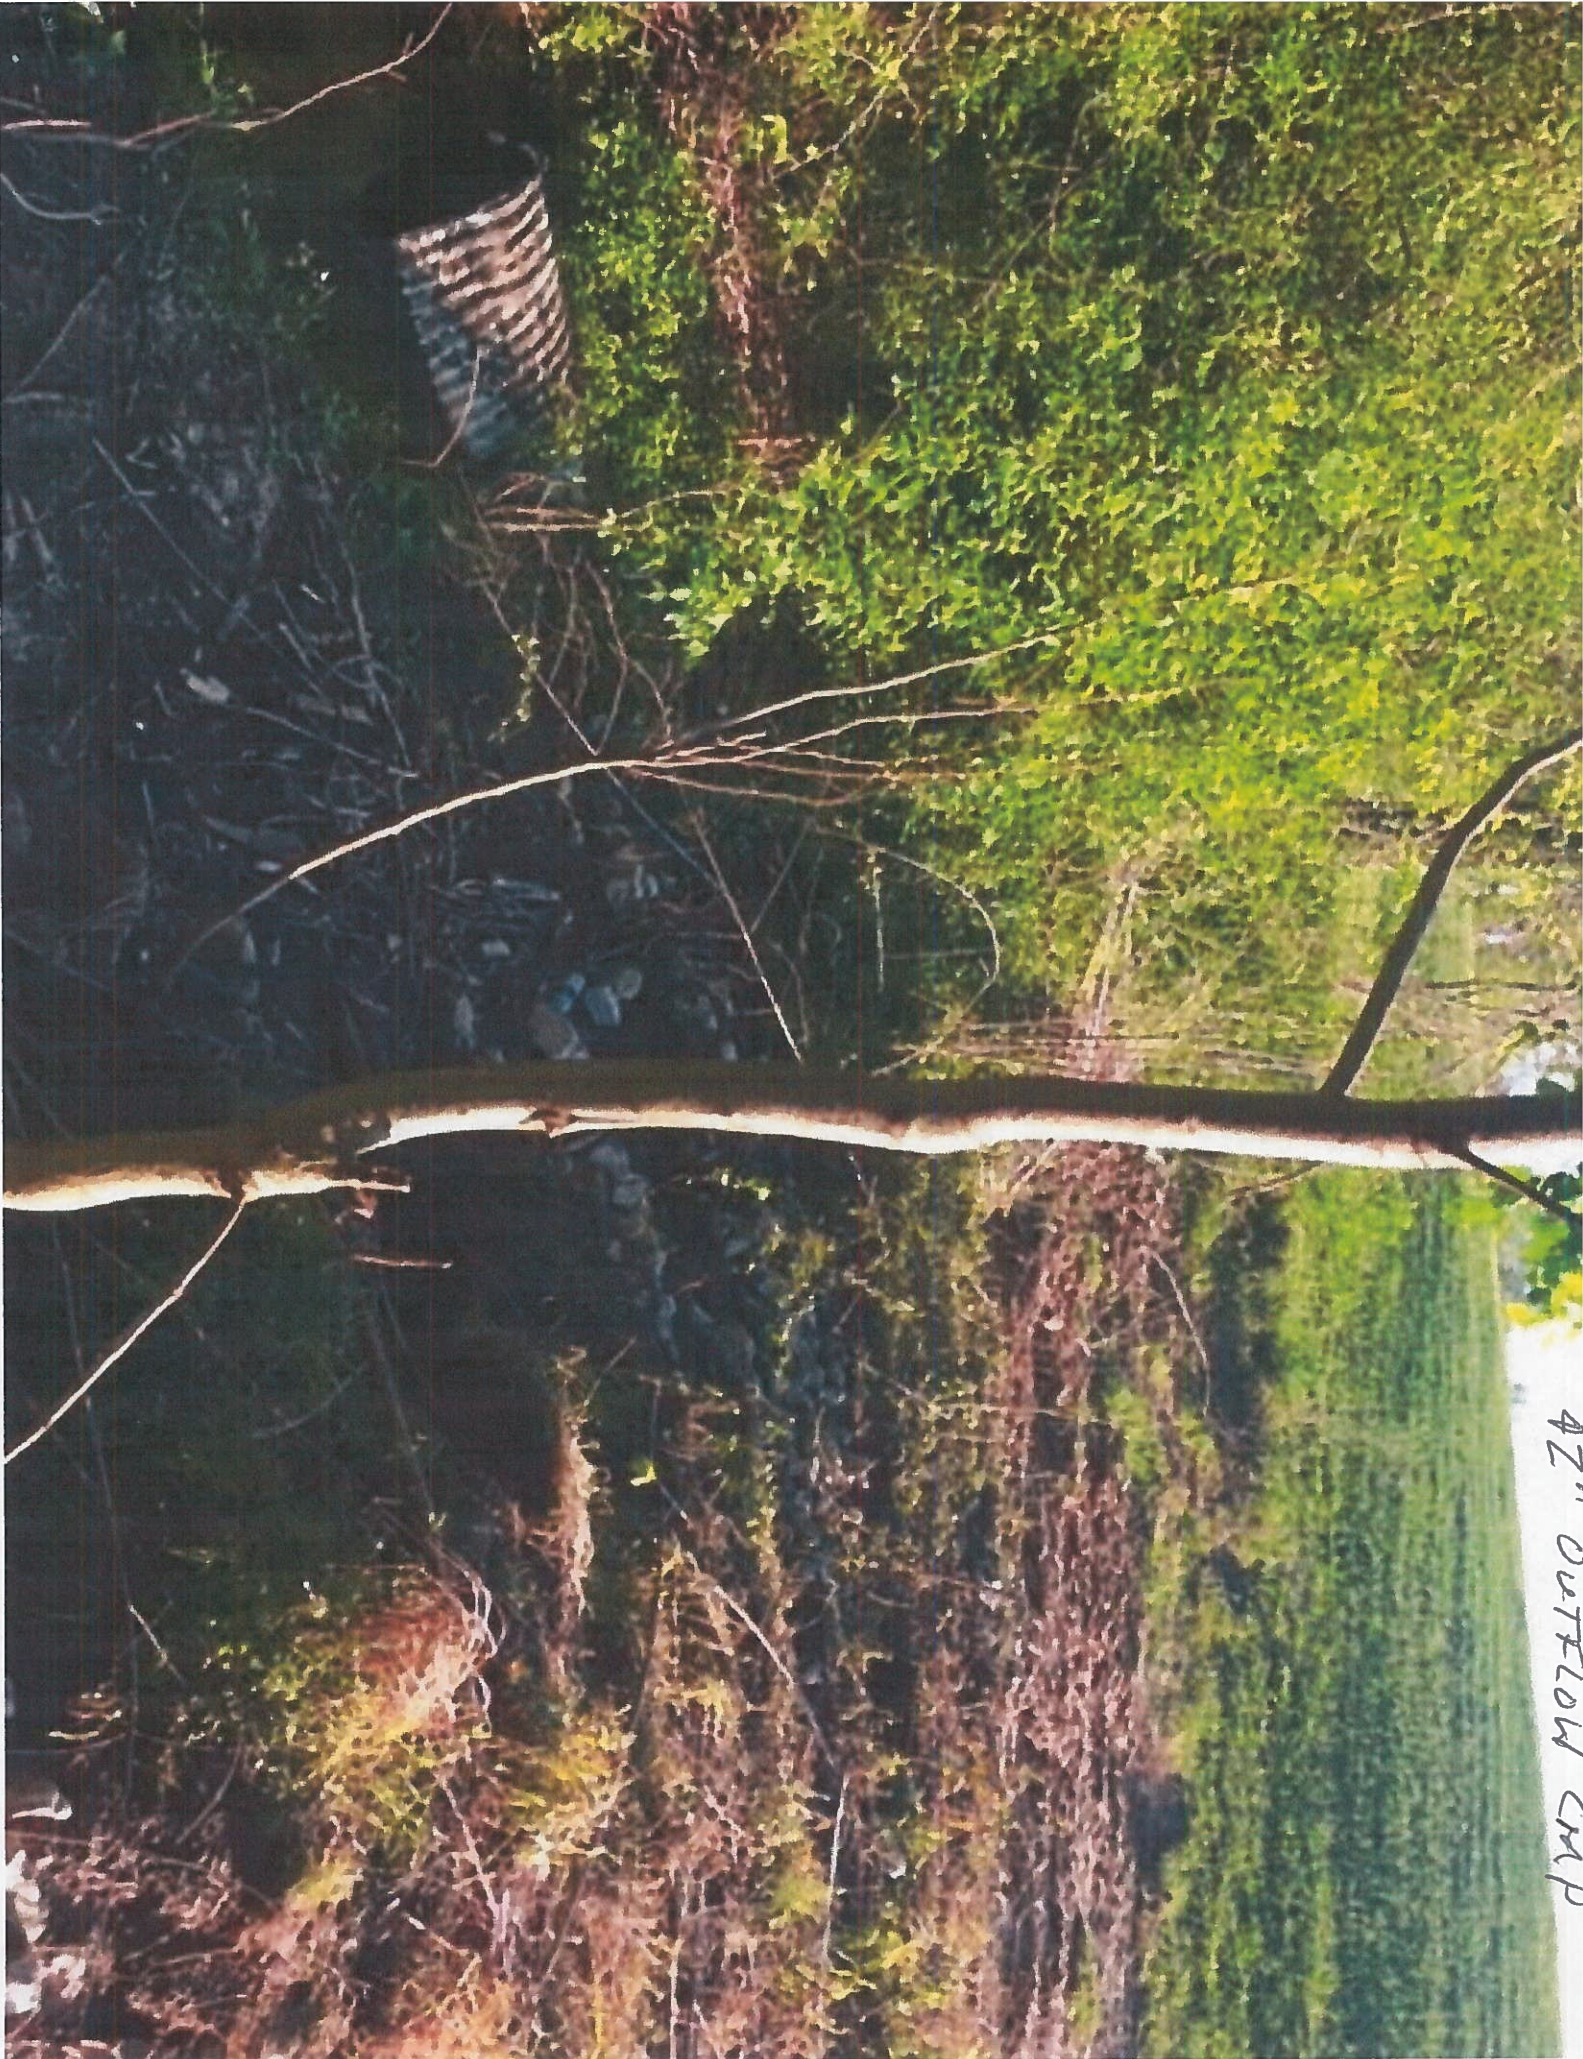
42" OUTFLOW CAMP

- Three small earth washes below Dam 3' x 10' and 2' x 2' were filled with clay dirt and seeded as shown on Photo. Filled 19 Mar 2020 (Photo: Outflow Pipe)
- Small willow growth removed at water's edge on 19 Mar 2020 (Photo upstream Bank)
- One large tree across drain ditch from Jan. tornado was cleared on 19 Mar 2020. Three other trees down from tornado but they are not on DAM. They will be cleared this summer.

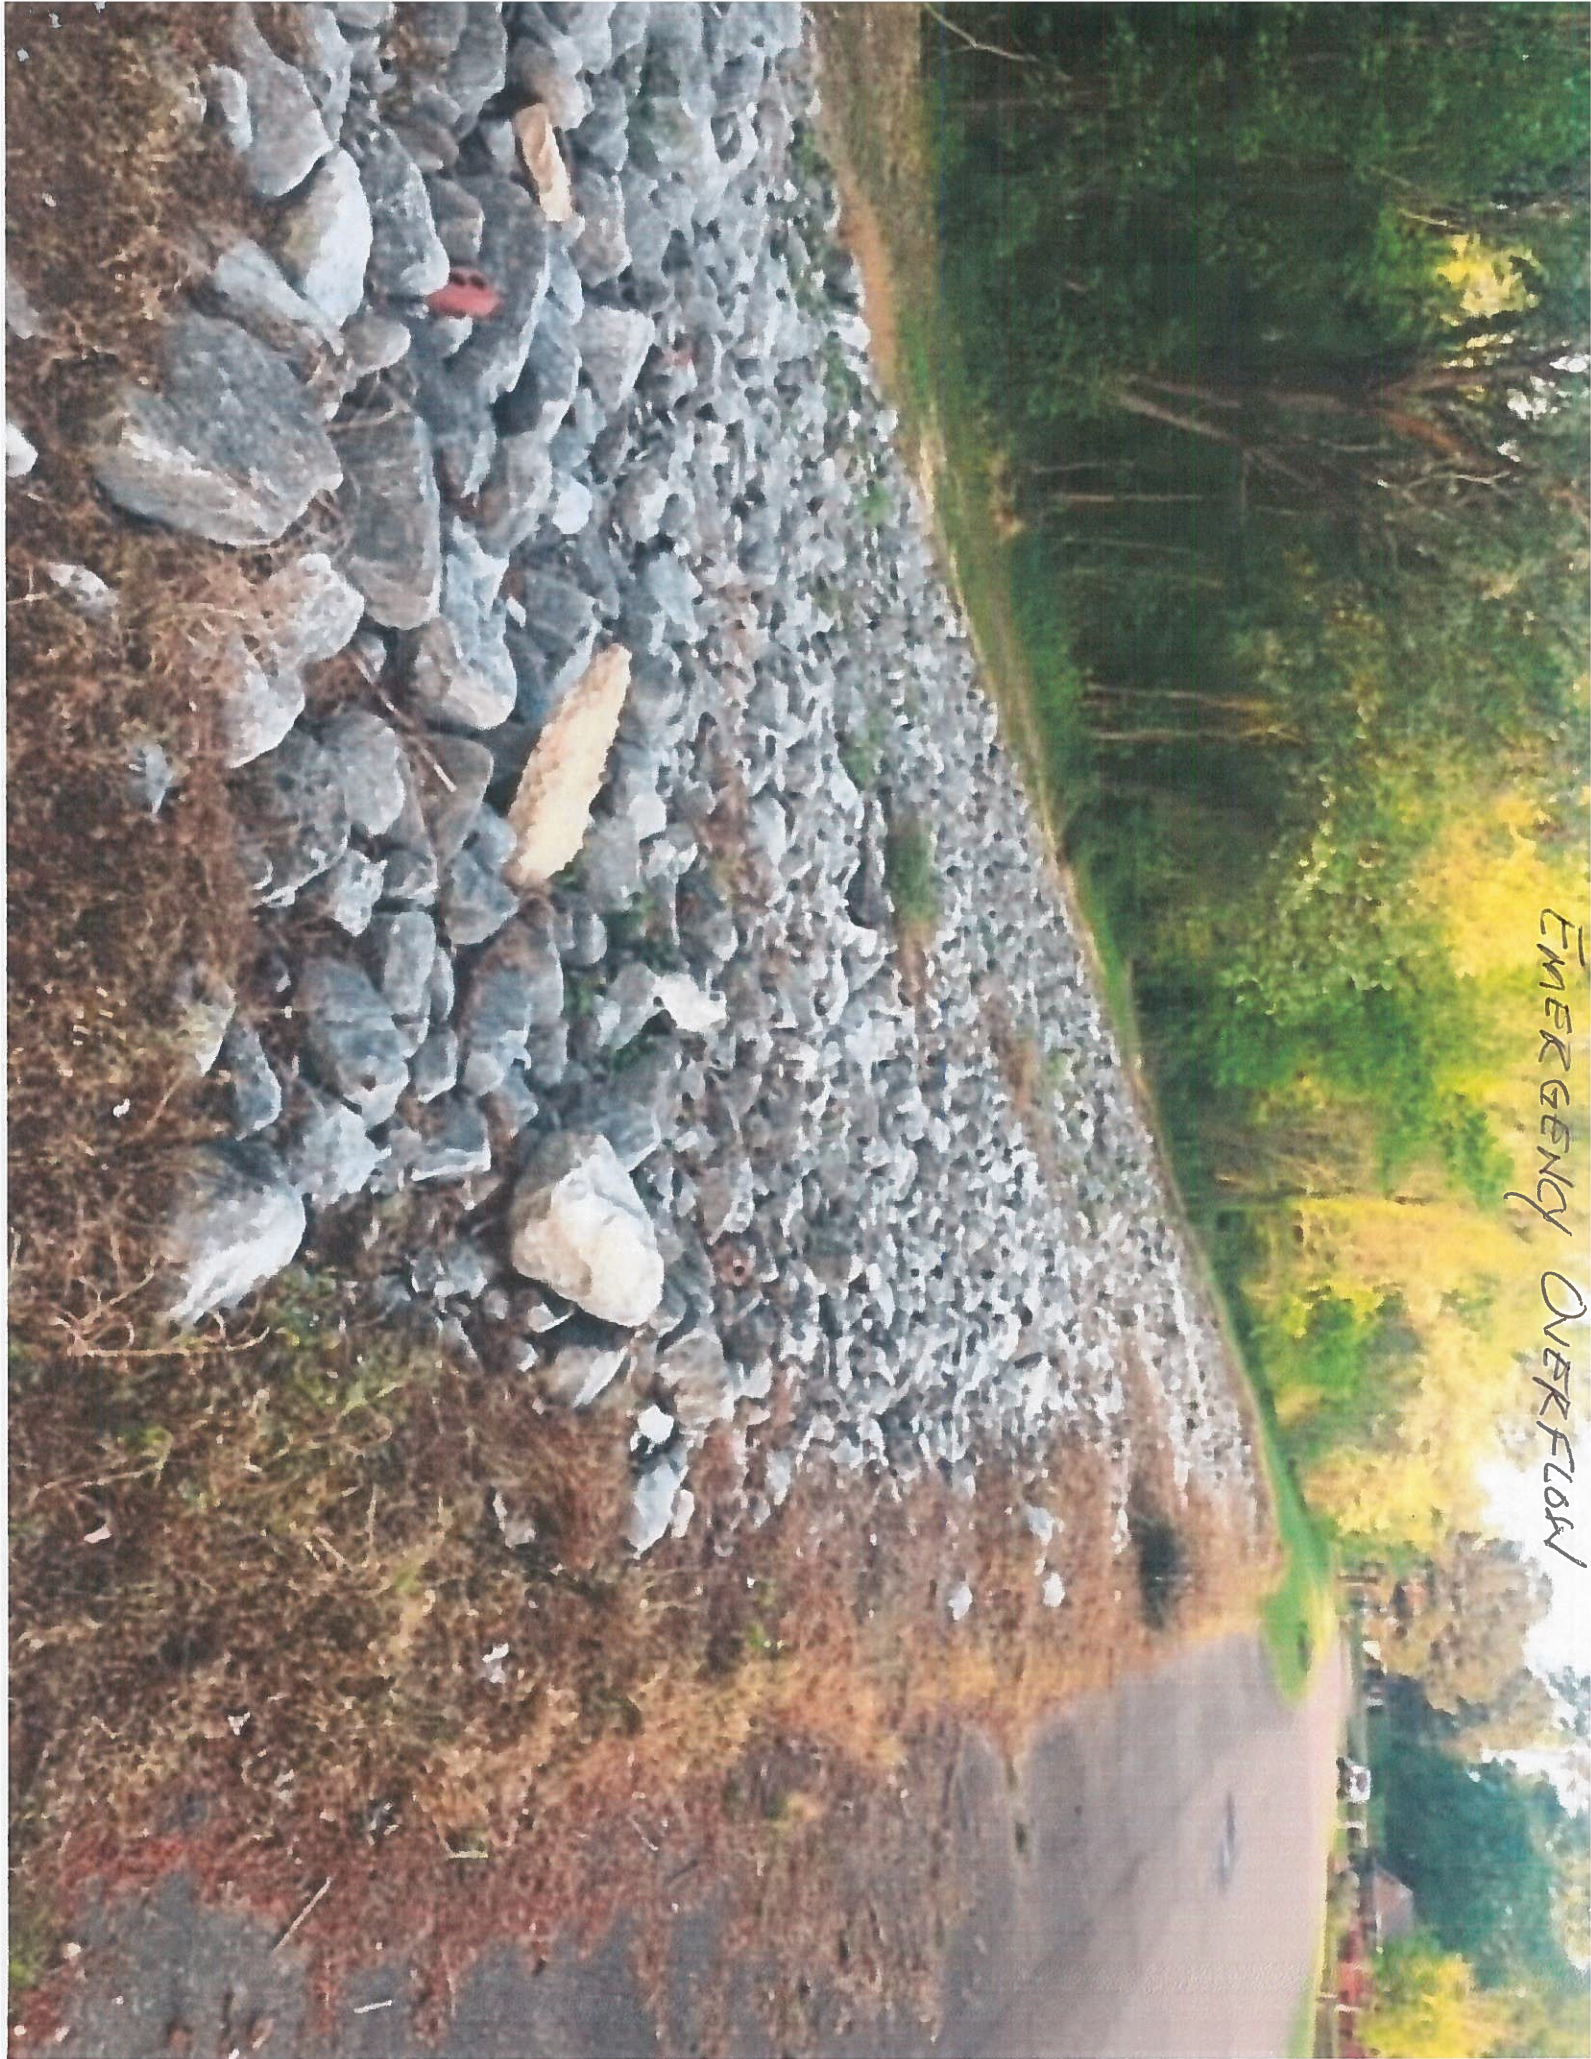
EMERGENCY OVERFLOW

Description: *150' x 2.0' emergency spillway with filter cloth and 200# stone 3'0 feet above 48" CMP drain inlet*
Vegetation (Trees, Bushes): *Vegetation and bushes keep cleared during year.*
