Formal Inspection Checklist

DAM NAME: MULTIP MANOR LAKE DAM

DAM INVENTORY NO: MS02896

June 27, 2019

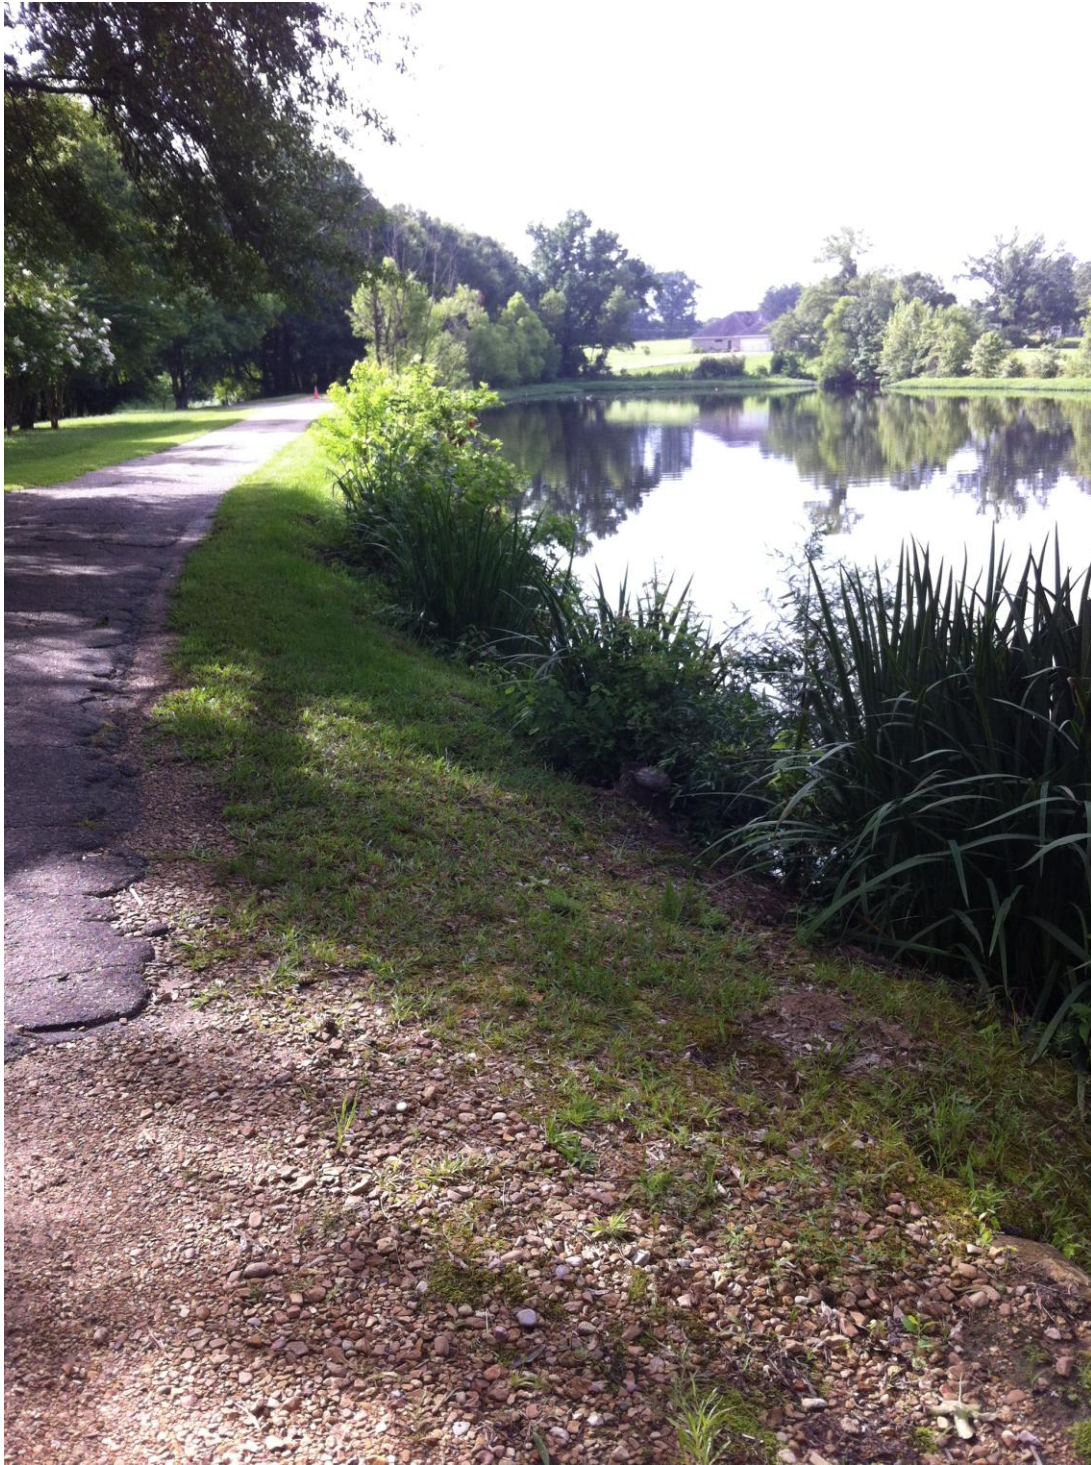
Wave erosion and brush along face of dam,

Photograph 1. Looking west across upstream face and top of dam from the Principal Spillway.

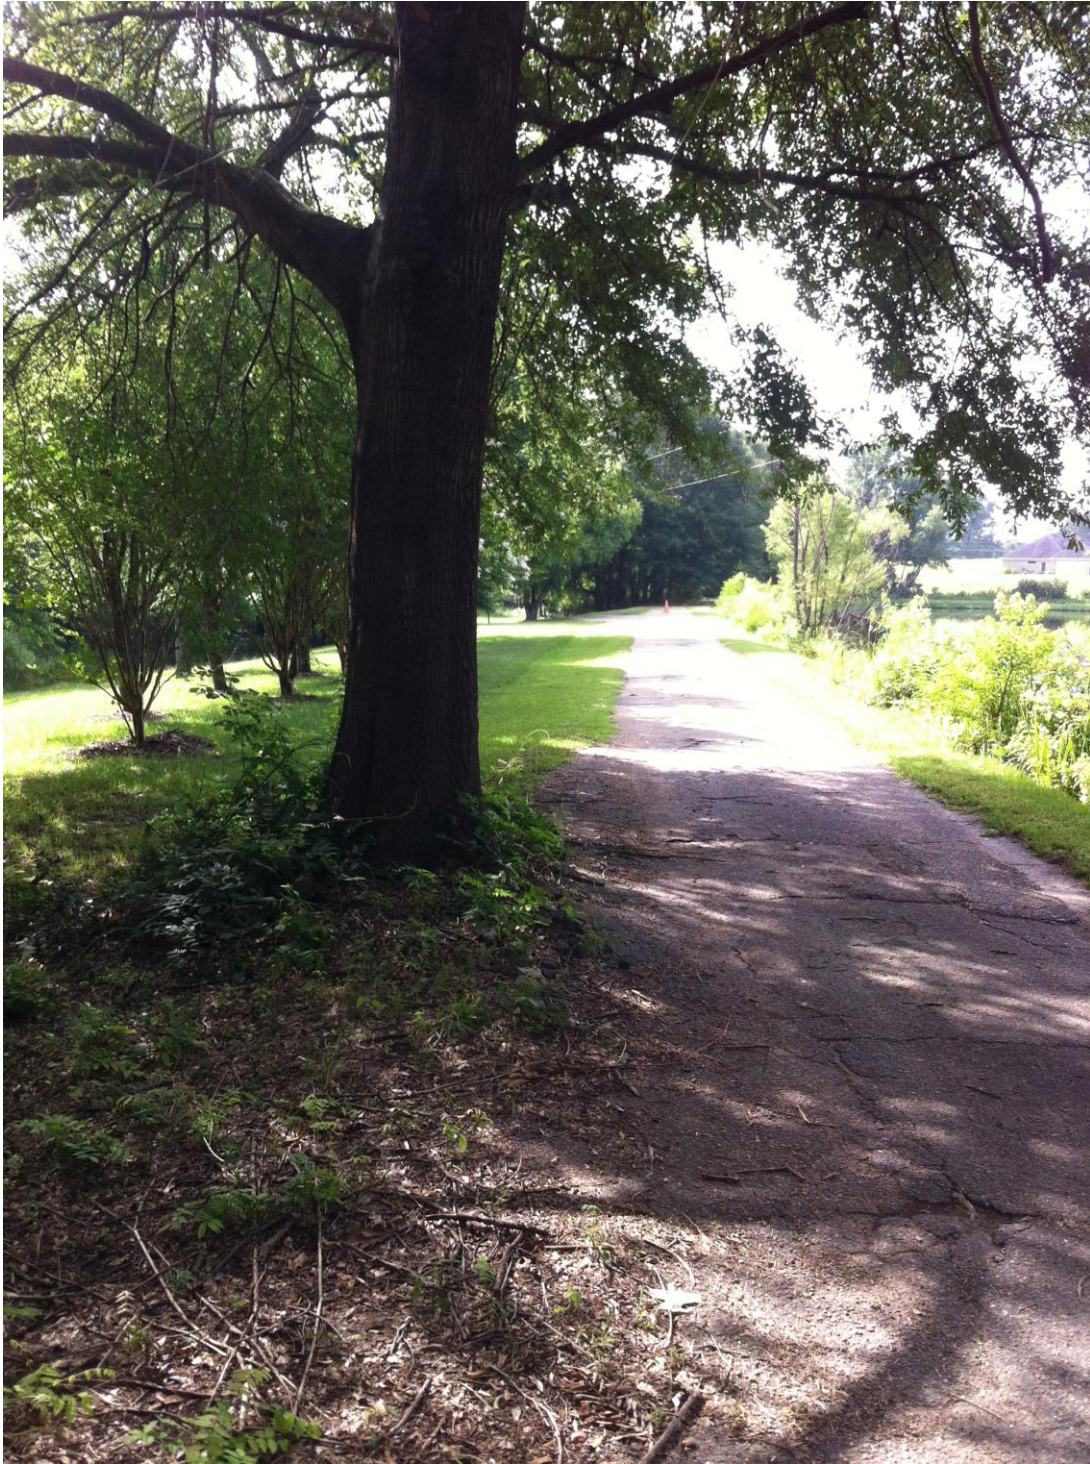
Trees and brush along most of back slope. No signs of seepage.

Photograph 2. Looking west along top of dam and back slope from Principal Spill Way.

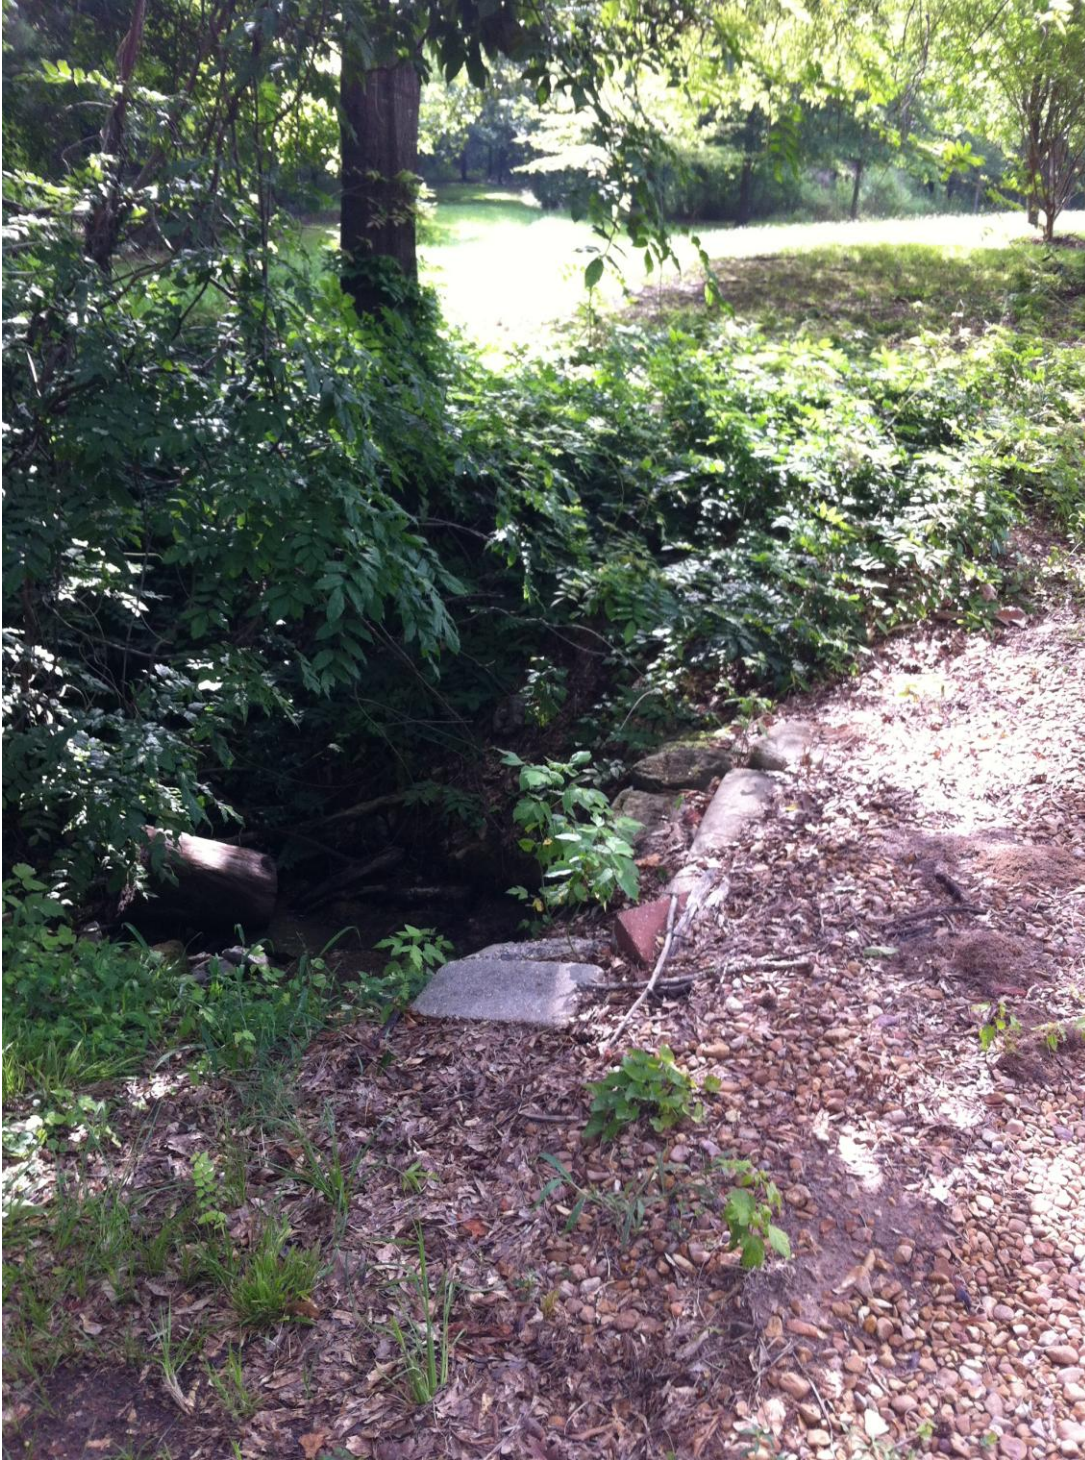
Photograph 3. Looking at downstream end of Principal Spill Way pipe in left (east) abutment.

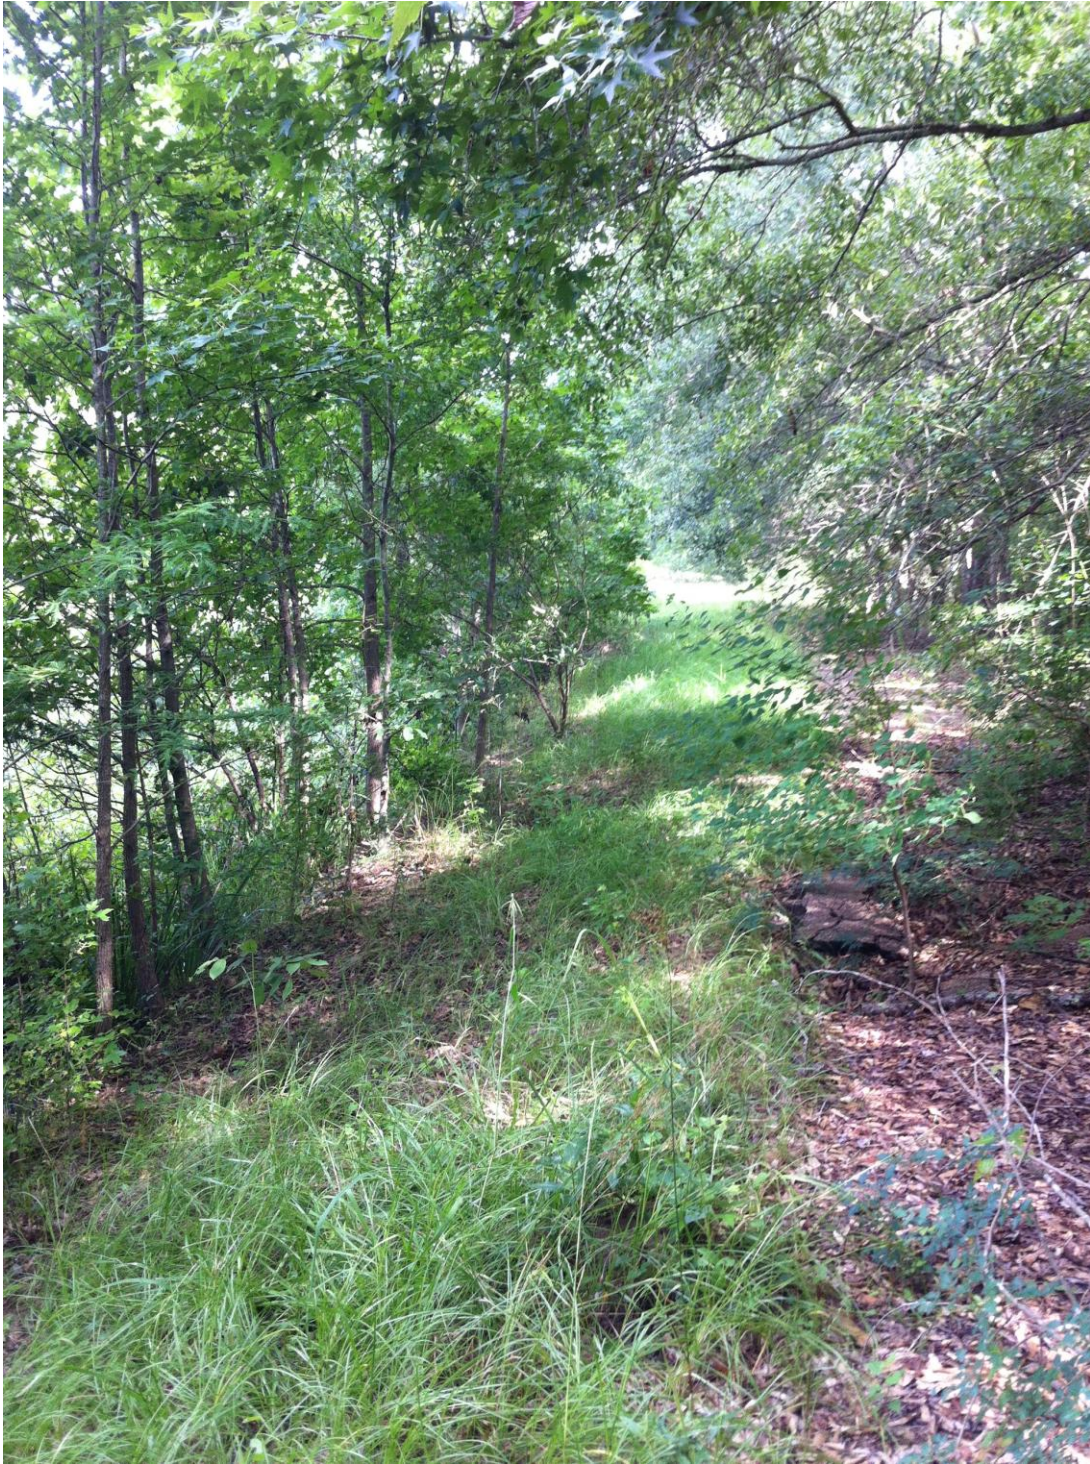
Photograph 4. Looking east across top of dam and front slope from near right (west) end of dam.

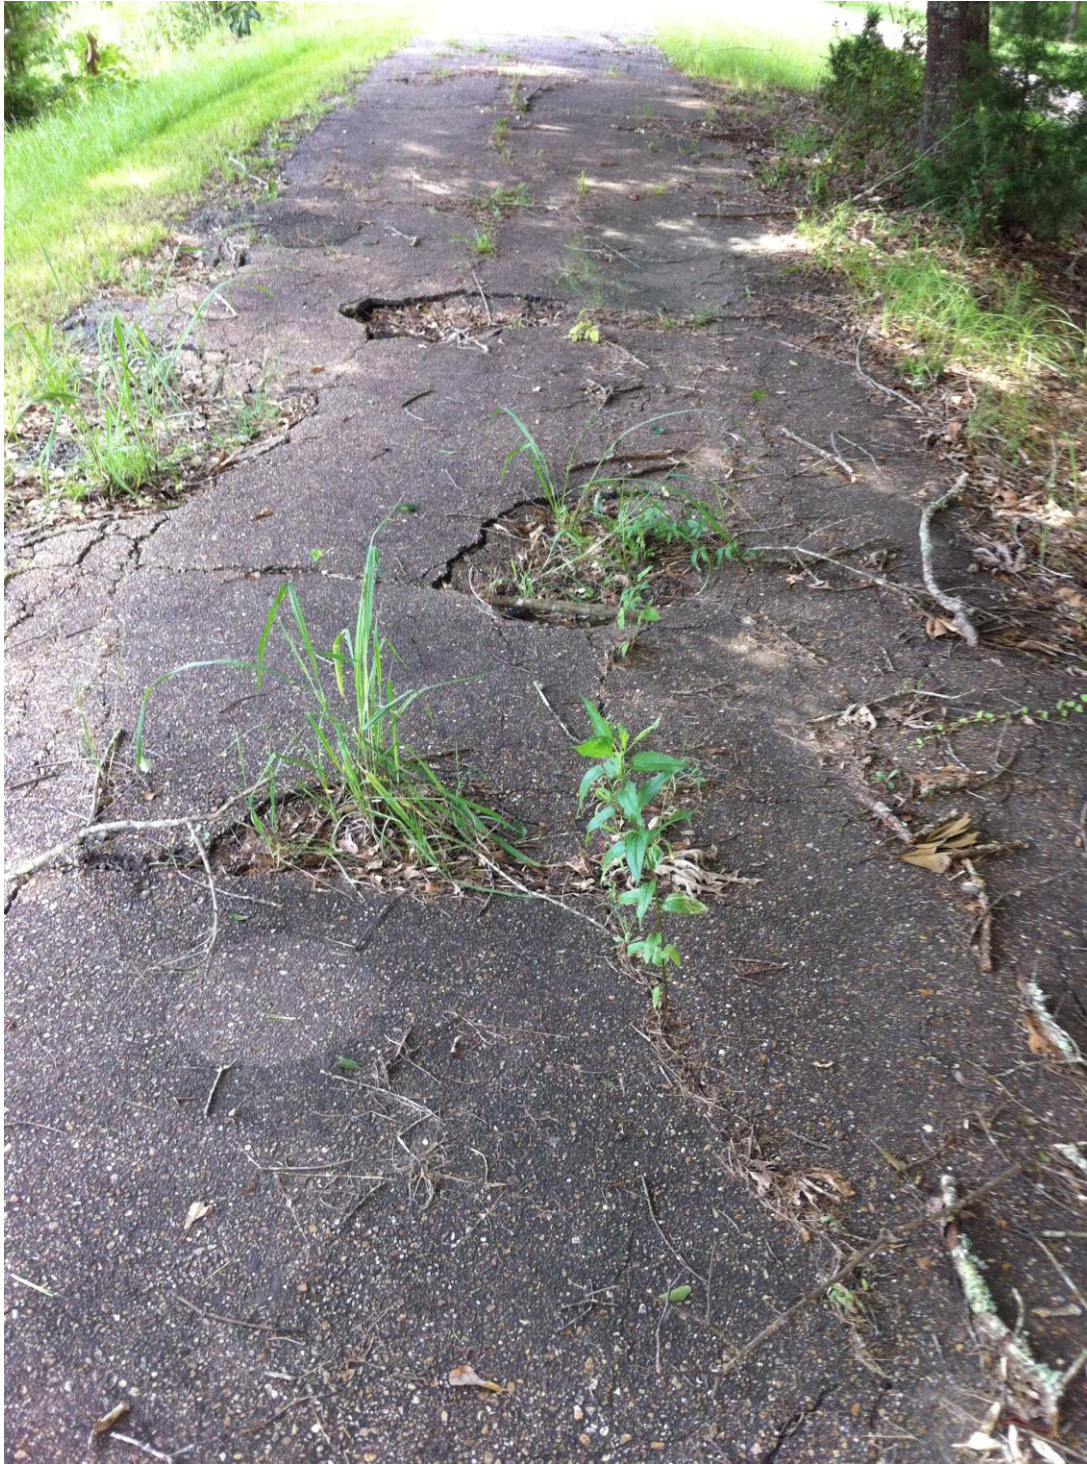
The asphalt surface is broken in numerous locations with sink holes and cracks along the top of dam.

Photograph 5. Close up of broken asphalt and pot holes on top of dam.

The trees and brush along the back slope and face of dam should be removed and a good grass cover established. The front slope should be repaired to provide a slope of three horizontal to one vertical (3H:1V) and protected by rip rap along the water line. The sink holes and cracks along the top of dam should be repaired with suitable fill material to help control seepage of water into the top of dam.

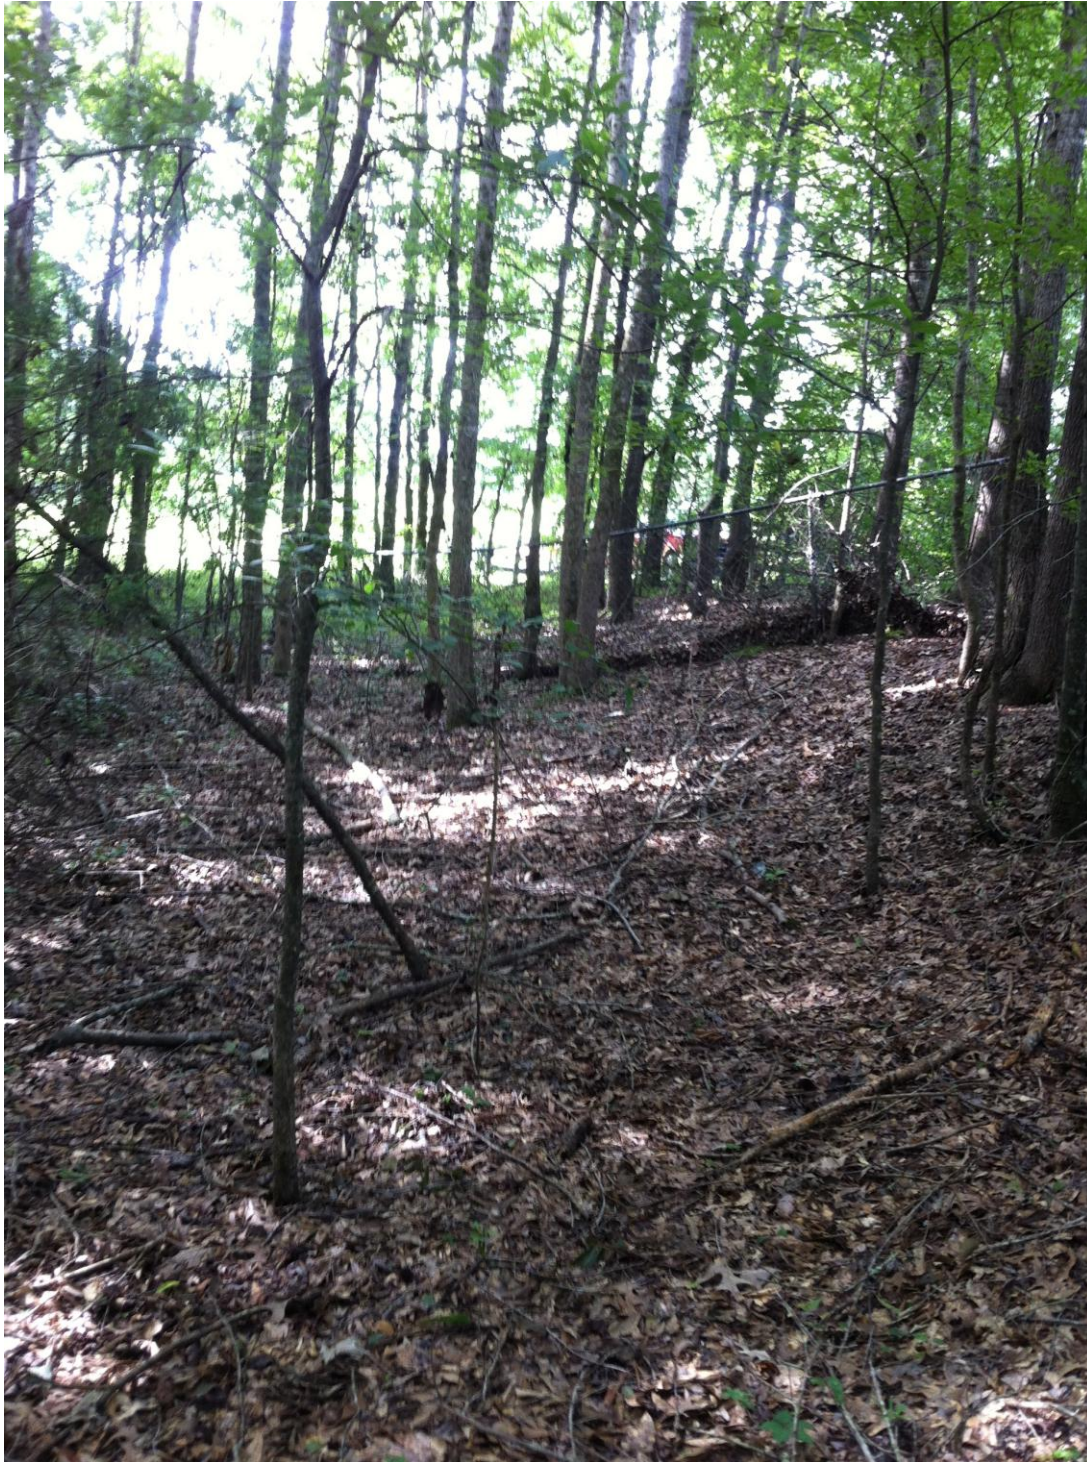
Photograph 6. Looking at trees on back slope of dam near the right (west) abutment.

The trees and woody vegetation should be removed and the front slope of the dam repaired.

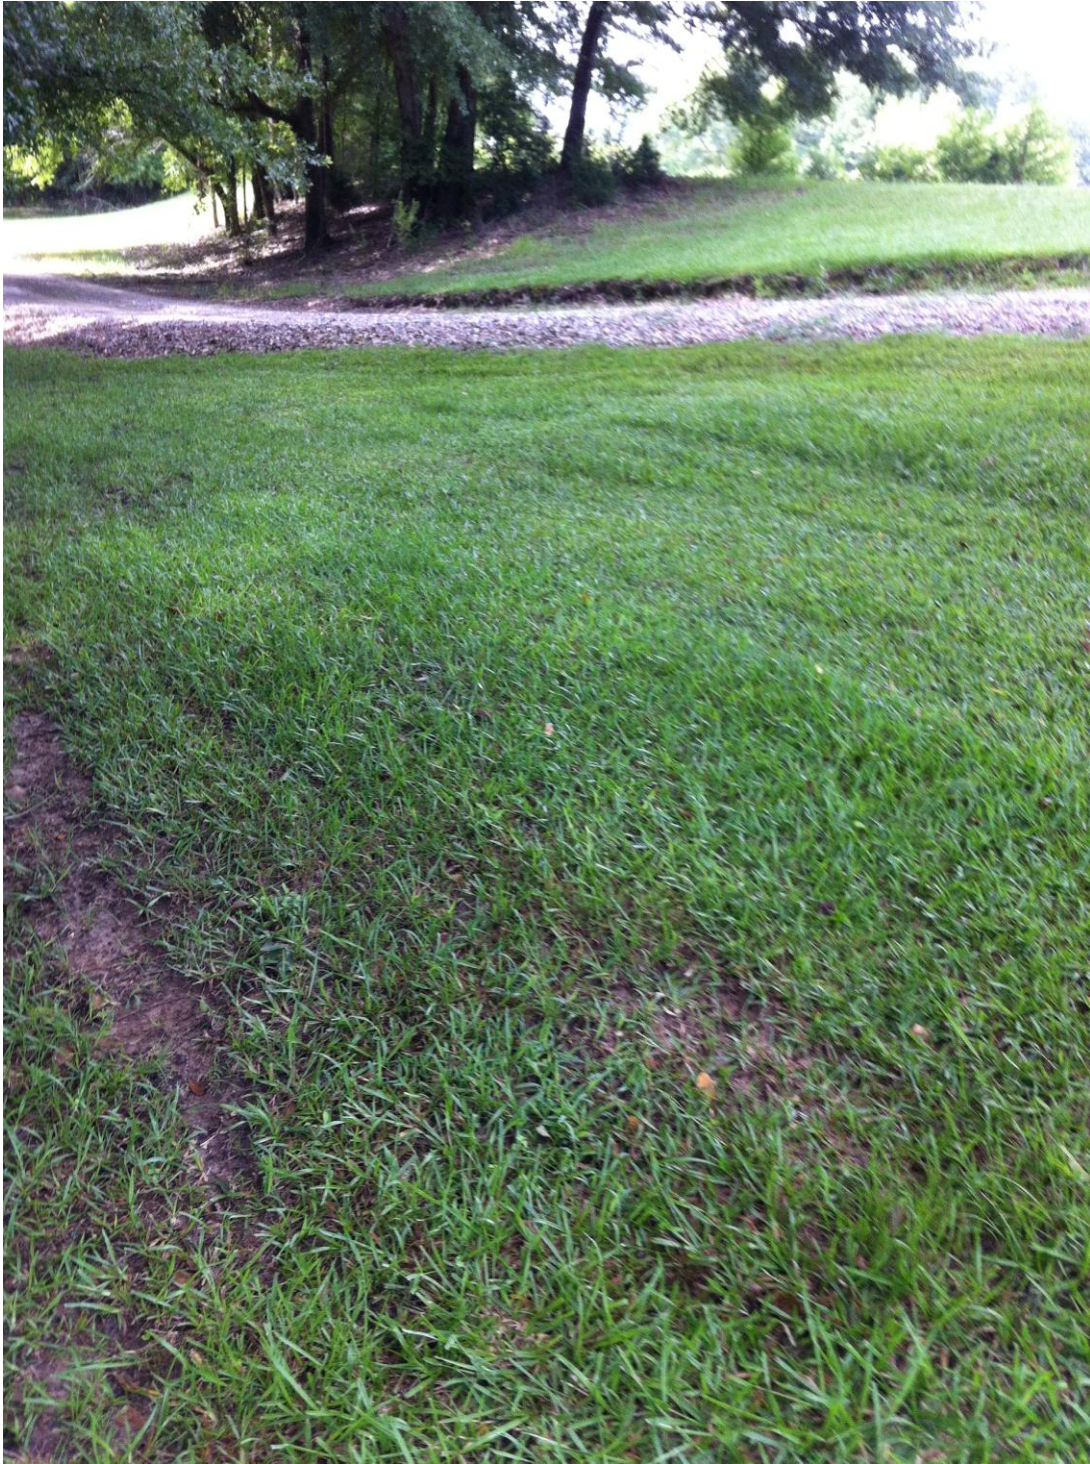
Trees and brush along downstream side of gravel driveway

Photograph 7. Looking west where gravel driveway crosses the back slope of dam.
