# Cross Creek West Dam

**MS – 03408**

## **Formal Inspection Report**

July 2021

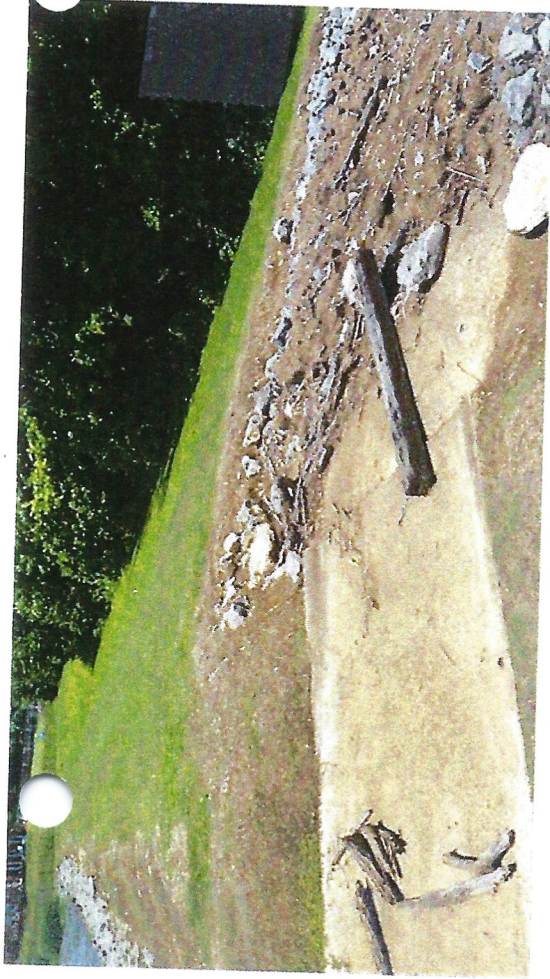
Photo No. 5

Unusual Conditions: Debris on spillway should be removed. See Photo No.5 and 7.

View of downstream end of principal spillway where it enters the grouted riprap flume. Accumulated debris should be removed. Also shown is the upstream slope, top of Dam and downstream slope. Tree growth is evident along toe of the Dam.

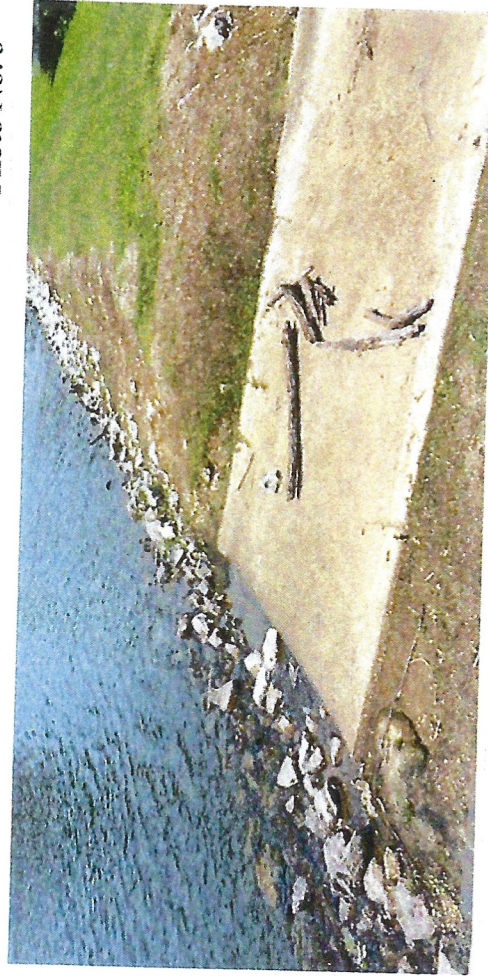
Photo No. 7

Description: No formal entrance channel is present. Lake outflows enter directly into principal spillway. See Photo No. 7.

View of entrance to principal spillway and upstream slope erosion protection.

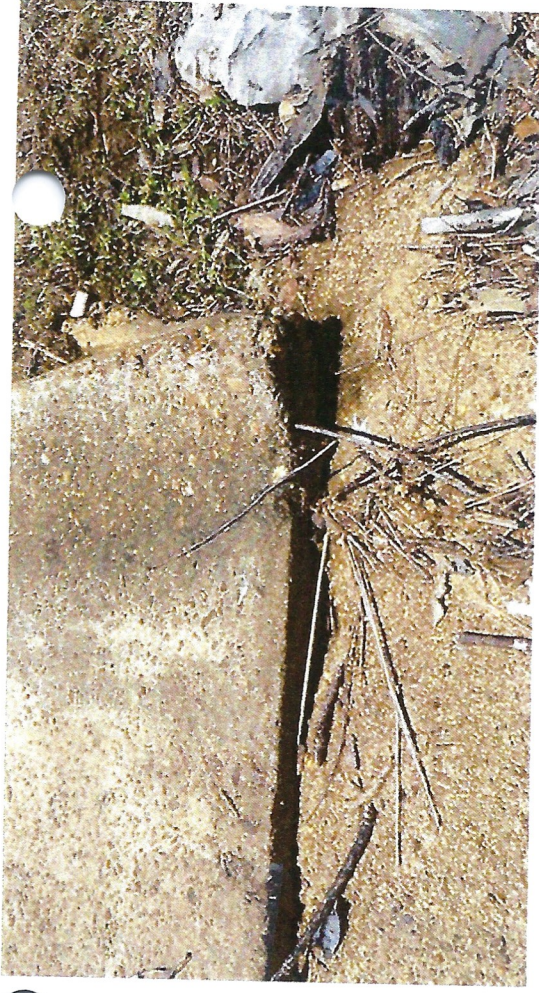
Signs of Movement: Some see Photo No. 6

Joints: Joints remain tight; however, the joints should be re-sawed and re-caulked due to age of concrete. See Photo's No. 5 and 6.

View of joint separation on concrete section of principal spillway. Spillway is aging and joints should be refurbished.

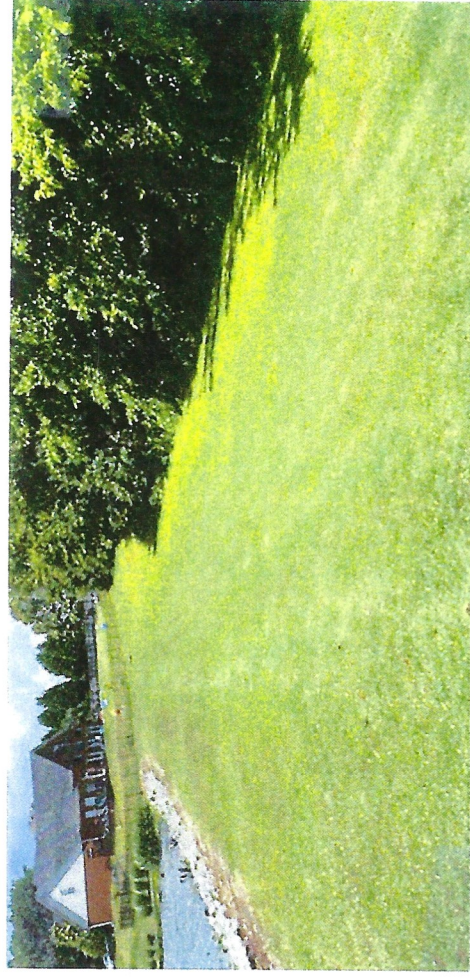
Photo No. 8

Comments: Woody vegetation exists within 50 feet of the toe (see photo No. 8), good vegetative cover exists ( see photo's No. 3 & 8), minor bare areas were observed and should be addressed( see Photo's No. 1,3,5,7,and 9), : Embankment ties into natural ground, no seepage was noted.

View of downstream slope <sup>west</sup> of principal spillway. Good vegetative cover exists and is well maintained. Tree growth exists along toe of Dam.

- Develop plan and implement for the removal of vegetation along toe of dam embankment to create a 50-foot buffer.
- Monitor any changes in downstream conditions.

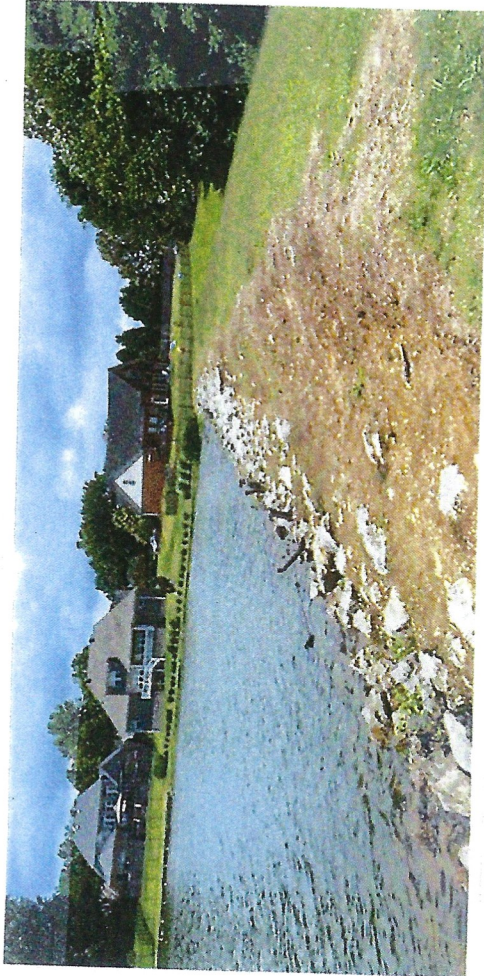
Photo No. 9

View of upstream slope, top of dam and downstream slope on the west end of Dam. Erosion has been previously placed on upstream slope. Tree growth along toe is also shown.
