DAM INSPECTION REPORT

HILDEBRANT DAM

Dam Inventory MS03868
Desoto County, MS

October 31, 2019

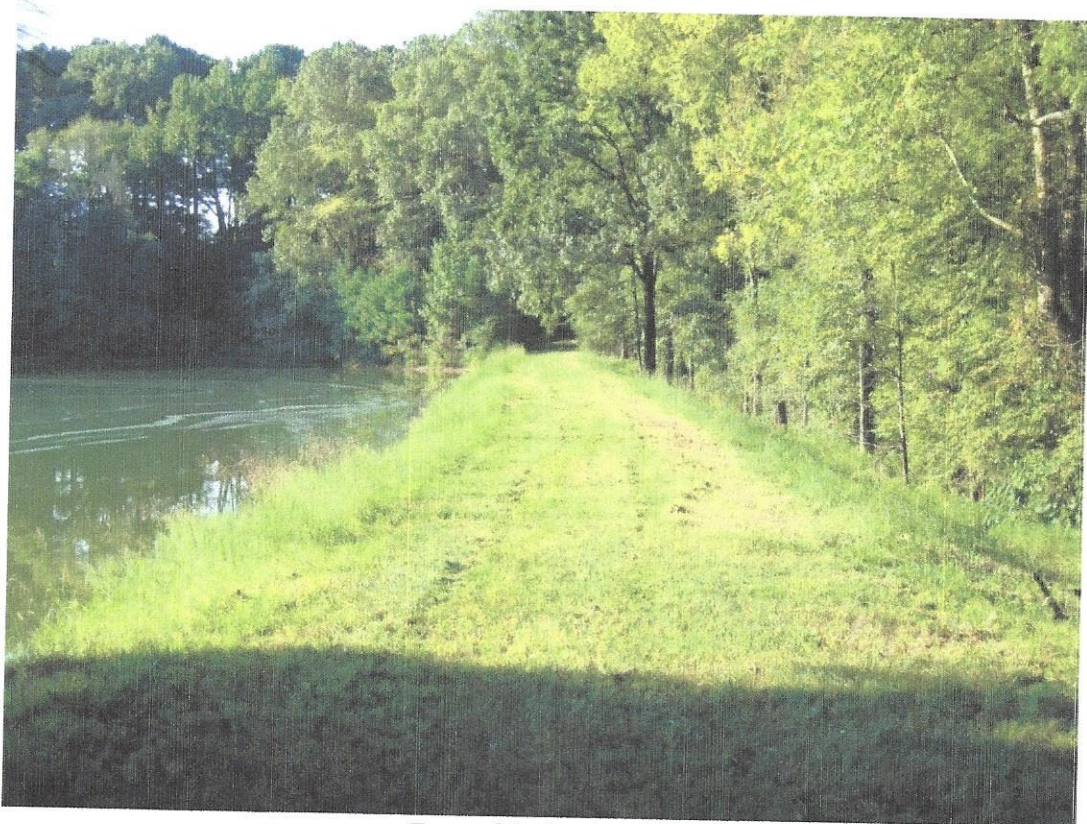
If Trees, Brush, Briars is checked above please describe the nature and extent of vegetation on the dam?
Trees and brush on/near downstream crown,

Topo of Embankment

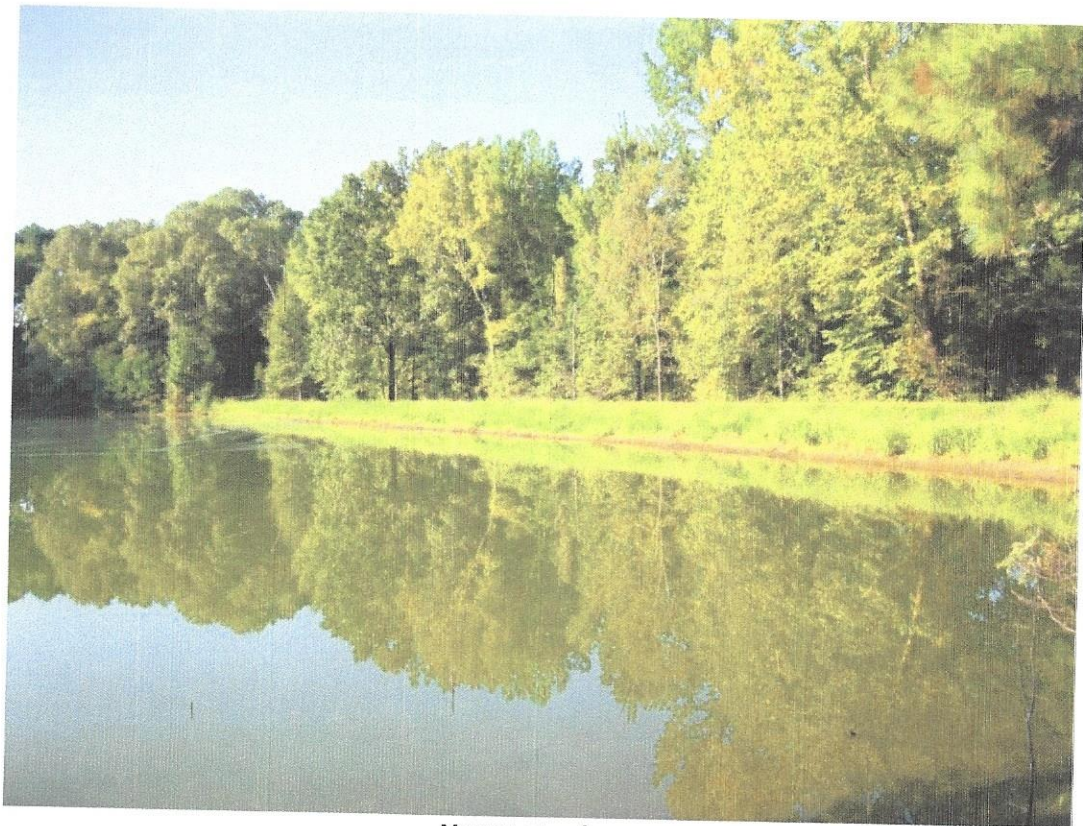
Small brush and tall grass present

- ☐ Satisfactory
☒ Fair
☐ Poor
☐ Unsatisfactory

Upstream slope

Mow or trim grass on upstream slope; Continue to remove trees and brush from downstream slope.

Increase frequency of removing grass on upstream slope and tree removal on downstream slope

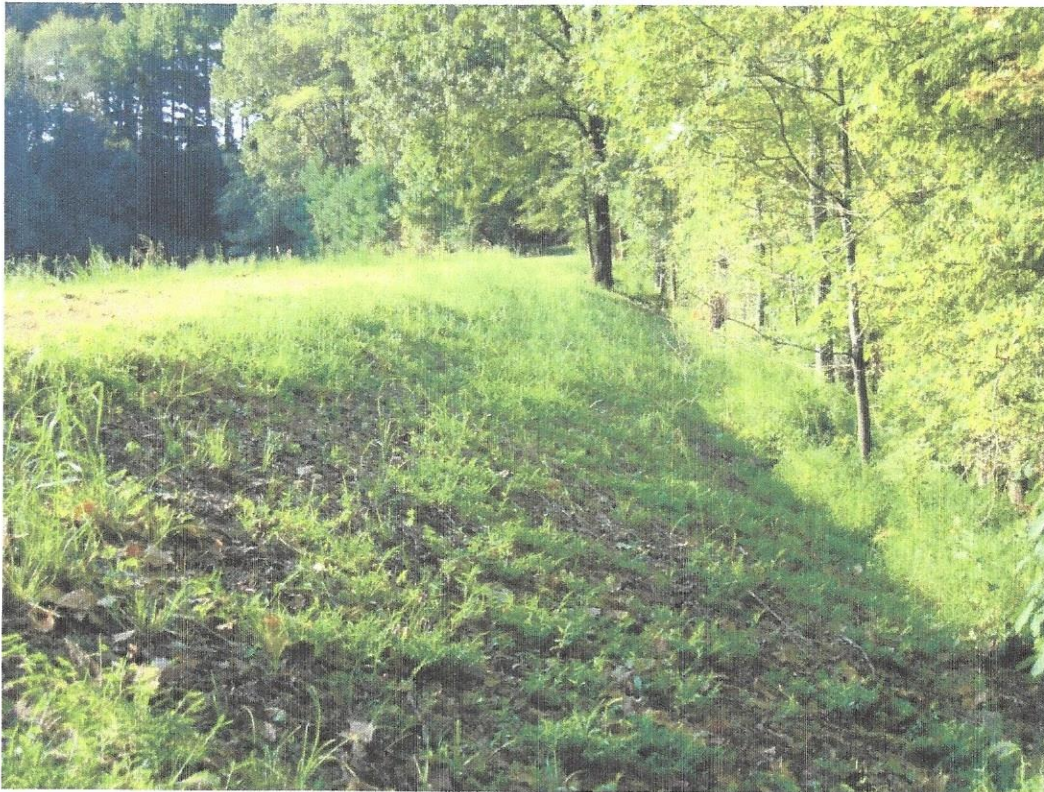
Trees and brush present on slope

Large, small trees and brush

- ☐ Satisfactory
☒ Fair
☐ Poor
☐ Unsatisfactory

Downstream Slope

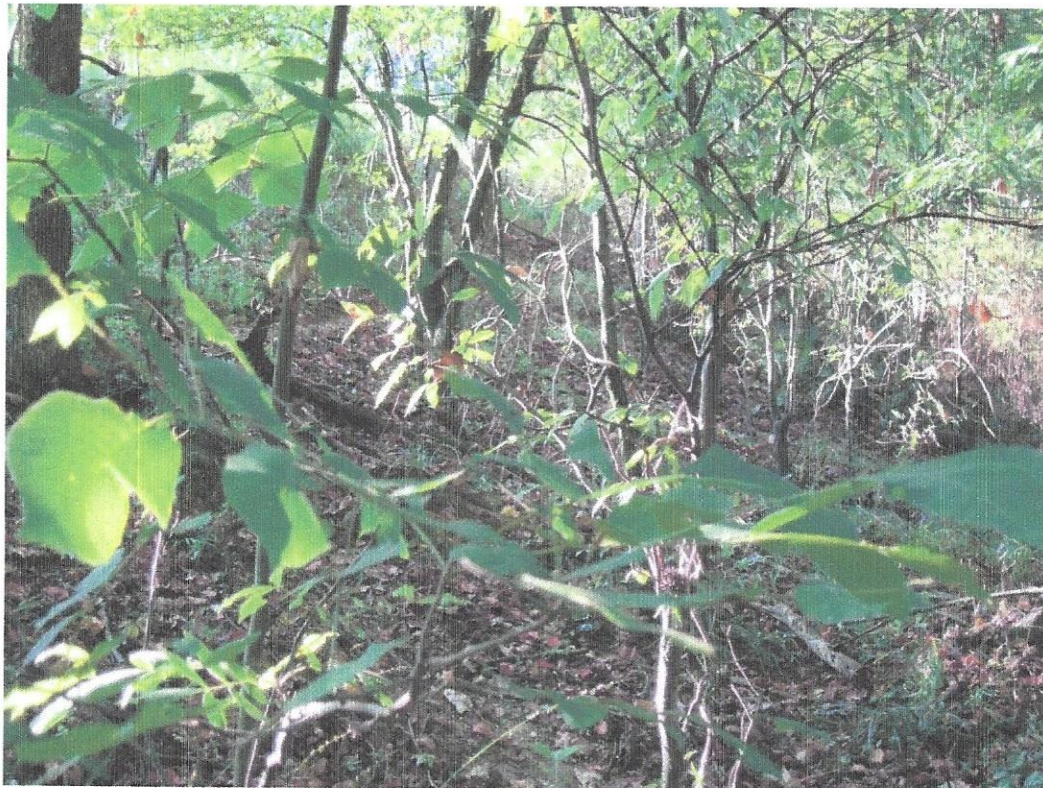
Downstream slope

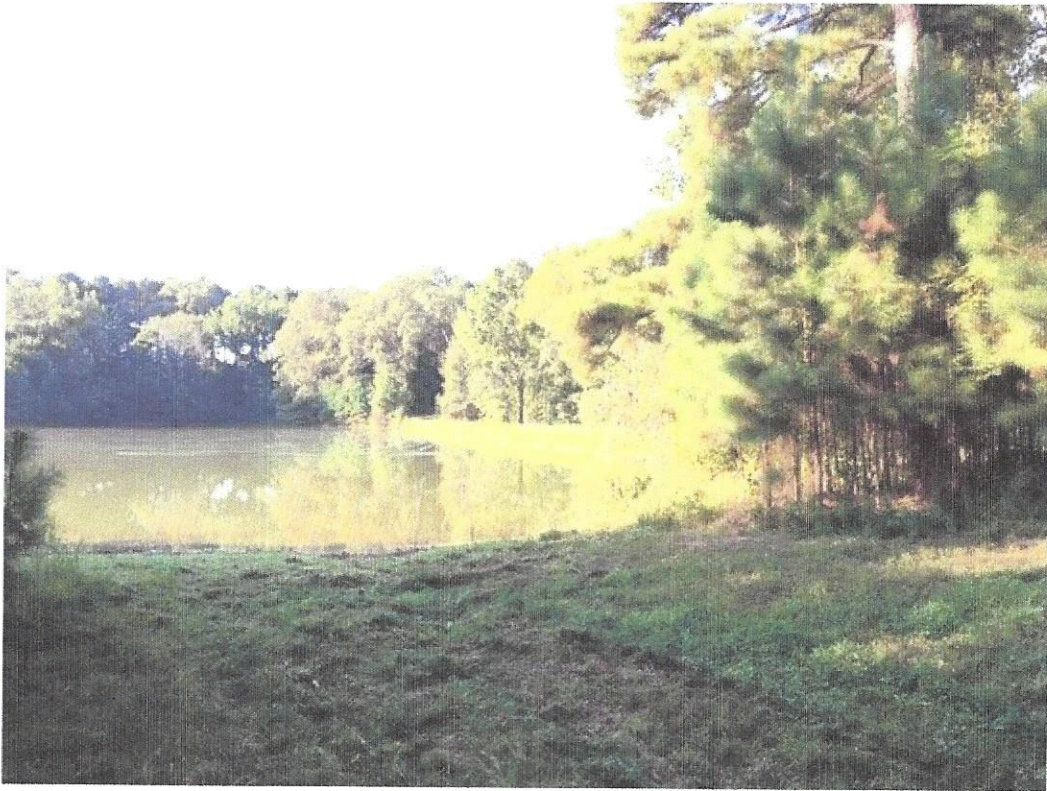
Description: **No defined entrance channel, spillway begins in reservoir area**

Debris: **Small amount of dead trees and brush, no concerns**

Spillway entrance

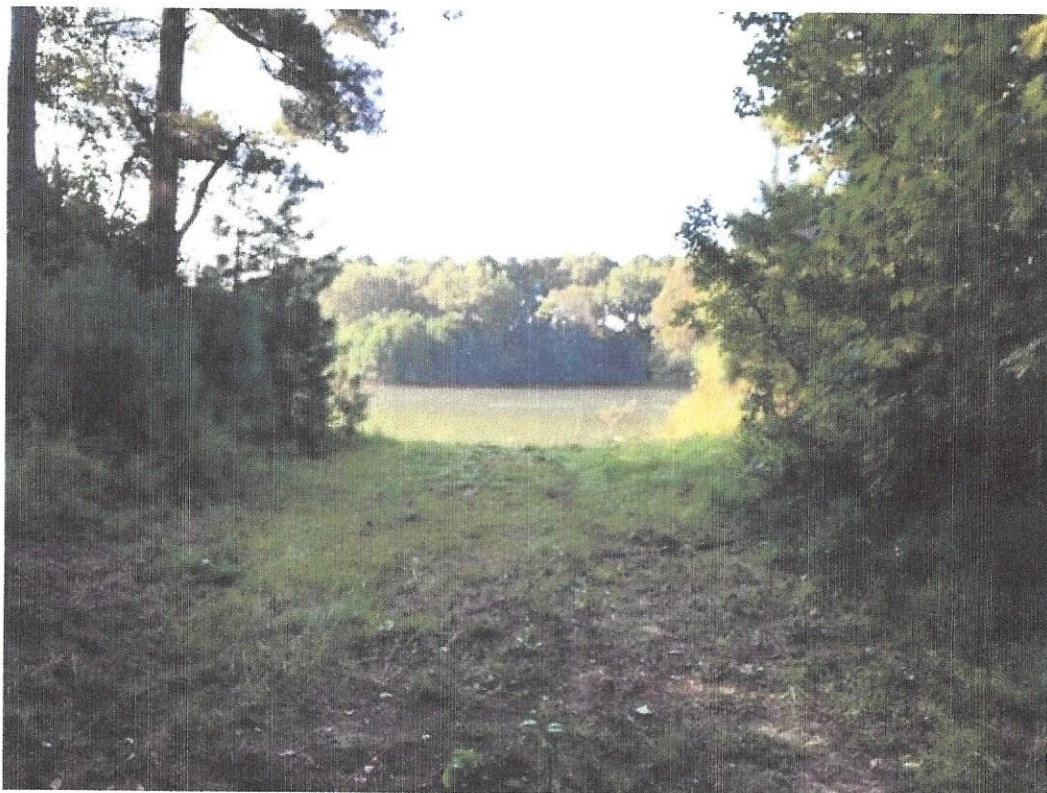
Description: **Earthen, nearly flat from reservoir to outlet ditch**

Condition of Material: **Satisfactory**

Spillway control section

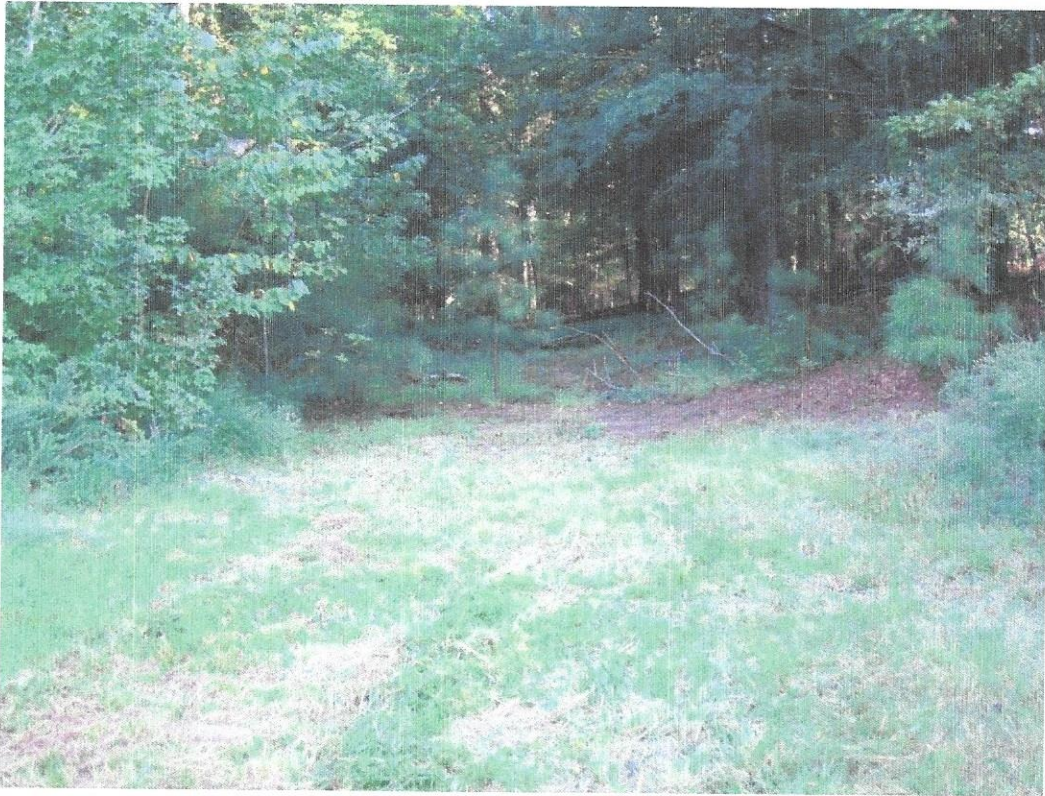
Spillway outlet

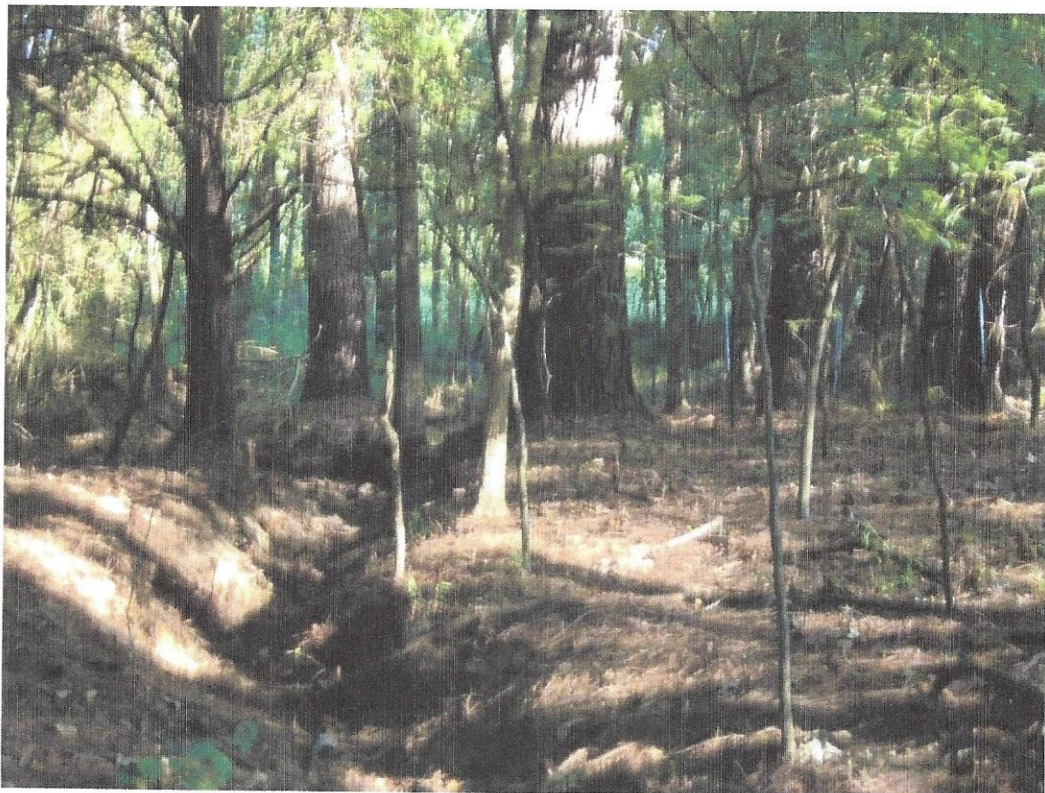
Vegetation (Trees, Bushes): **Small brush on slopes**

Erosion: **None**

Outlet ditch
