# Cross Creek West Dam

**MS – 03408**

## **Formal Inspection Report**

July 2021

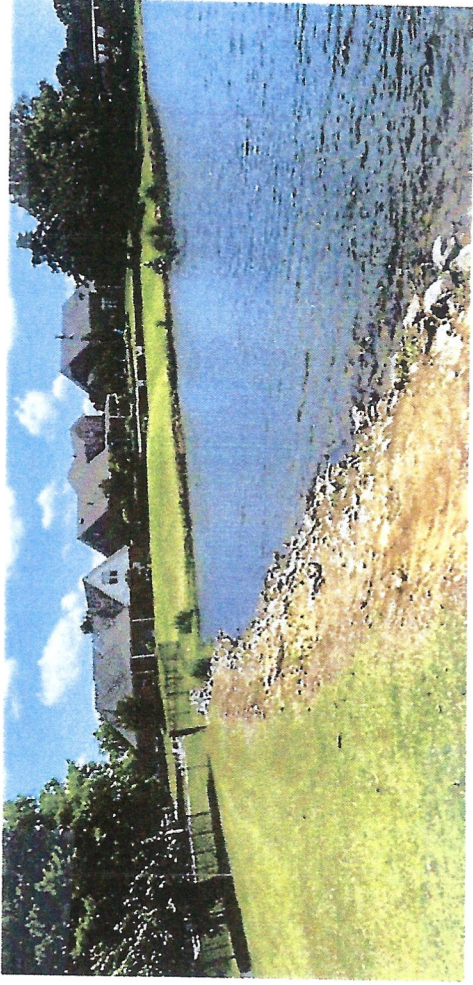
Photo No. 9

View of upstream slope, top of dam and downstream slope on the west end of Dam. Erosion has been previously placed on upstream slope. Tree growth along toe is also shown.

- Develop plan and implement for the removal of vegetation along toe of dam embankment to create a 50-foot buffer.
- Monitor any changes in downstream conditions.
