DAM INSPECTION REPORT

HILDEBRANT DAM

Dam Inventory MS03868
Desoto County, MS

October 31, 2019

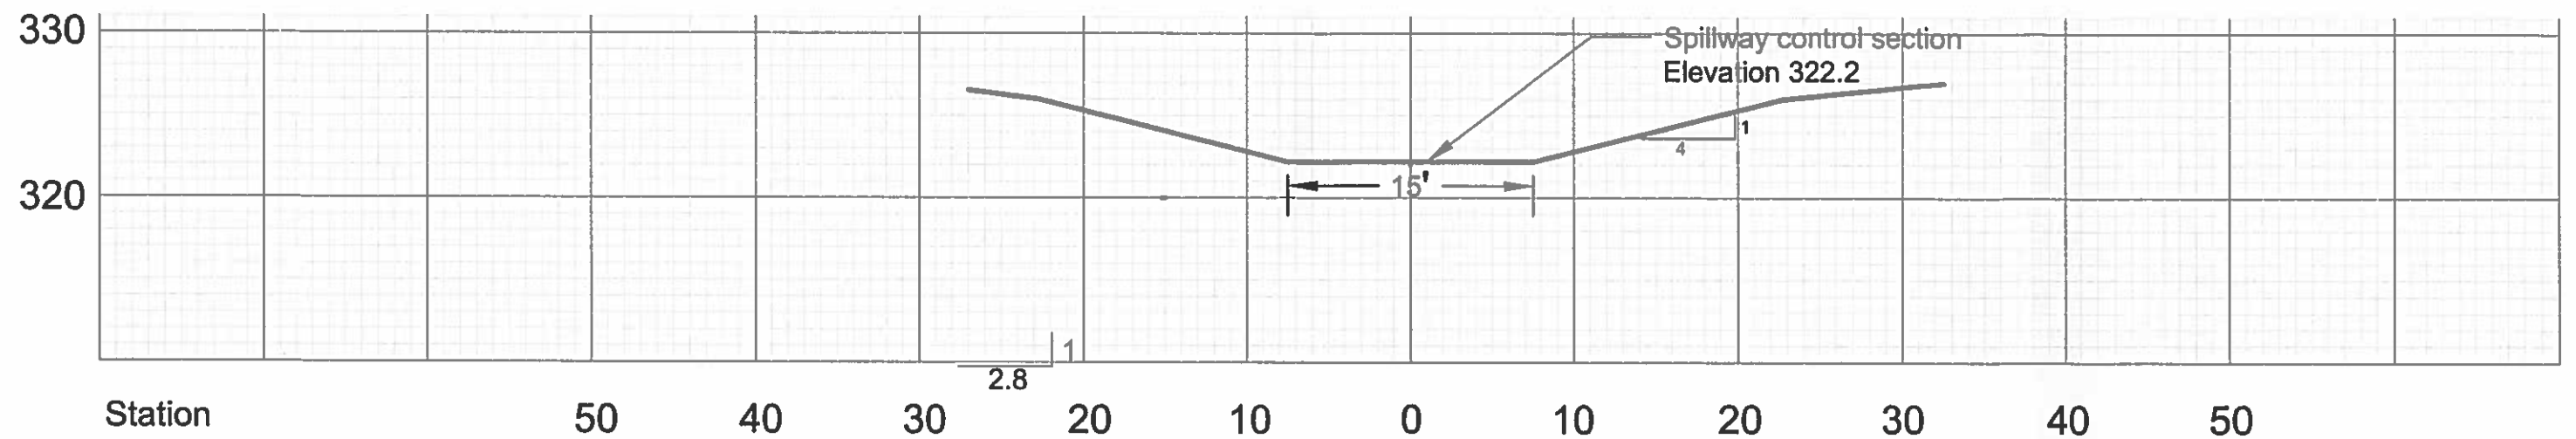
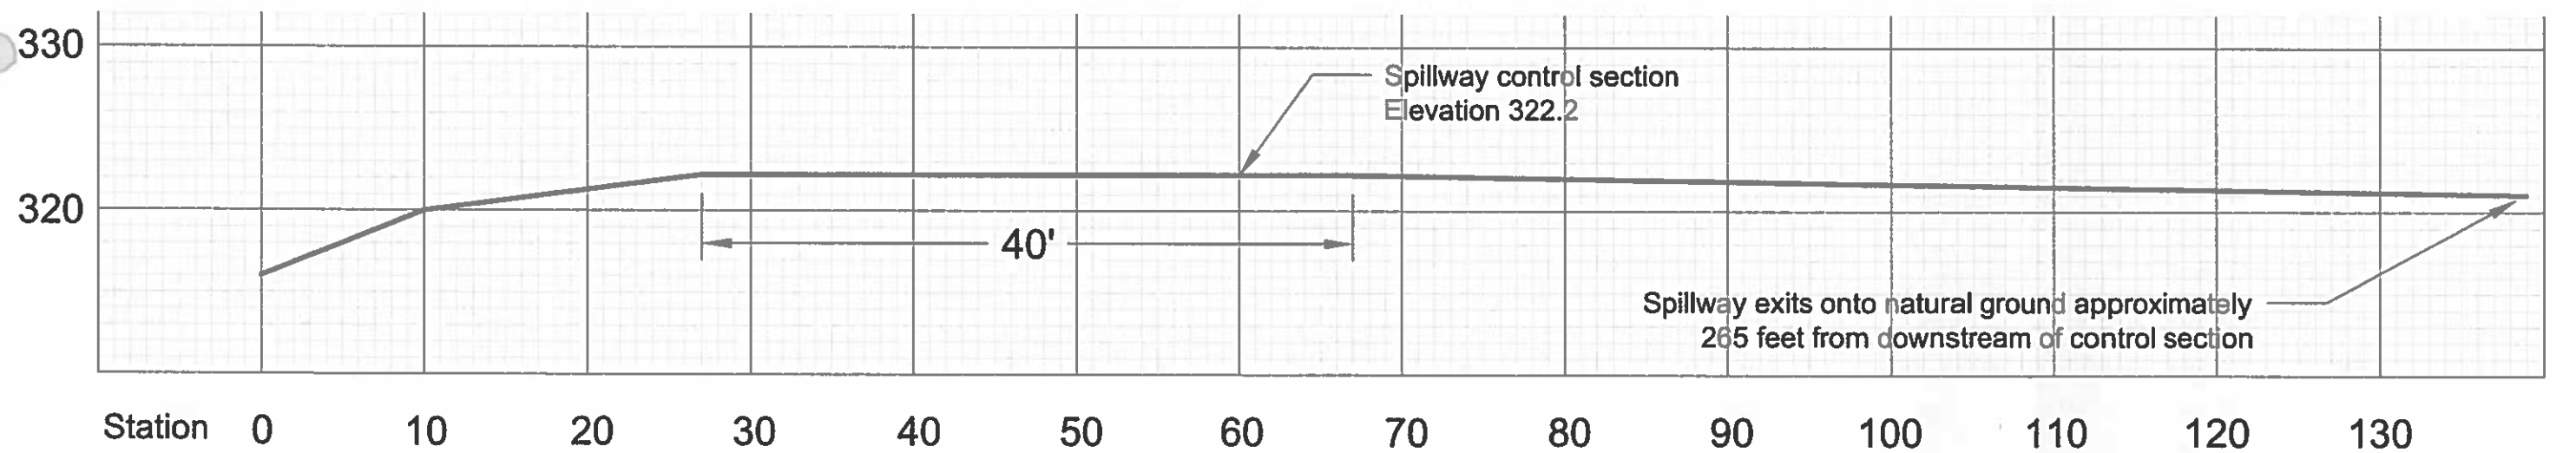
Drawn By: JSW	Date: 11/05/2015
Checked By: JSW	Sheet 18 of 28

Unusual Conditions: **Though the M.J. Simmons Dam is immediately downstream of this dam, the spillway does not flow into that dam. It flows into an adjacent drainage path and eventually into the culvert under Reed Road downstream of the M. J. Simmons dam**
