EMERGENCY ACTION PLAN

Ross Barnett Dam and Reservoir

STATE ID MS02716

US Army Corps of Engineers

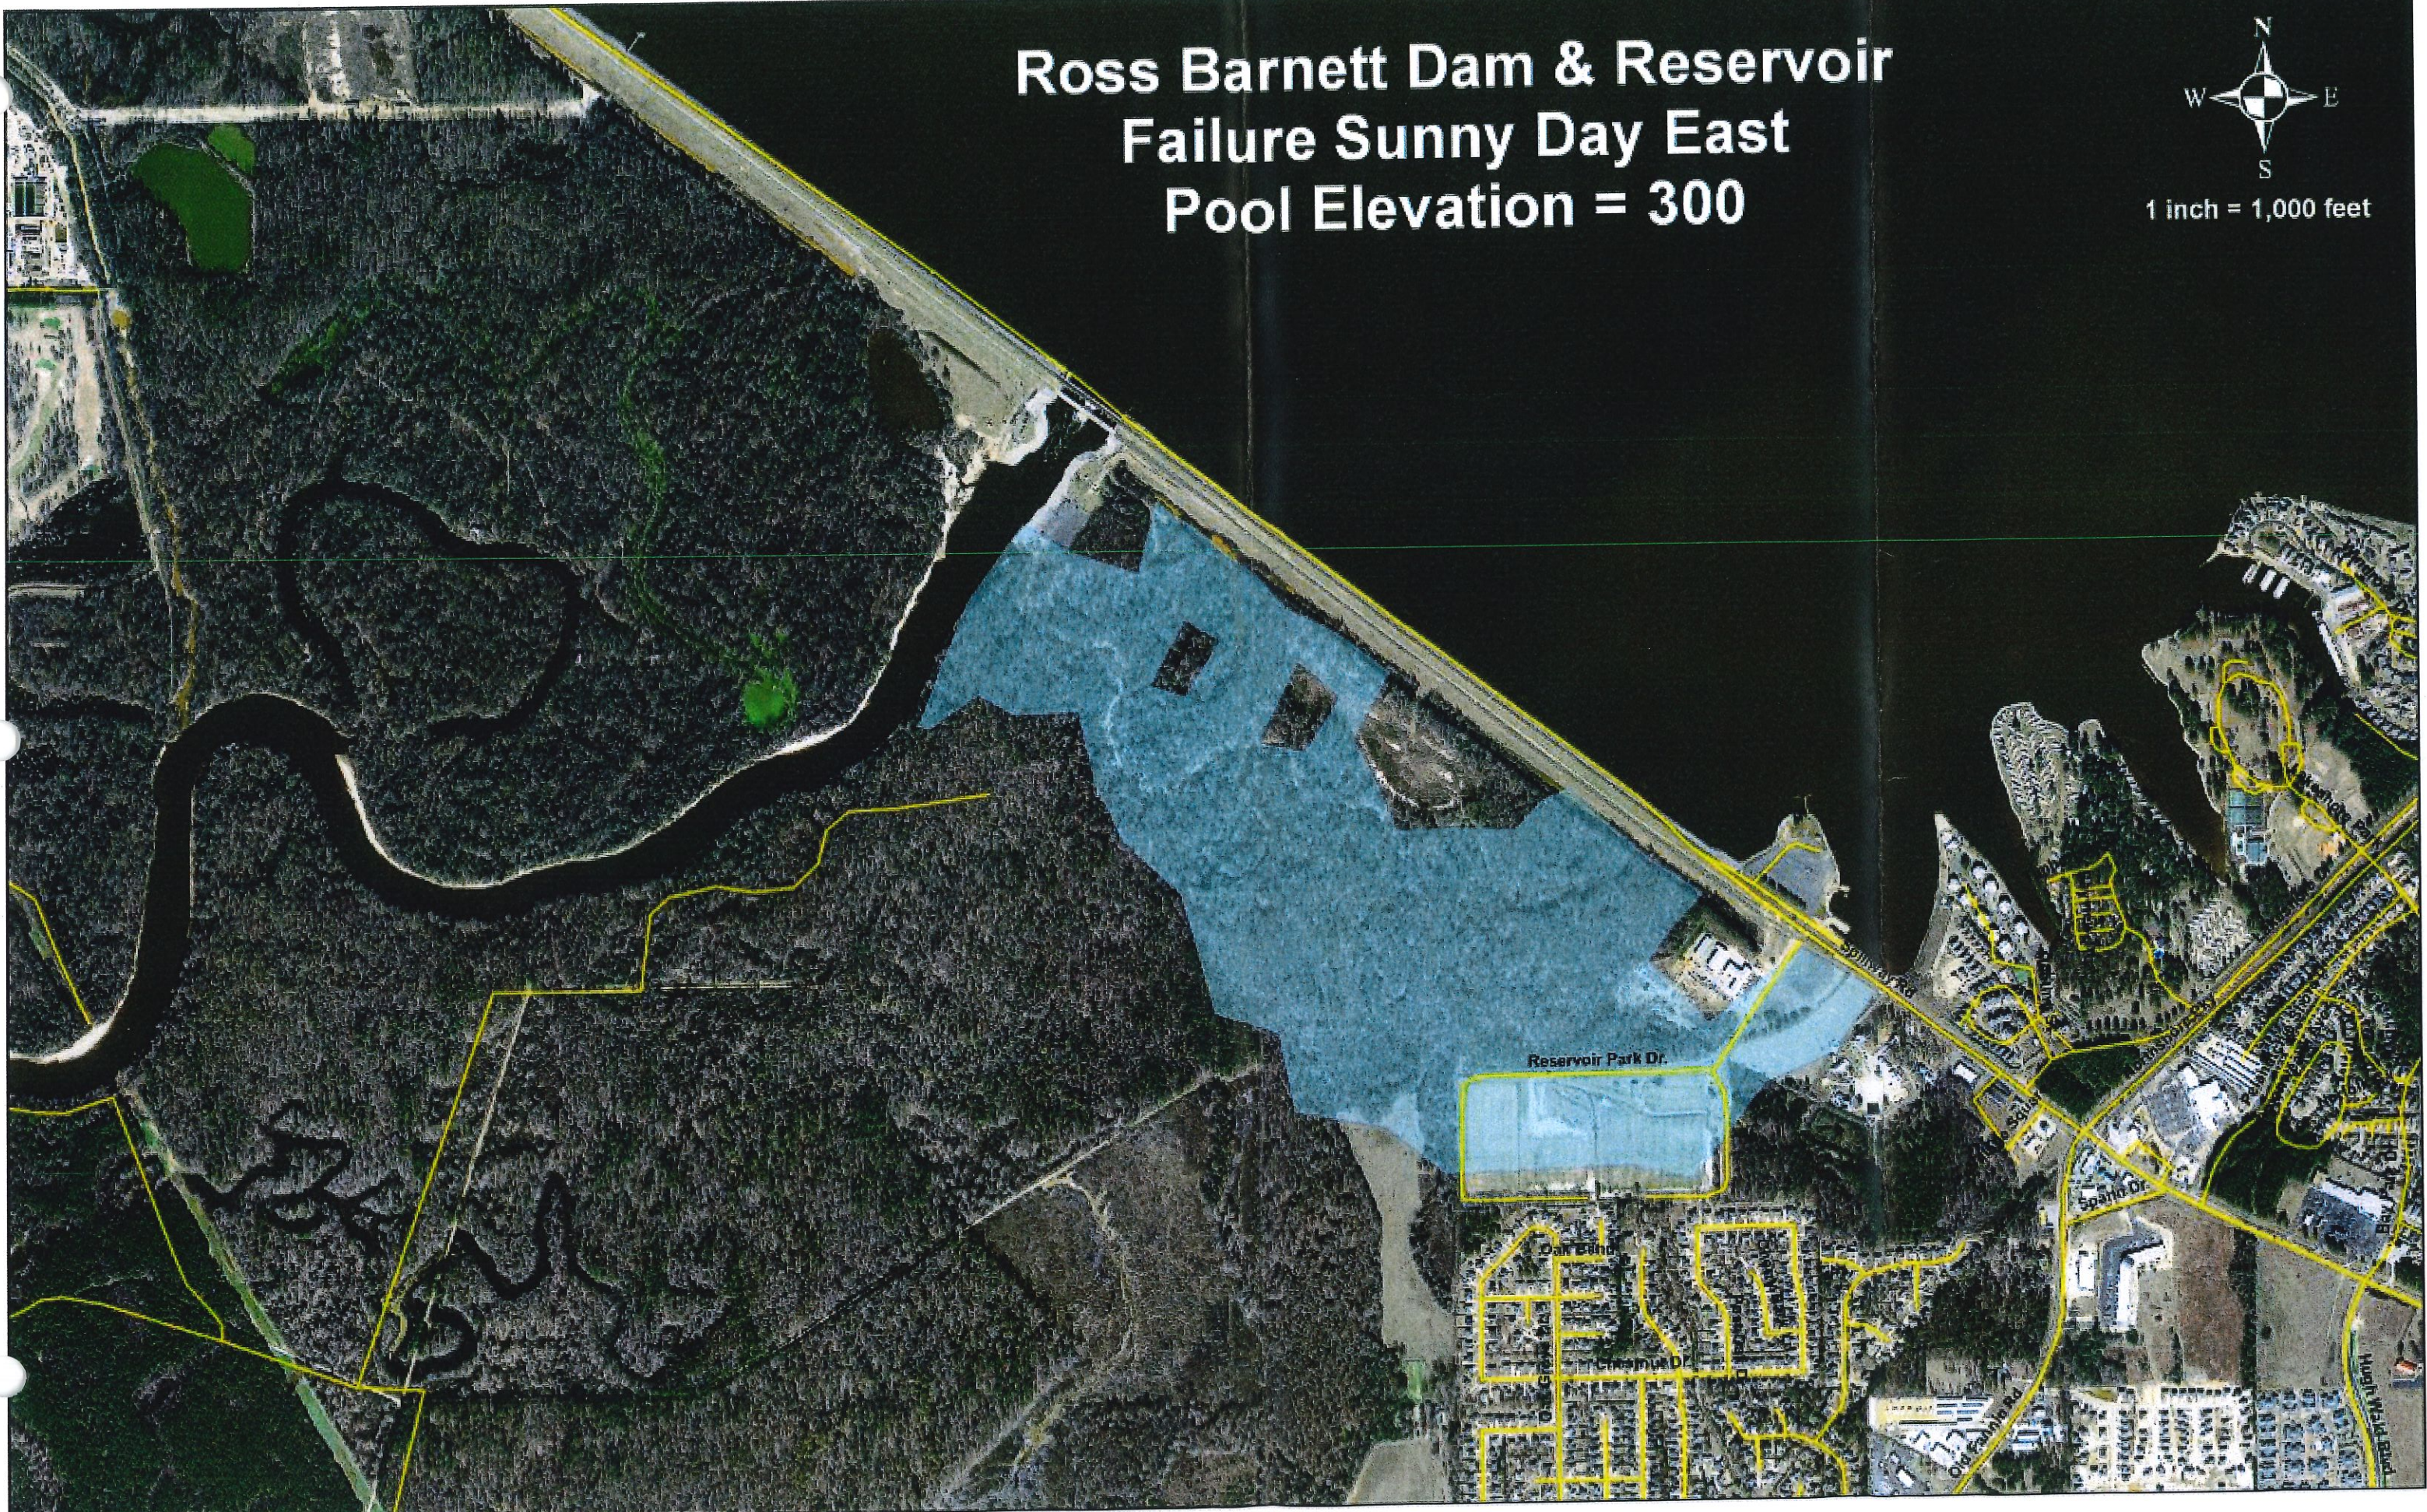
**Ross Barnett Dam & Reservoir
Failure Sunny Day East
Pool Elevation = 300**

The area immediately downstream of the Reservoir that will be inundated is shown in inundation maps on pages 8-11. The index of inundation maps and all inundation maps showing areas affected from the Reservoir to Lawrence County are found on pages 12-21.

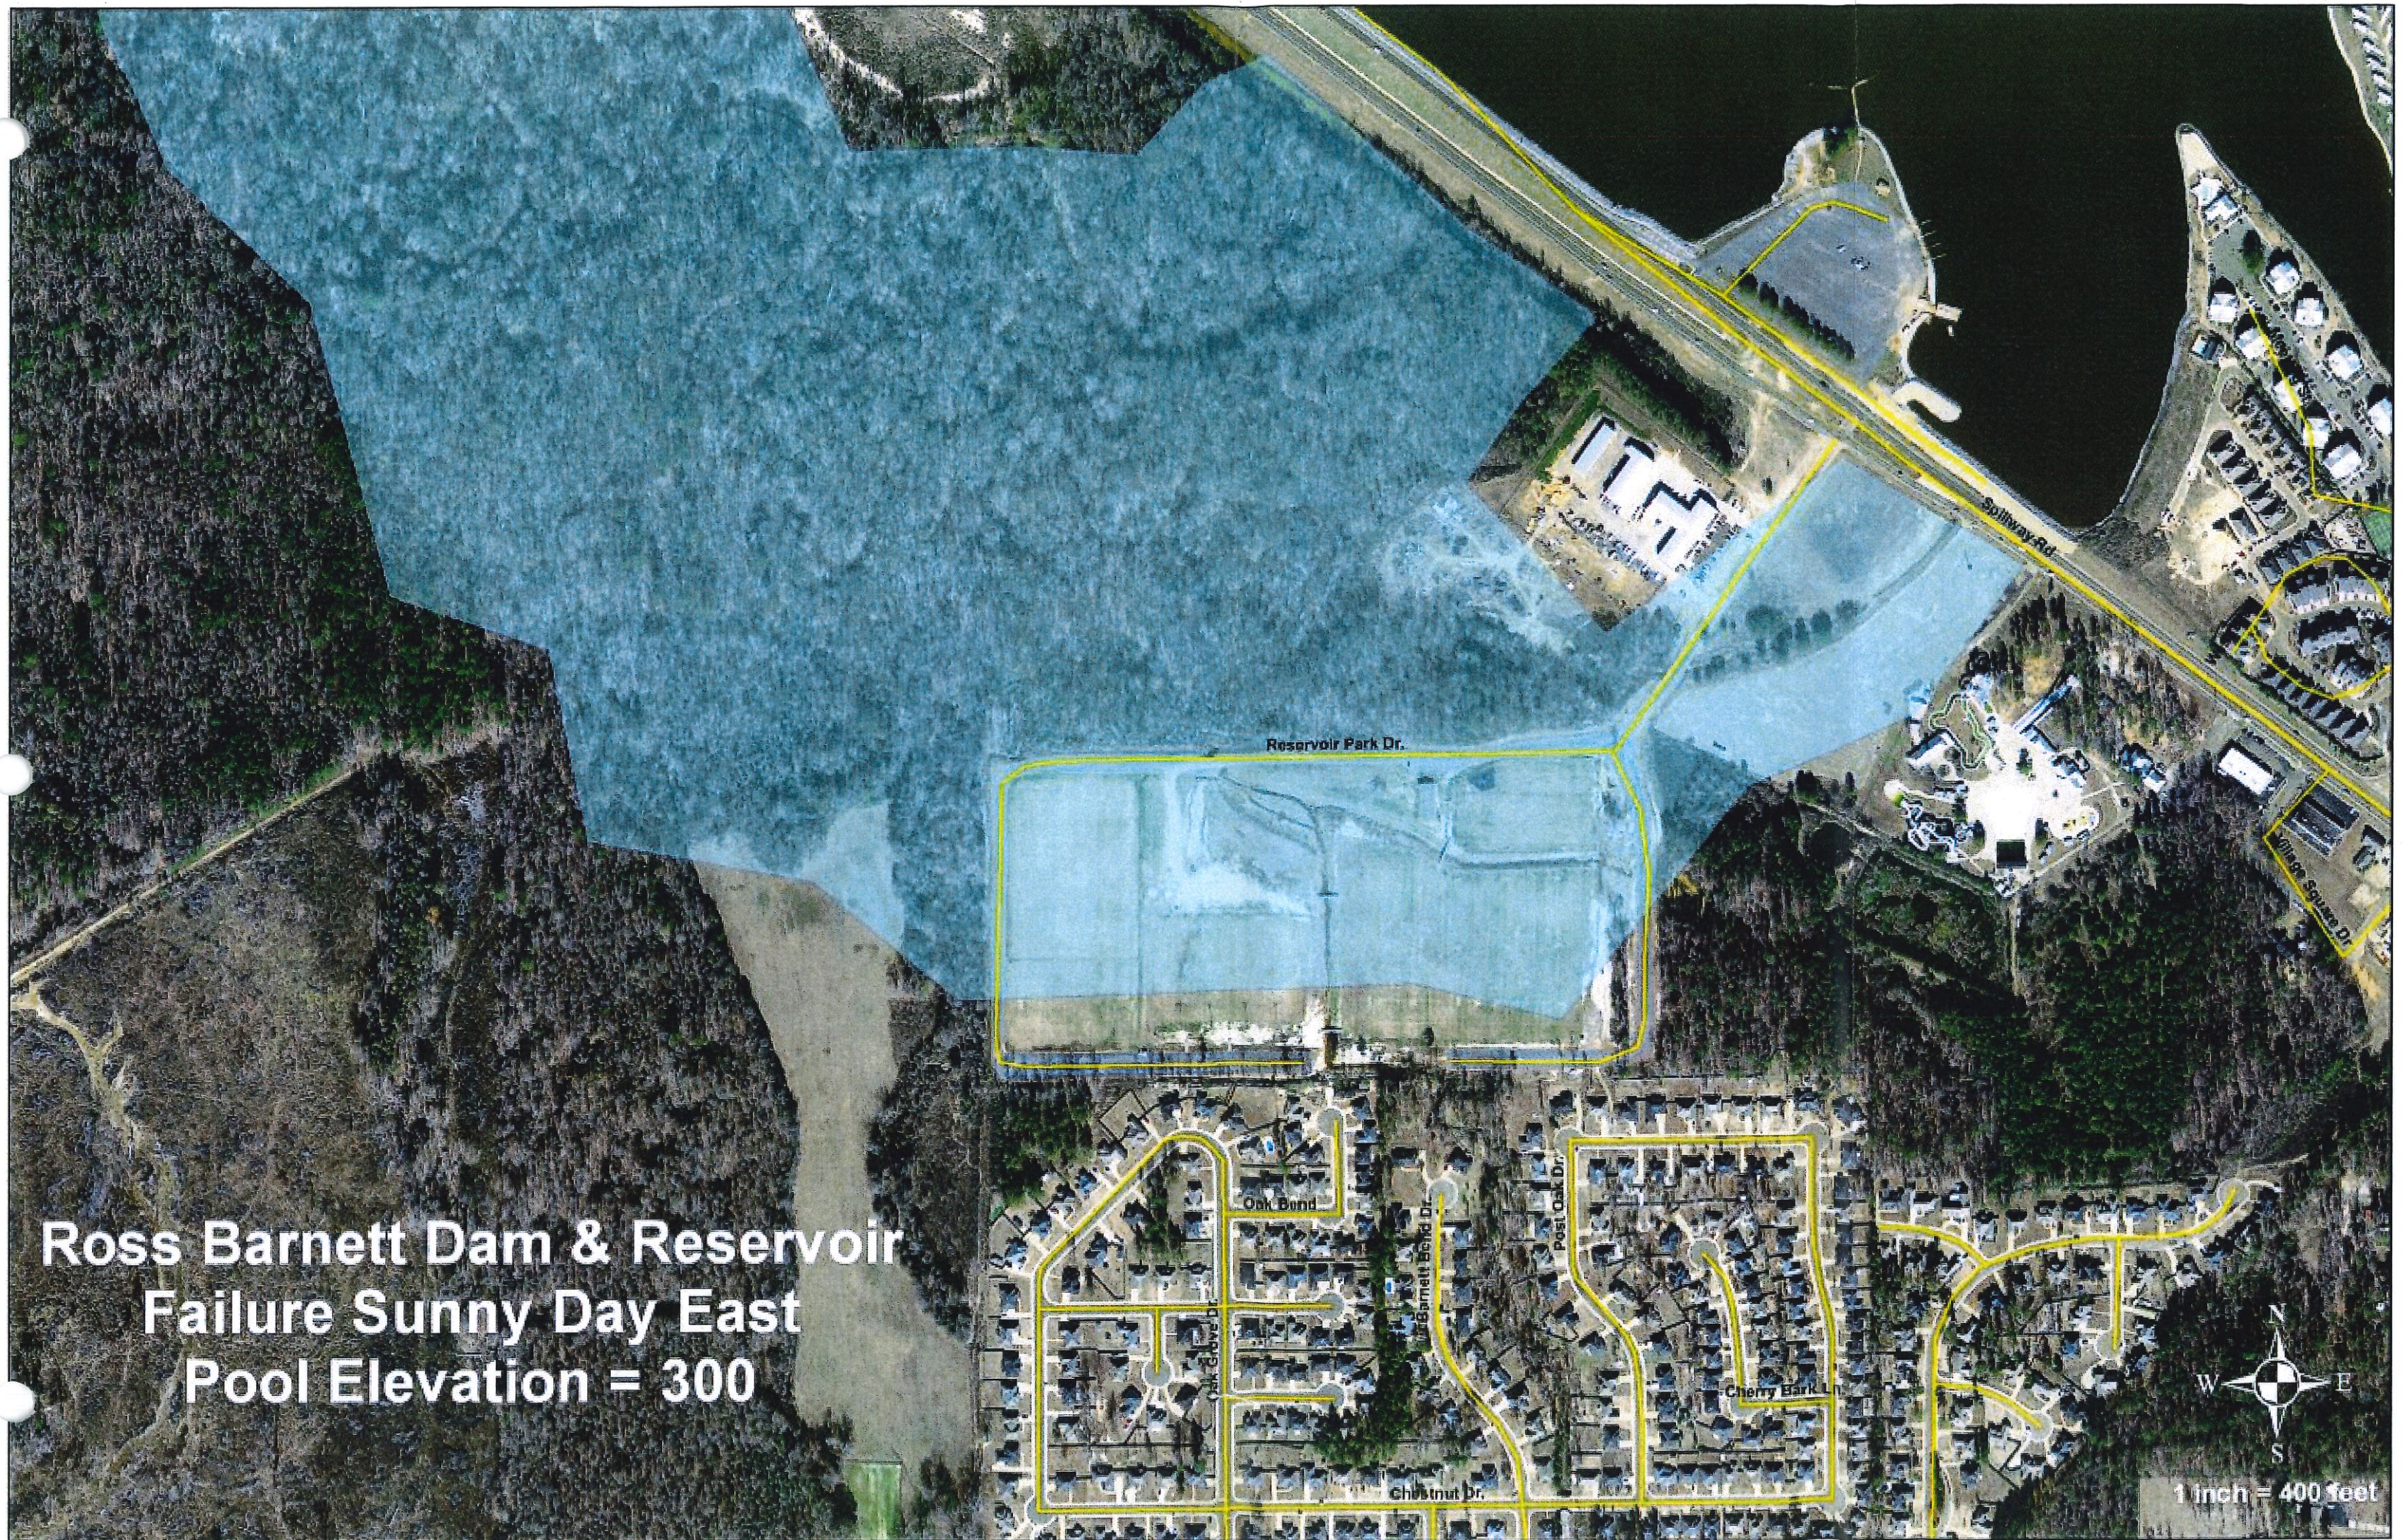
Ross Barnett Dam & Reservoir Failure Sunny Day West Harbor Pines Mobile Home Community

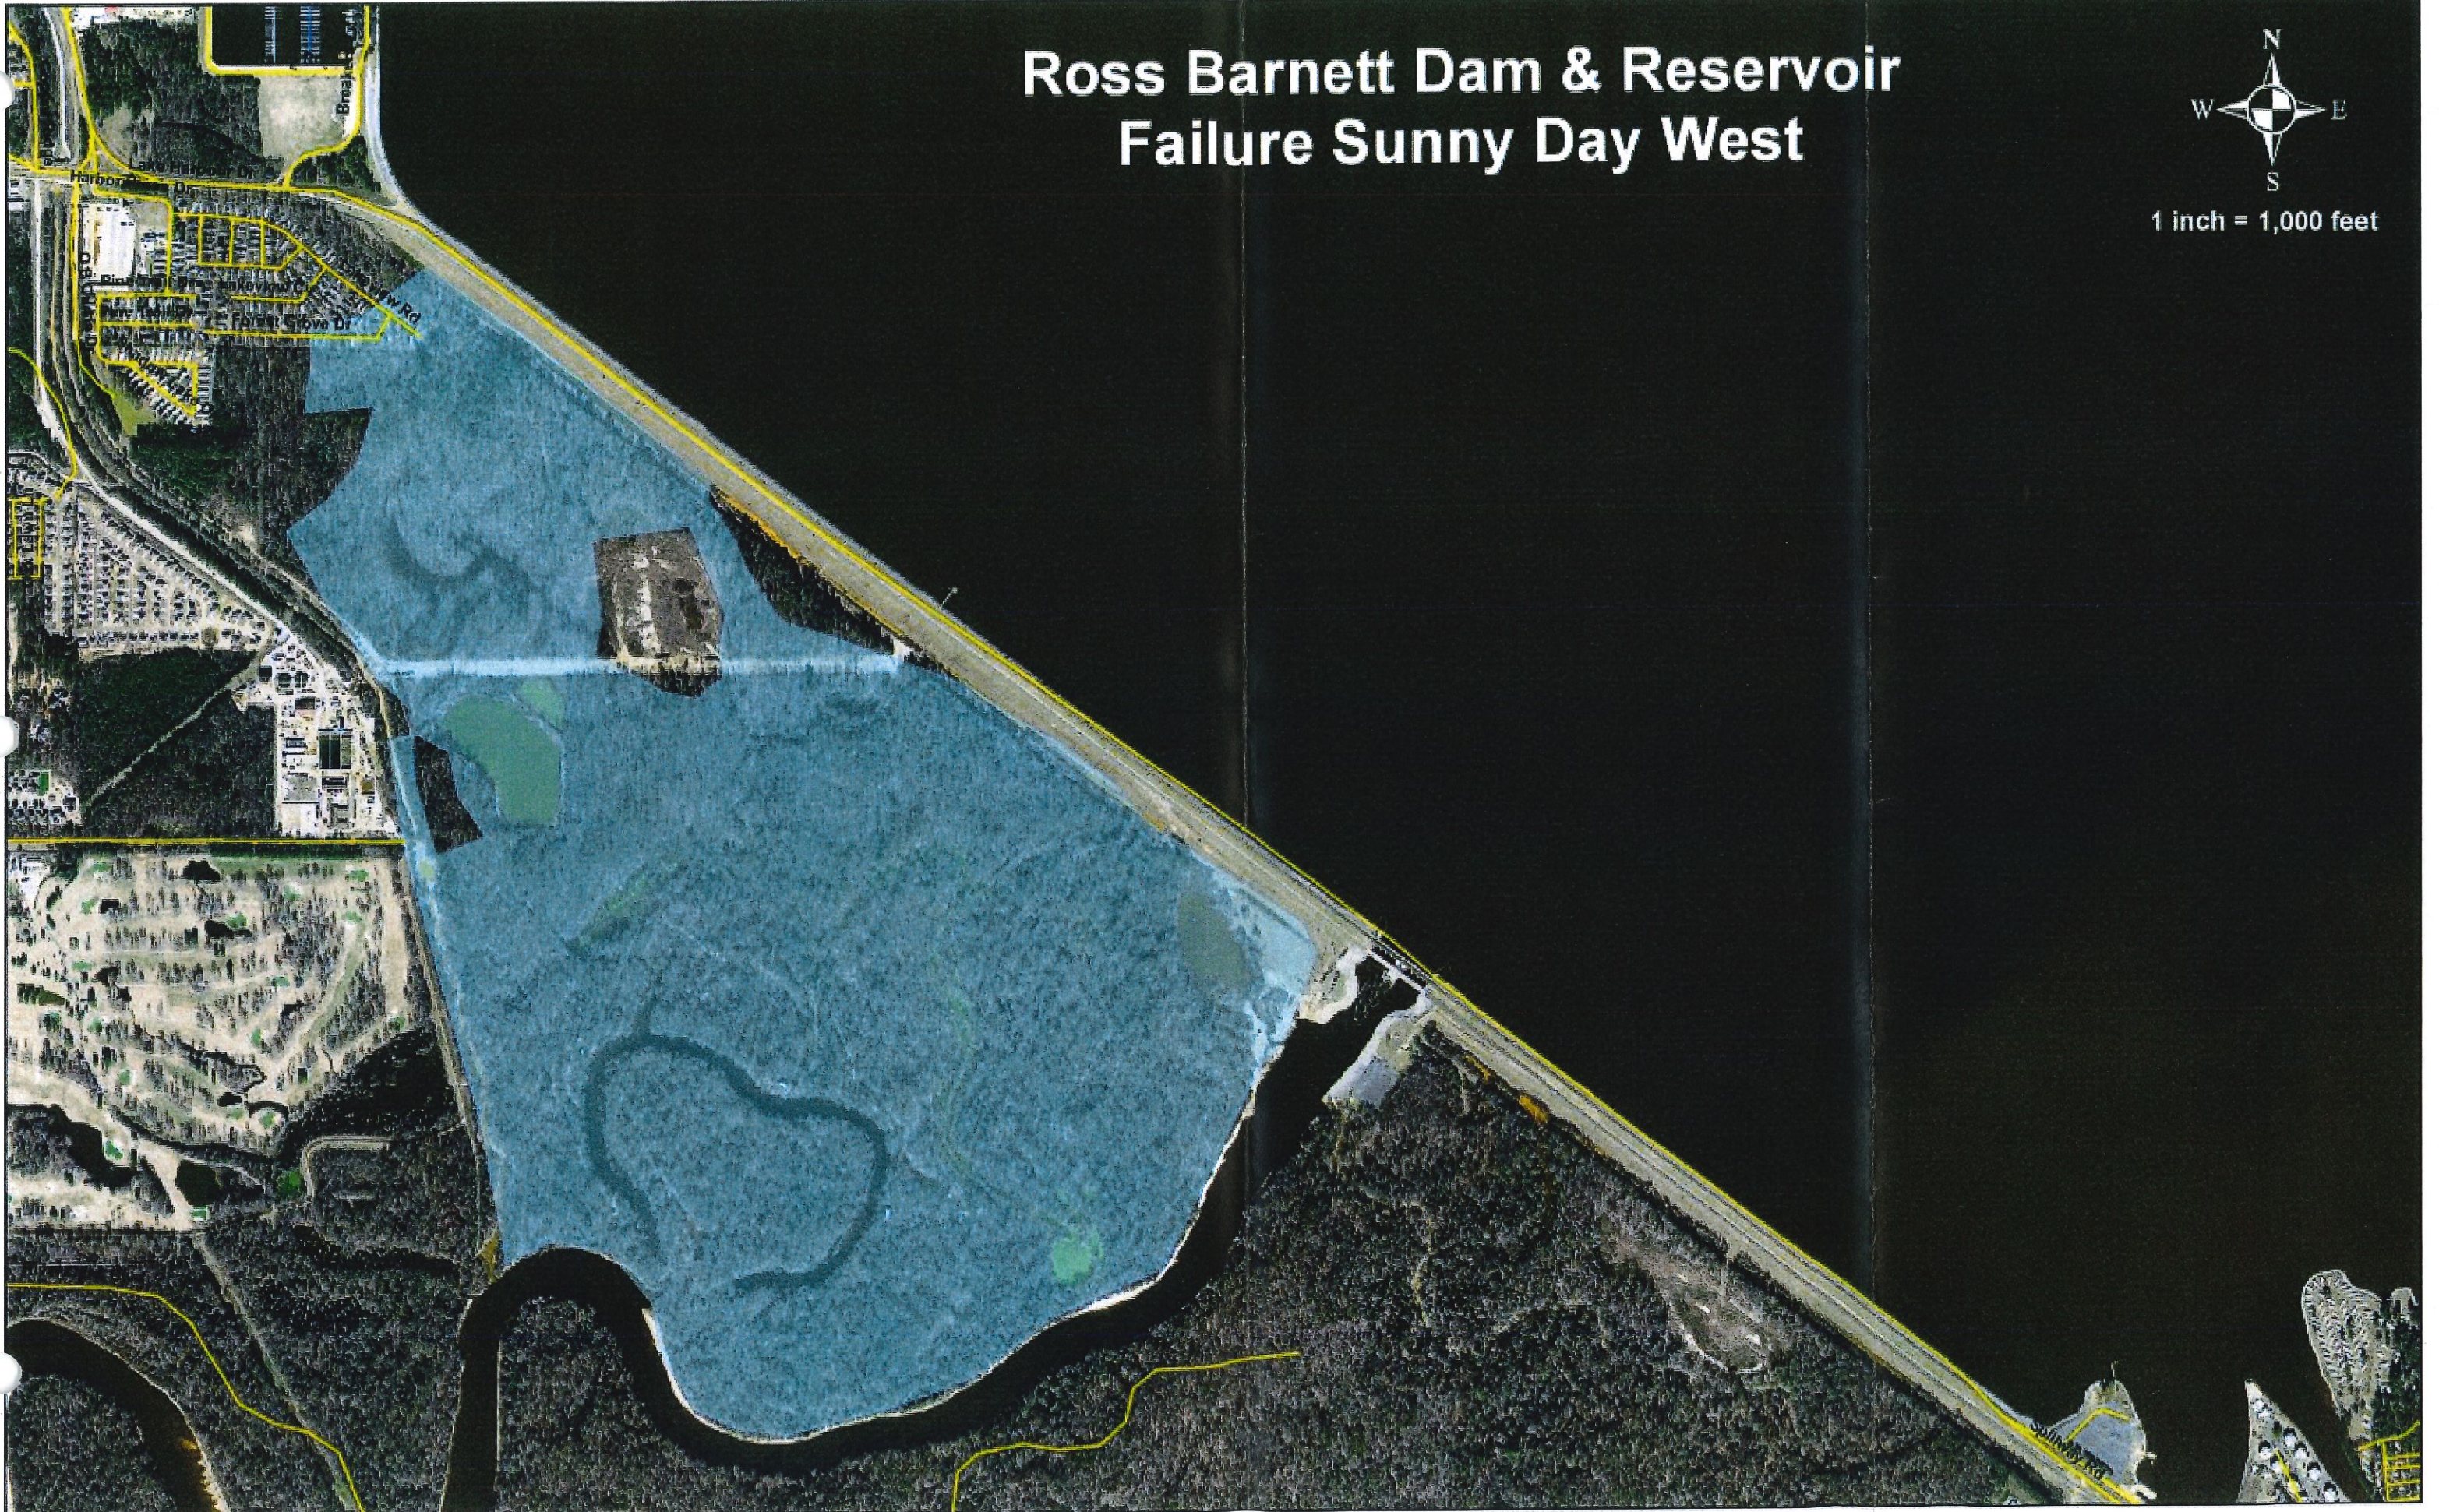
**Ross Barnett Dam & Reservoir
Failure Bank Full Stage
Inundation Maps
Index**

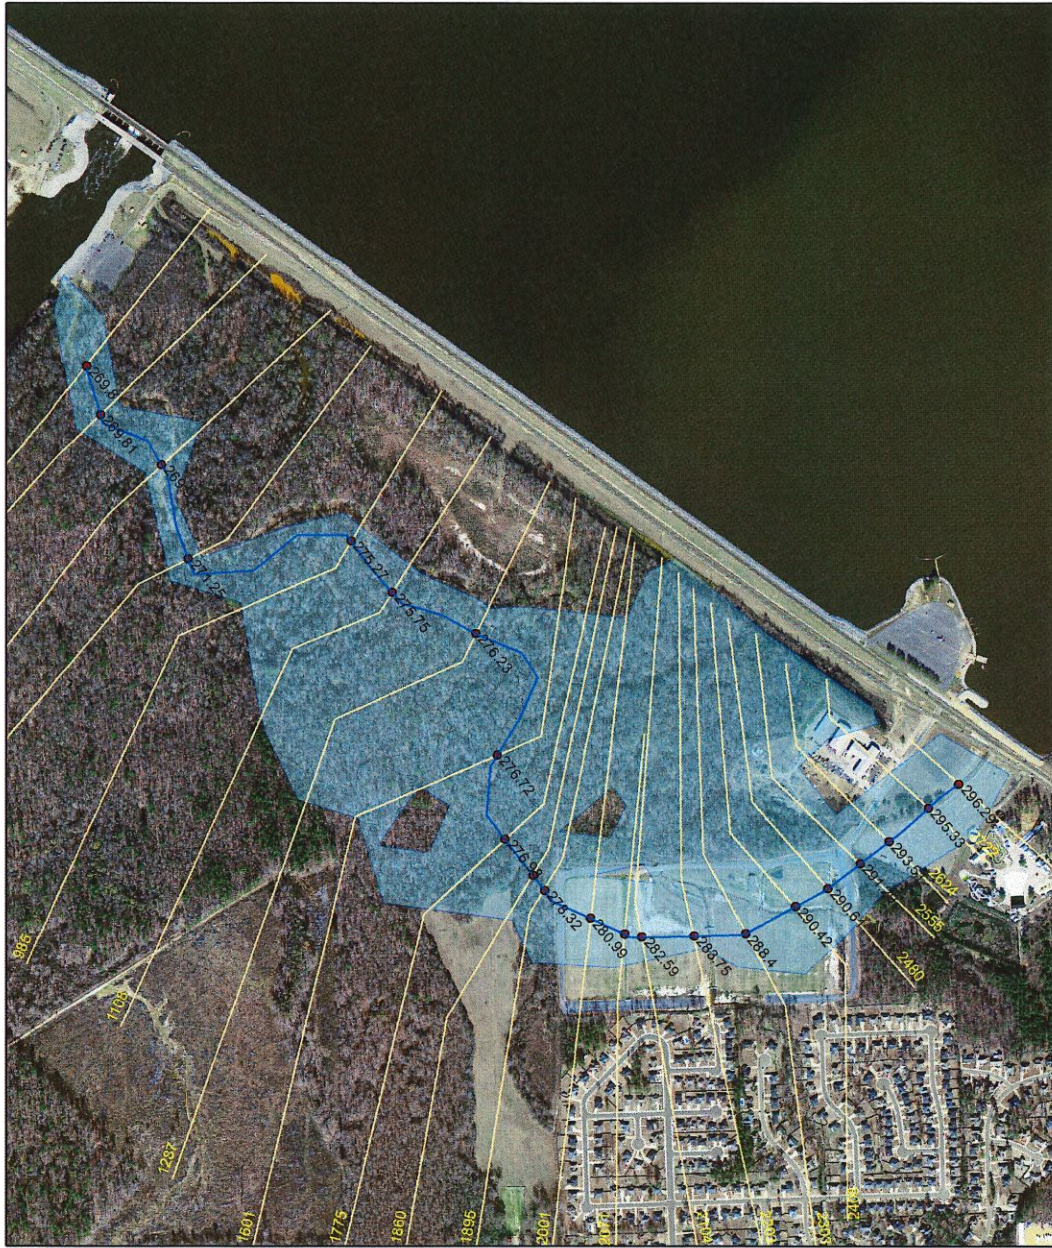
Plate 11a

Ross Barnett Dam & Reservoir
Failure Sunny Day East
Pool Elevation = 297 Feet

commercial areas in the vicinity with the flooding raising the Jackson gauge to 21.0 feet. The impacted area can be seen on Plate 11.

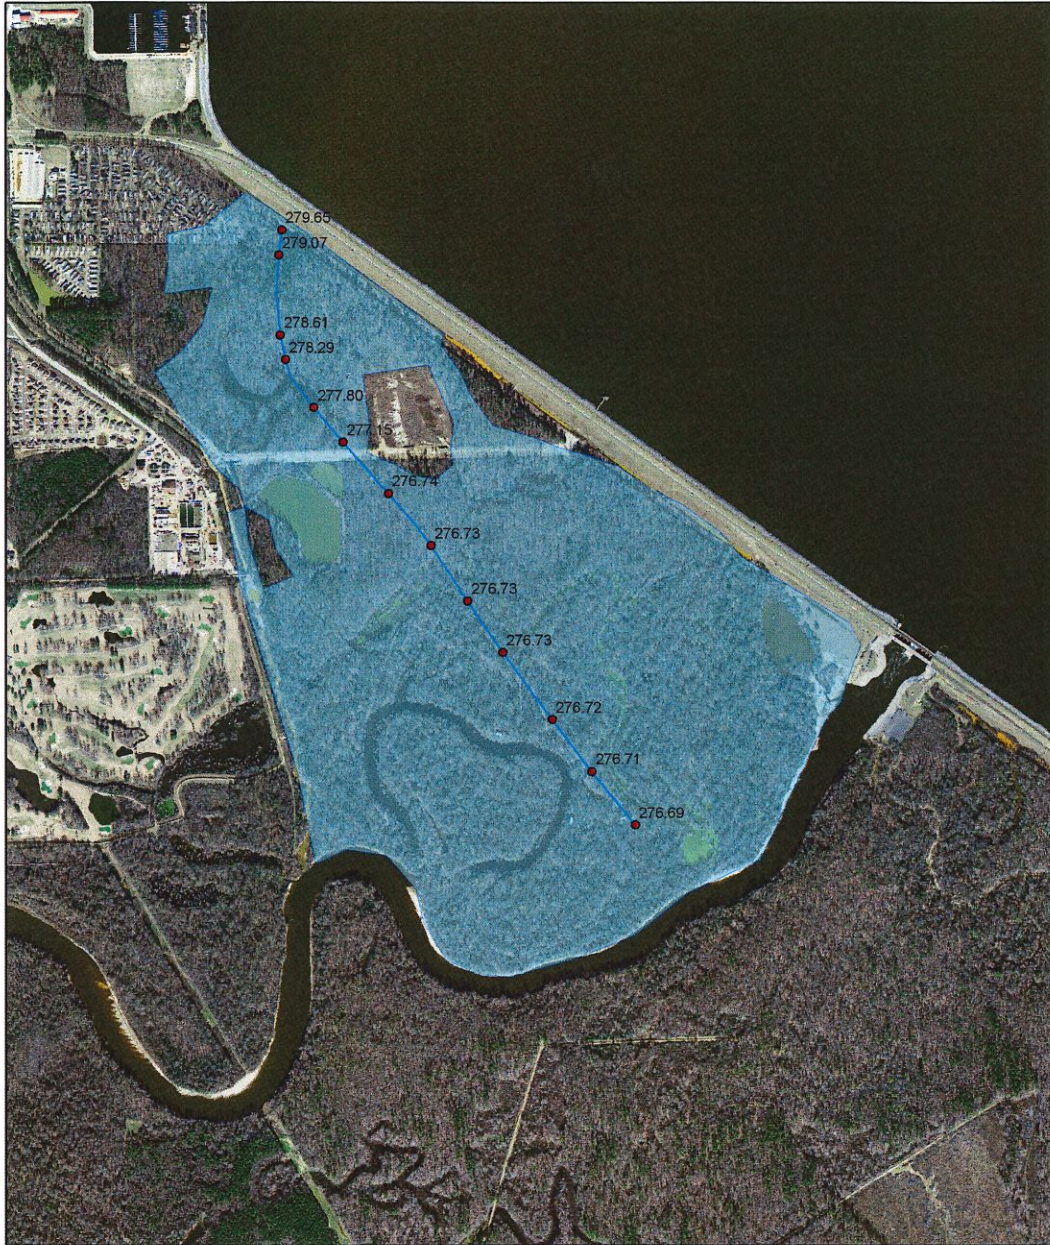
Plate 12

Ross Barnett Dam & Reservoir
Failure Sunny Day West

The Sunny Day West event breach was located near the mobile home park on the west end of the Dam. The results show very little to no impact on the park with the flooding raising the Jackson gauge to 15.9 feet. The impacted area can be seen on Plate 12.
